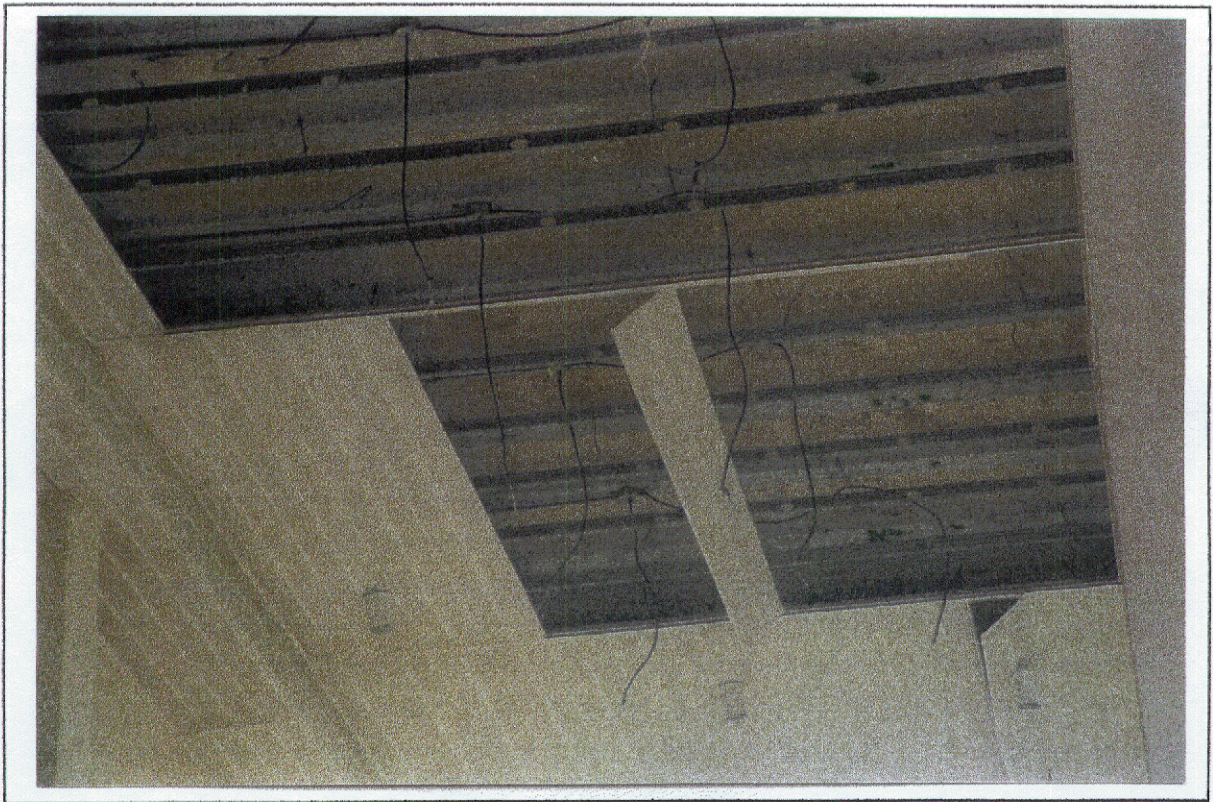
Photo 11 - Suspended ceiling at the entrance to the Hospital
A large proportion was removed during the passage of Keith

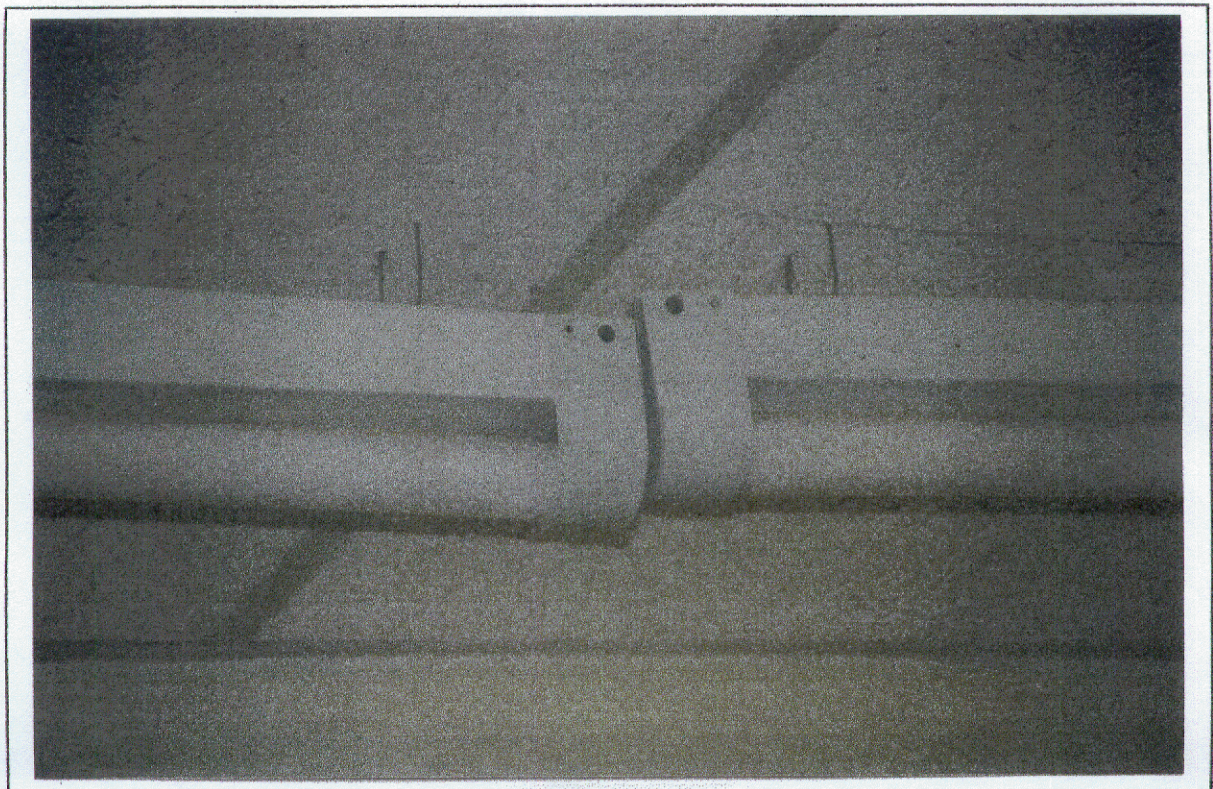
Photo 12 - Suspended light fixtures in the Hospital
Inadequately attached, even without an earthquake
