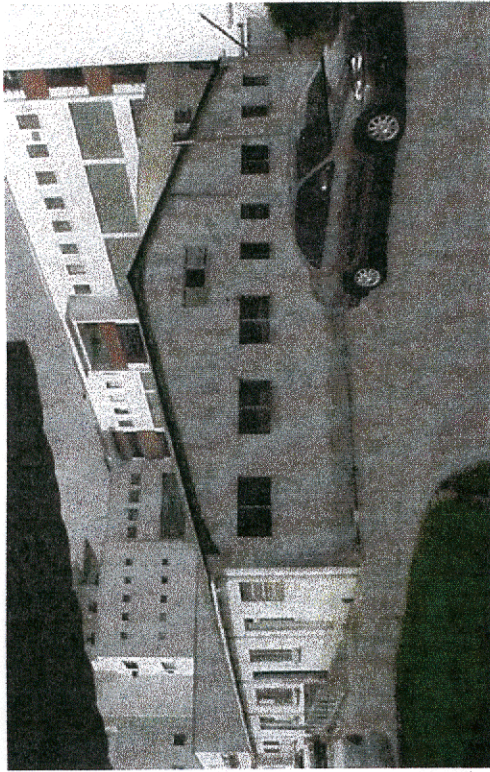
**Photo 21.** The South elevation of the Orderlies' Dormitories.

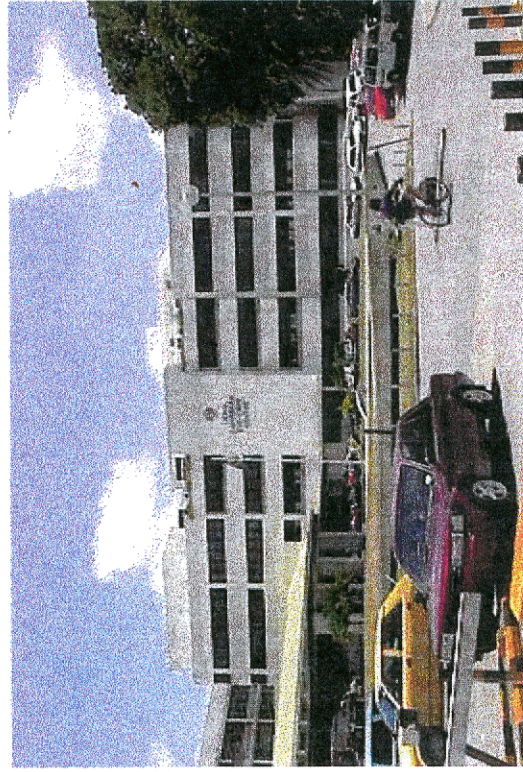
**Photo 22.** The Lion's Eye Care Centre, occupying the upper three floors of the building, is not yet functional. The Accident and Emergency Ward, on the Ground Floor, is in use.

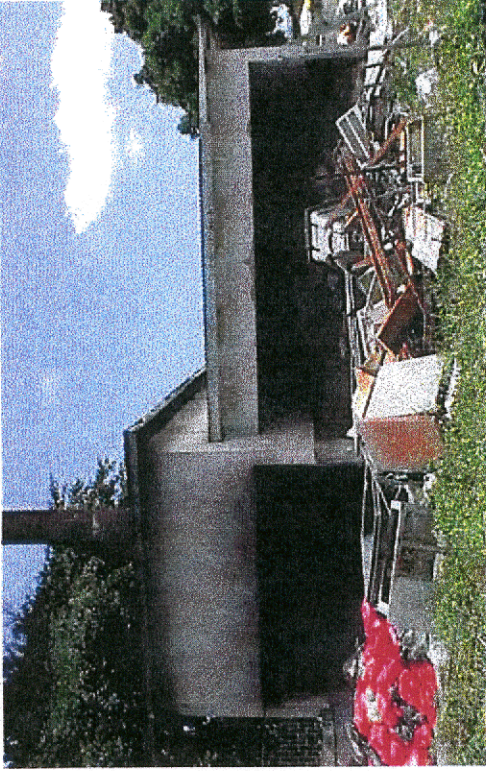
**Photo 23.** The harsh environment in which the Small Incinerator is located has proved to be detrimental to its condition.

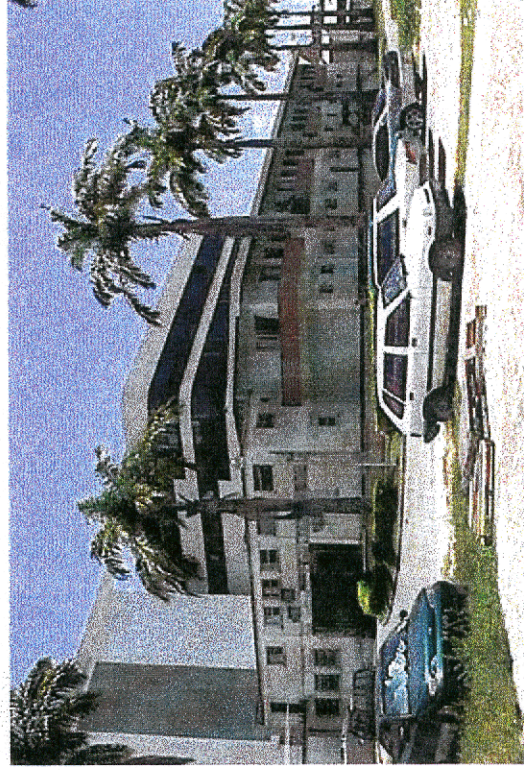
**Photo 24.** The Delivery/Storage Annex and its entrance, as viewed from the North. The Engineer's block can be seen in the background.
