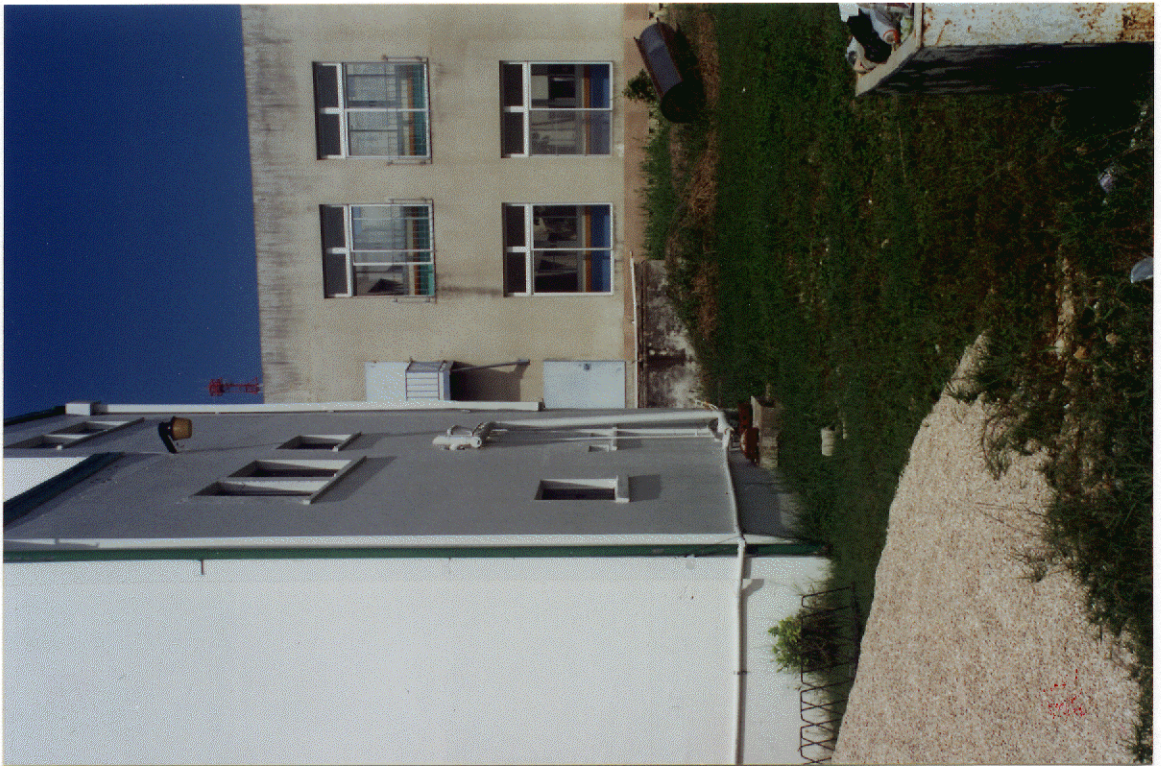
Photo 5 - Vulnerability to flooding

Lower floor of adjacent KMHM (background) is at the Category 2 storm-surge level

Lower floor of Laboratory is substantially lower than that of KMHM

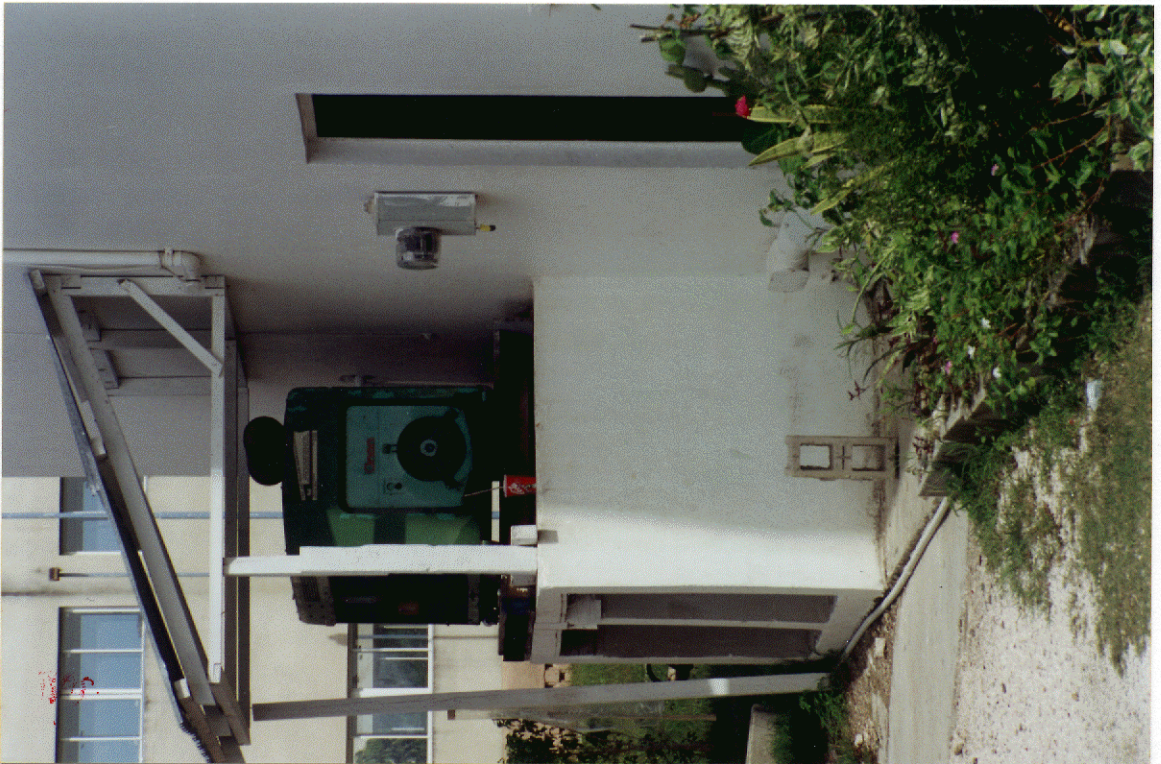
Photo 6 - Standby generator

Elevated to reduce vulnerability to flooding

This generator was not in working order at time of visit.
