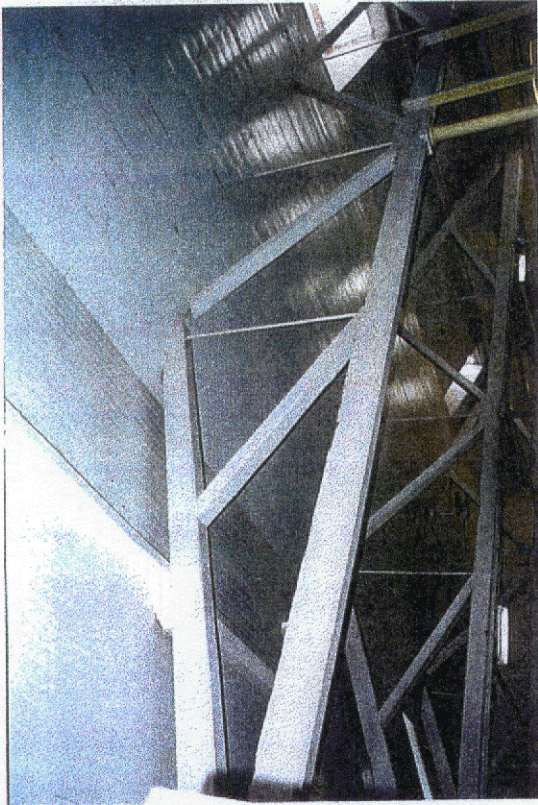
Photo 25: Typical roof truss in Femal Ward.

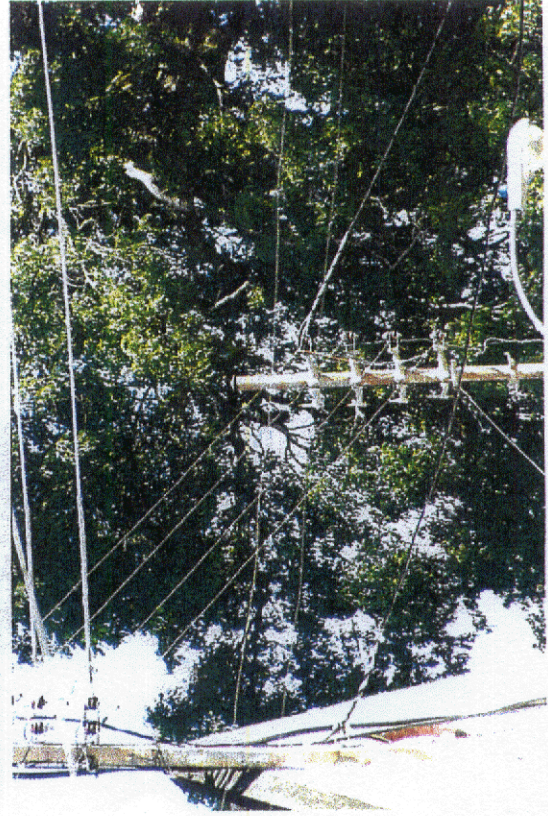
Photo 28: Electrical distribution wires suspended on poles on hospital compound. These are prone to damage during a hurricane and should be buried.
