## **APPENDIX D**

### Photographs

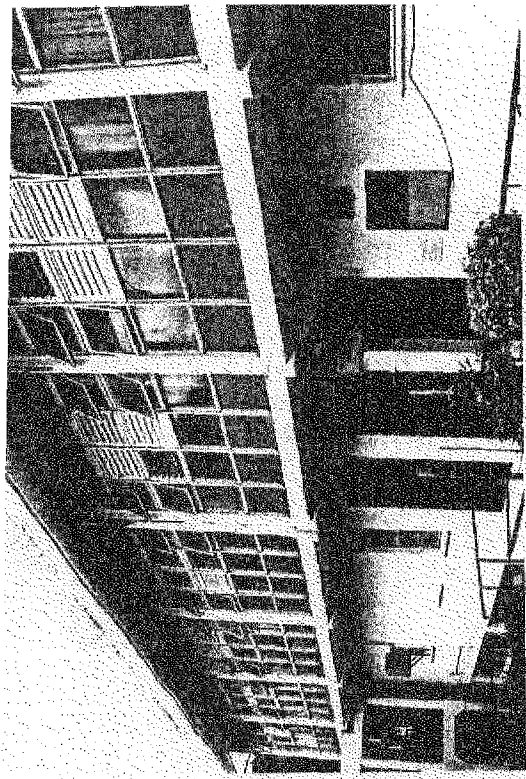
3. These large glass panels on the eastern face of the Paediatric Wing are very vulnerable to flying debris during a hurricane.

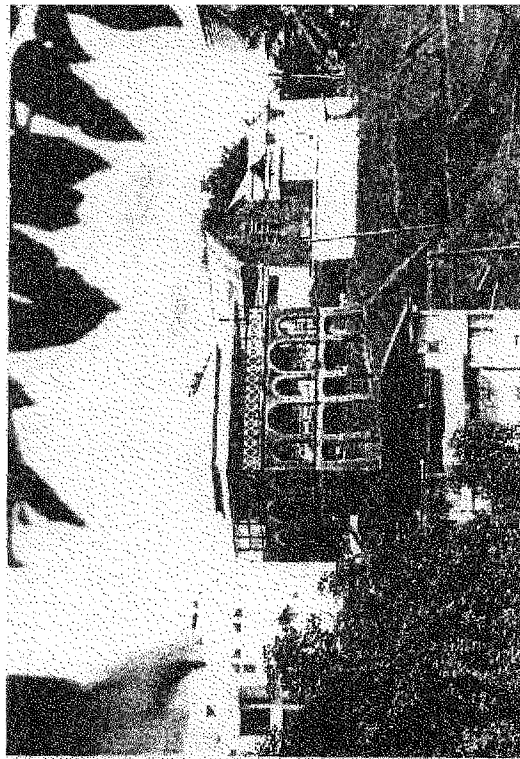
2. The Baron Wing with the new maternity block to the left and the water tank and part of the L-Block to the right. The Chest Wing is partly hidden in the foreground.

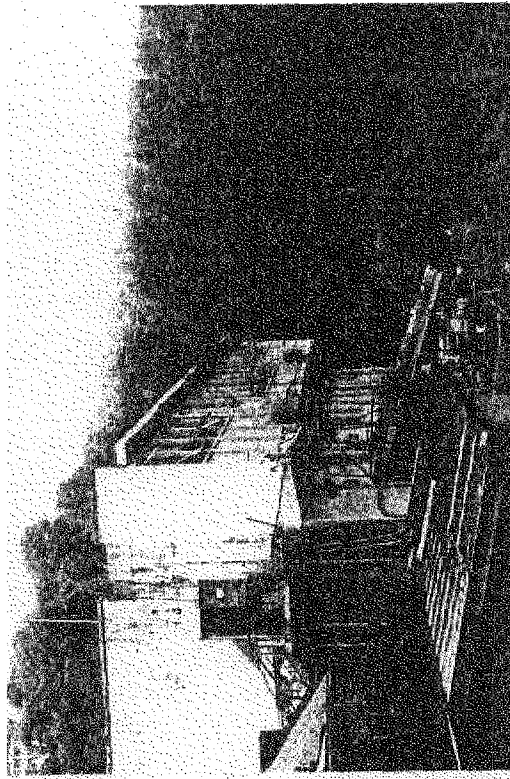
4. More glass and evidence of lack of maintenance on the west face of Paediatrics.

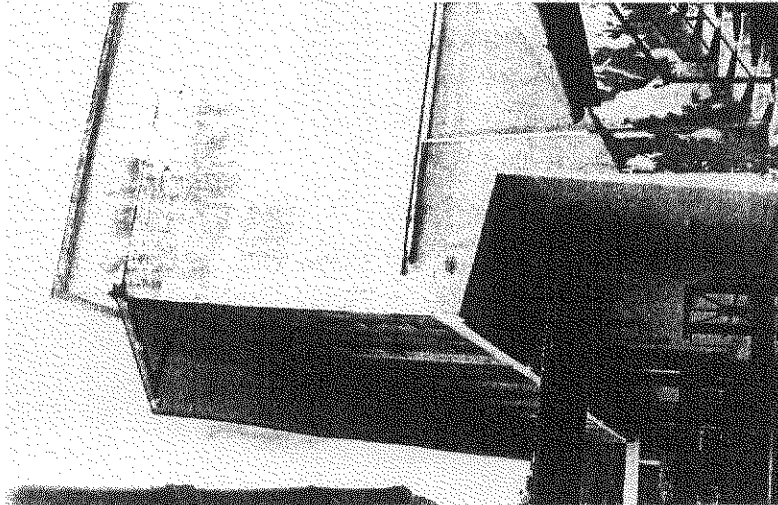
5.

General deterioration on the Paediatrics Wing. Note vertical cracks in upper and lower columns and horizontally along the bottom of the roof ring beam.

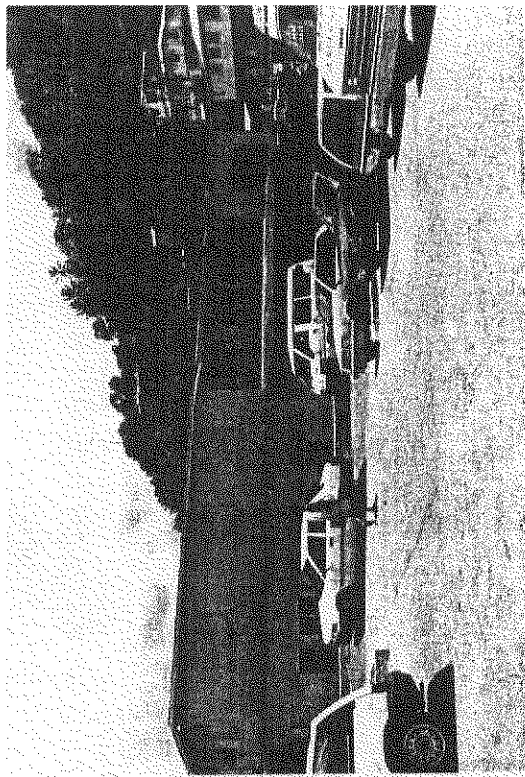
8.

The Laboratory building at the rear of the administration building. Note the slender columns and the link between the two structures.

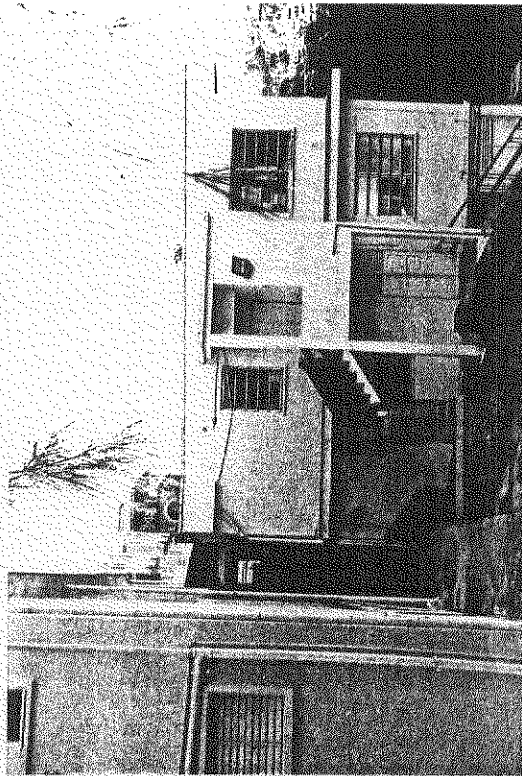
6. A view of the multi-storey structure which houses Cardiology, Nephrology, an STD unit, nurses quarters and a cafeteria.
