2.30 St John's Health Centre

This building suffered substantial damage.

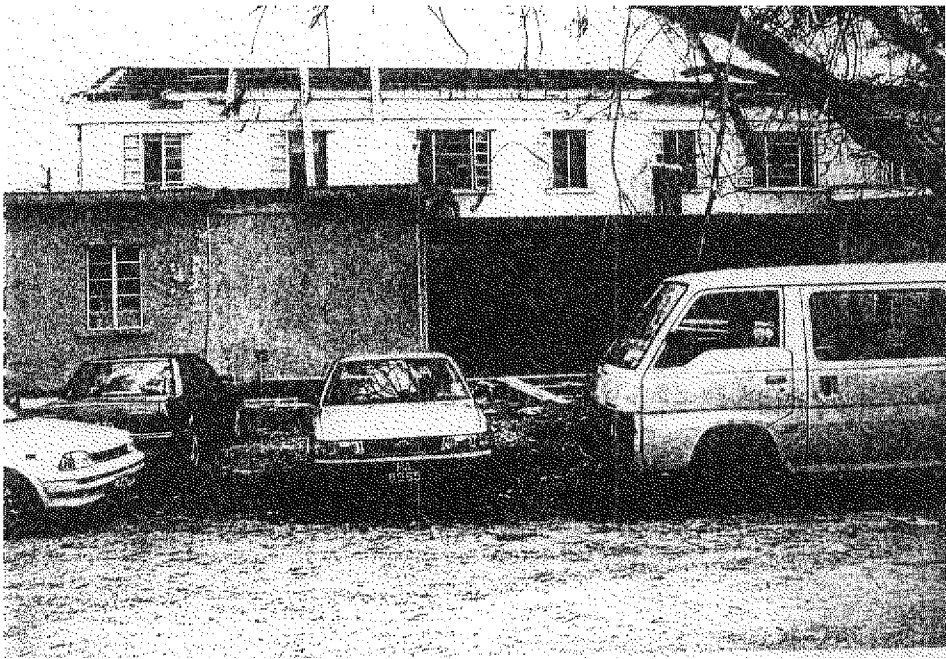
- Much of the roof sheeting, some of the roof structure and most of the upper-floor ceiling were damaged or destroyed.
- Dental Unit - water through ceiling; some window catches missing

St John's - destruction of roof.

- Repairs were in progress, being executed by the Jamaica Defence Force, under the supervision of Mr Beazer of the Public Works Department
- This building was badly damaged by Hurricane Hugo 6 years earlier. It was repaired but not obviously strengthened.
- The upper floor was in use although repairs were in progress on the roof. This was clearly dangerous.
- The "Nissan" huts used for storing old items are in a bad state of repair. They pose a danger to other buildings on the compound in that, should they fall apart, their components could damage otherwise intact property.

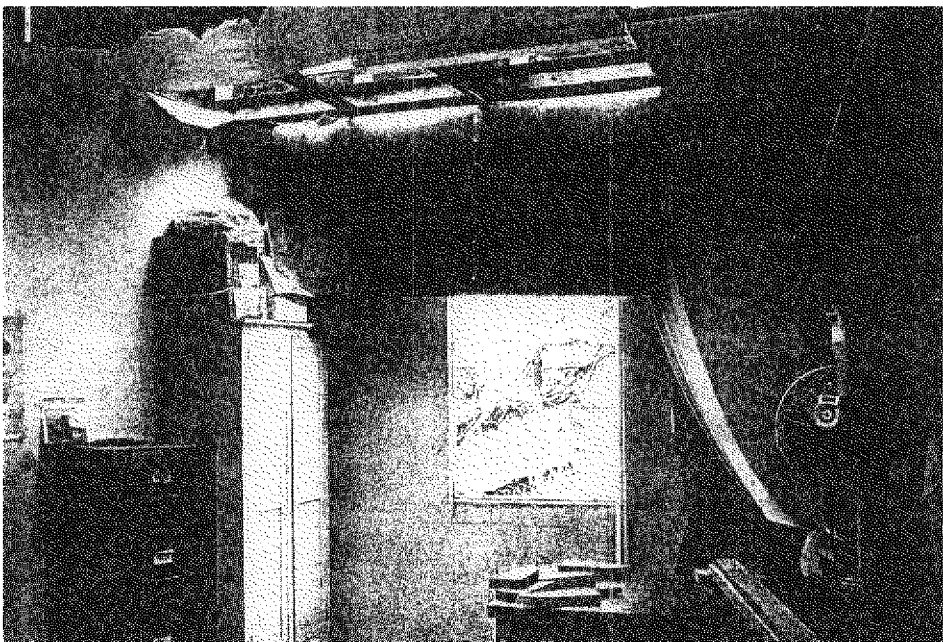
- Lunch Room - water damage
- Typing Room - water through ceiling
- Ivy-Jean Benjamin's Office - a lot of water; ceiling destroyed (termite invested before Luis)

St John's - consequent destruction of ceilings.
