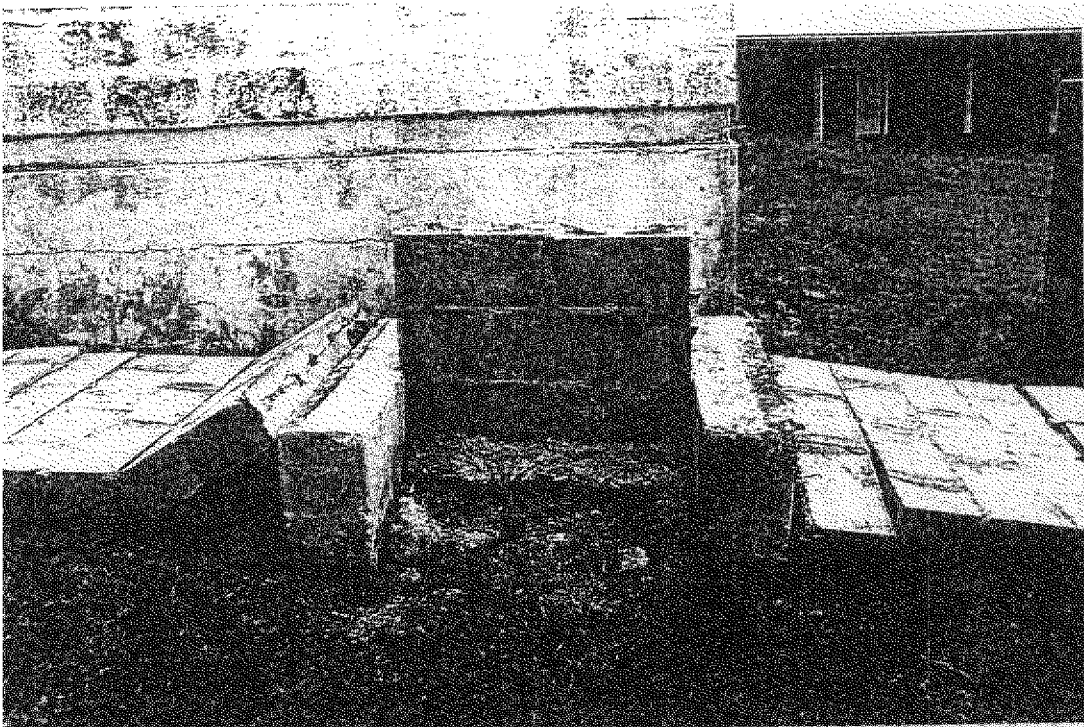
Photo JH-3: Blockwork piers to water tank collapses. Note no tying of 6" blocks to the original 8" blockwork piers.

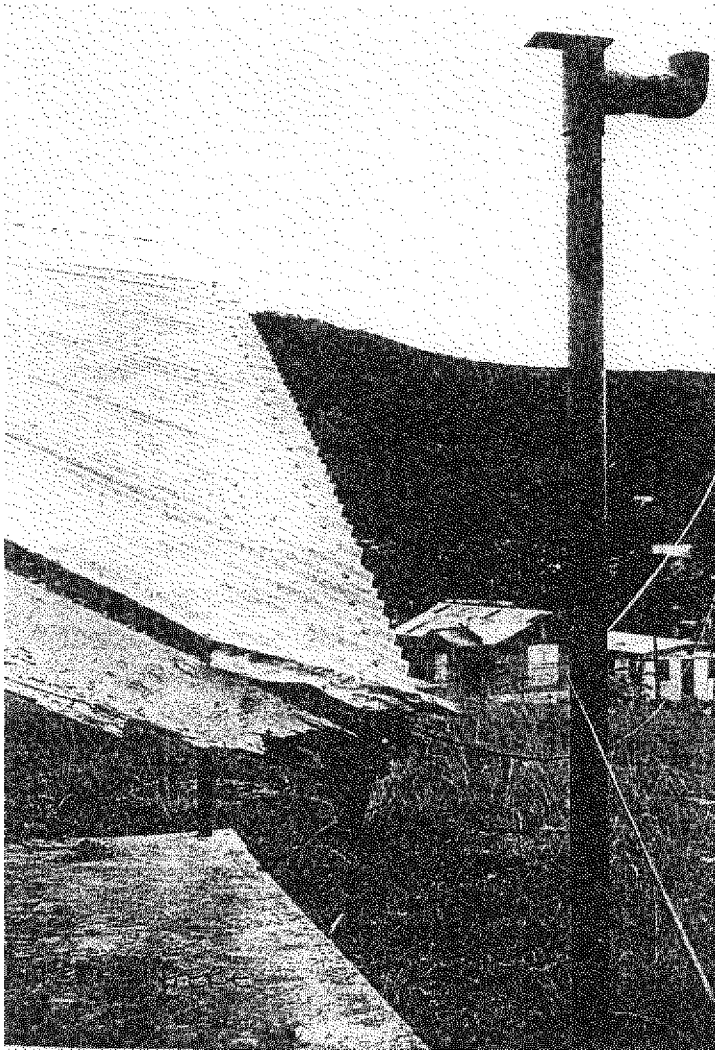
Photo JH-4: Rotten end of support to patio roof.
