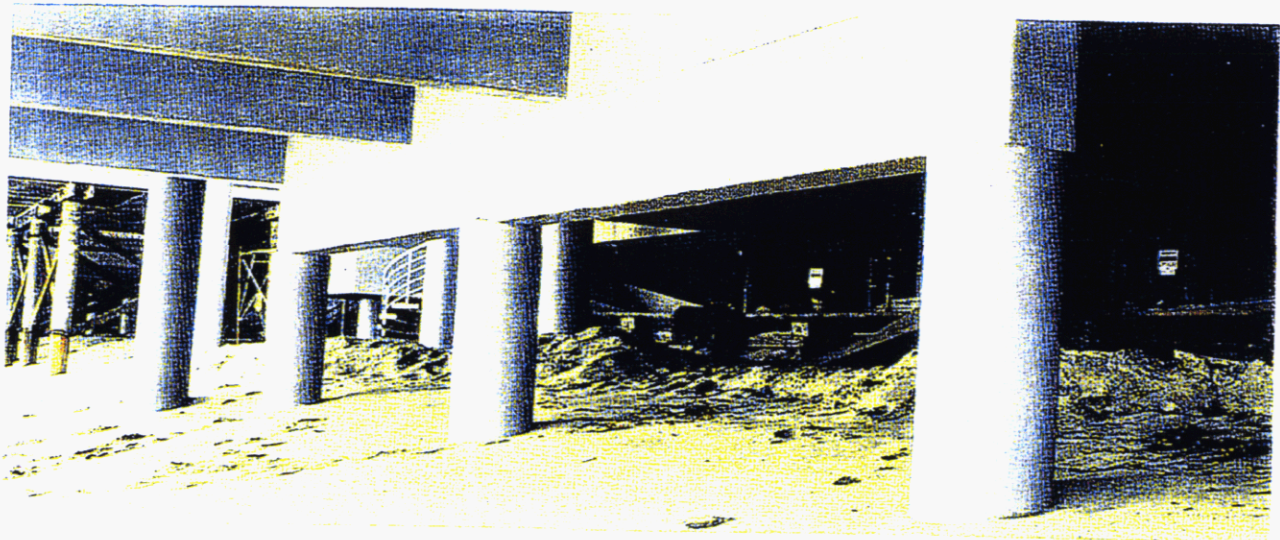
Completed beam and column application in Malibu, California.

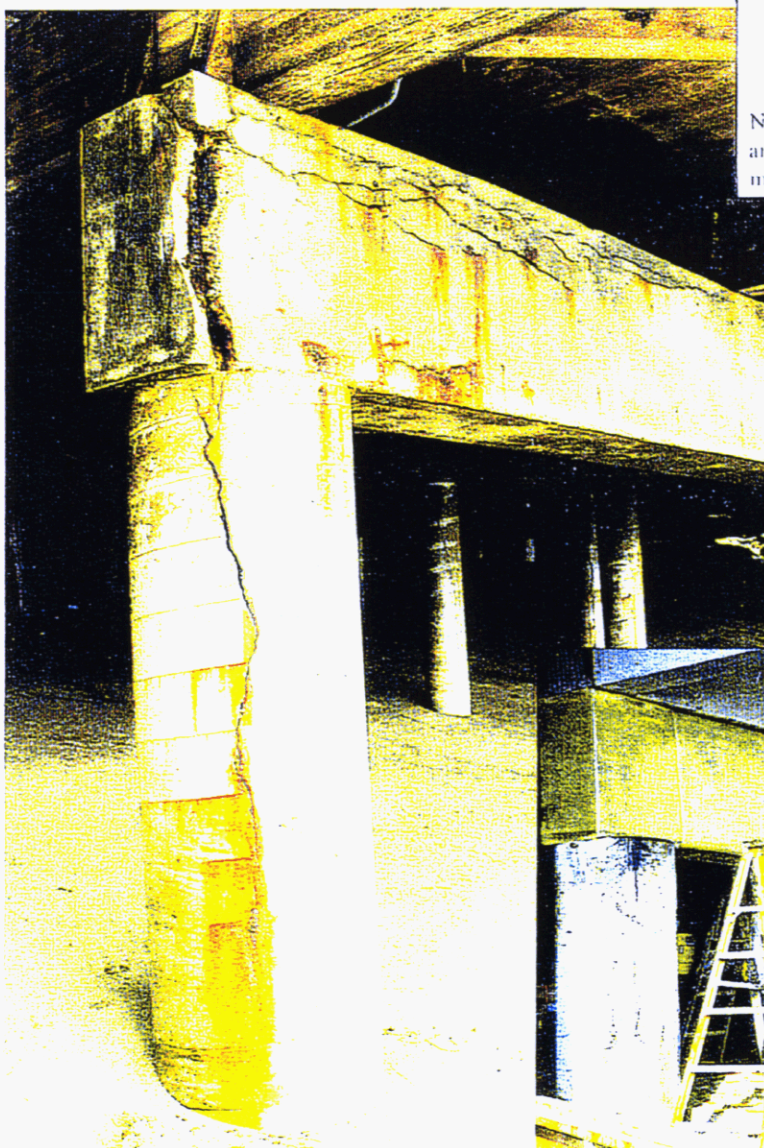
Severely corroded beam-column on Malibu Beach. Deteriorated concrete was removed and repaired prior to application of Fiberglass™.

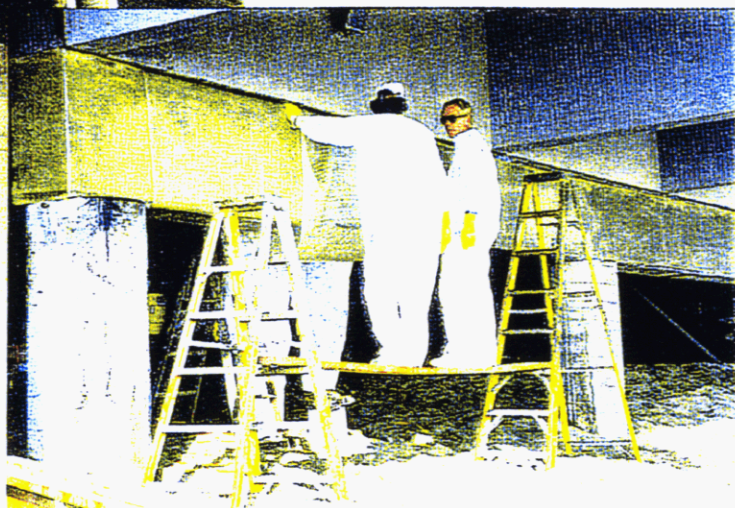
Simple hand application of saturated Fiberglass™ to the underside and sides of a beam on the beaches of Malibu.
