Completed beam and column application in Malibu, California

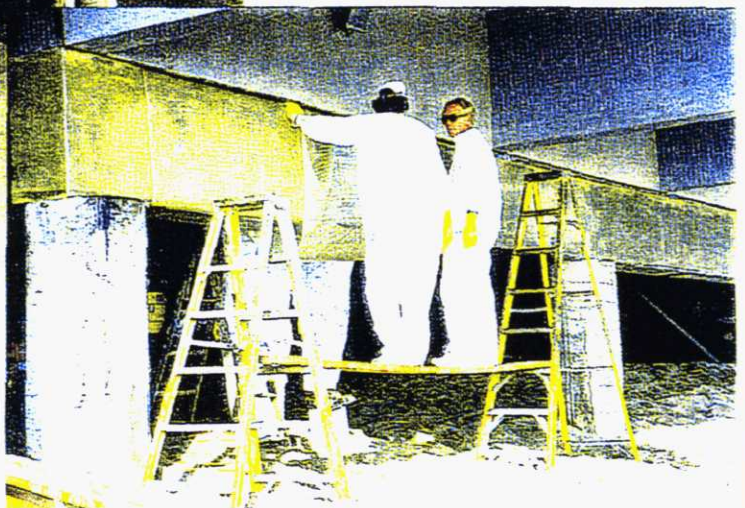
Simple hand application of saturated Fibrwrap™ to the underside and sides of a beam on the beaches of Malibu.
