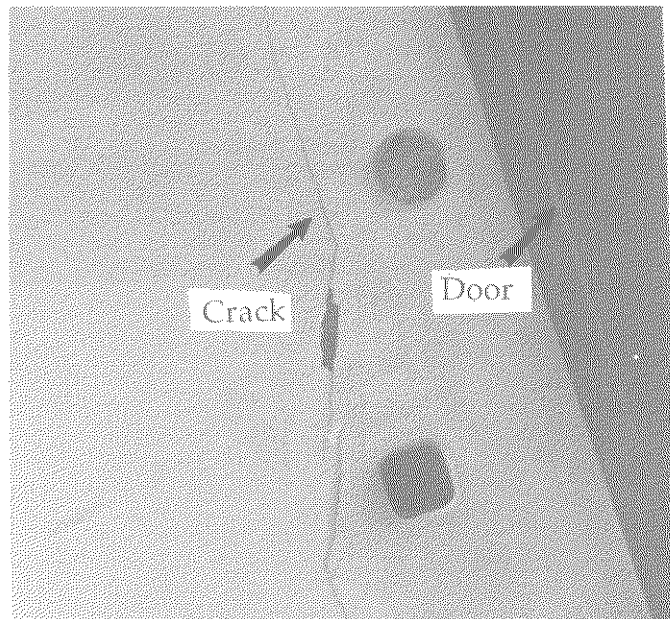
Figure 3-3: 42-story high-rise concrete buildings in Cairo experienced only nonstructural damage.

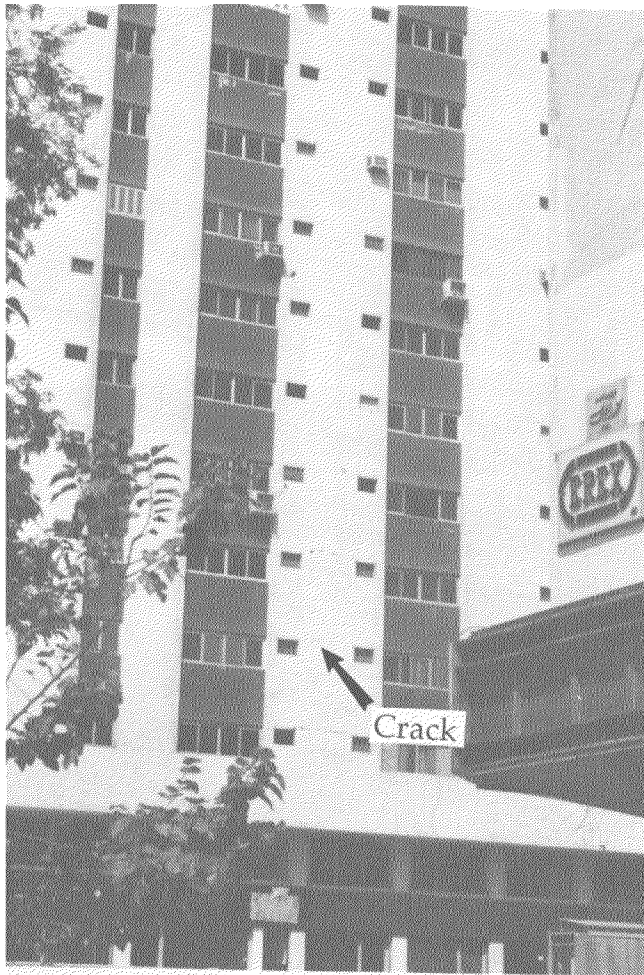
Figure 3-4: Nonstructural horizontal cracks in a 14-story concrete-frame building.
