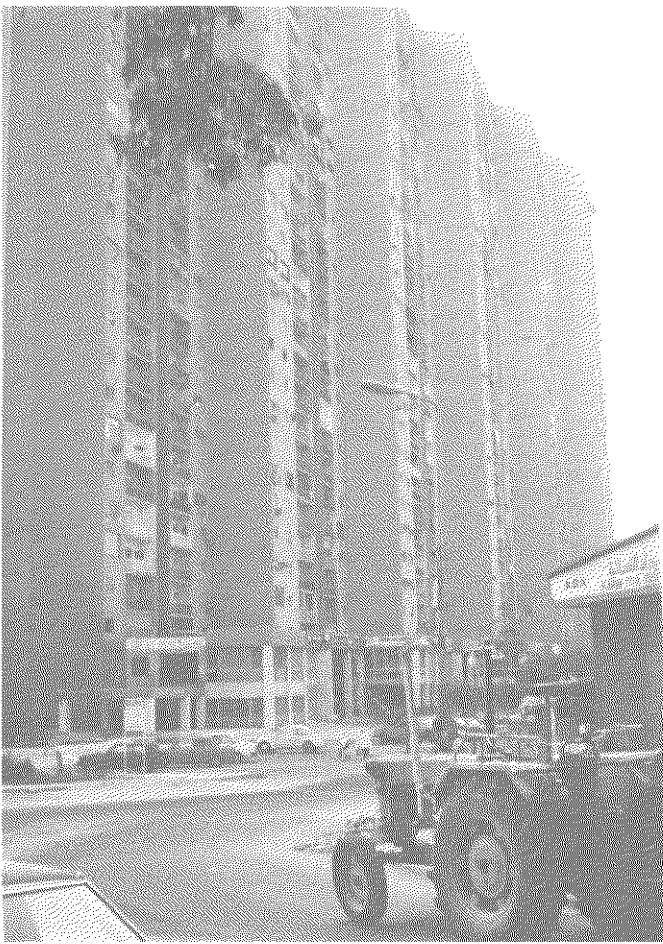
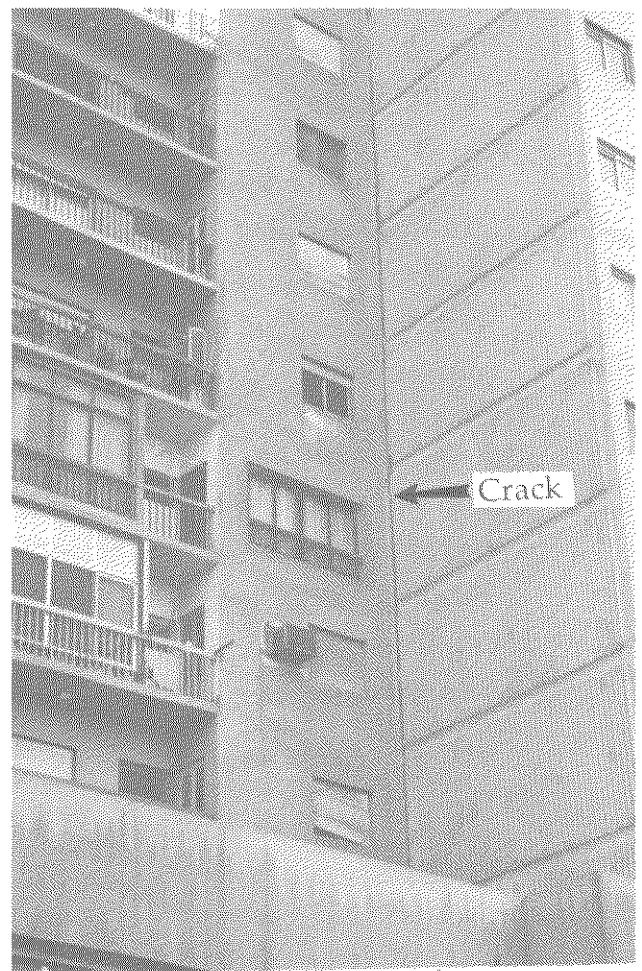
Figure 3-5: Vertical crack in a 36-story shear wall concrete building due to building irregularity.

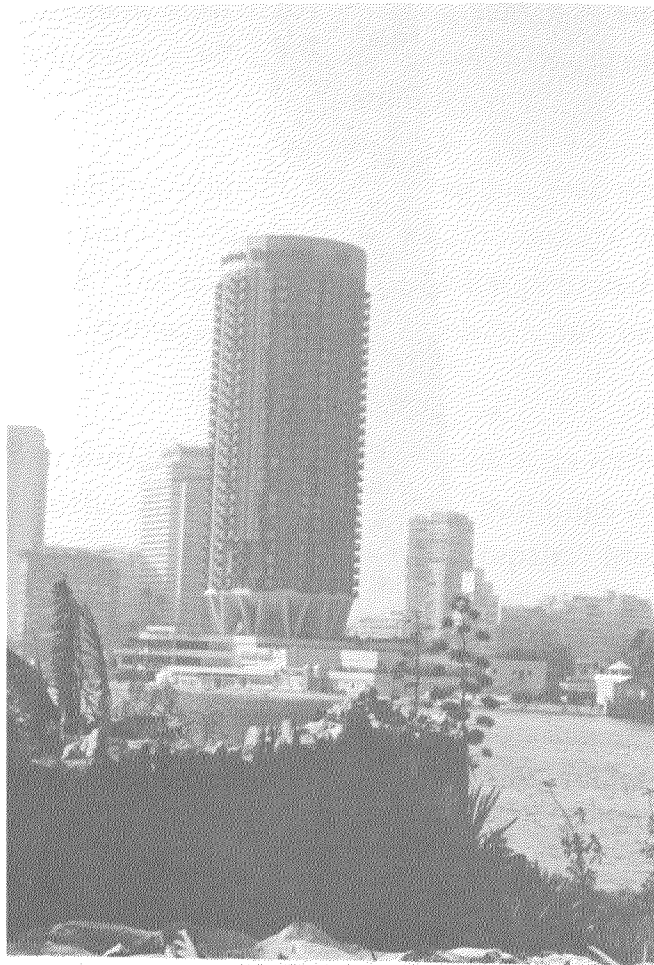
Figure 3-7 shows a new, 30-story cylindrical hotel (about 20 km from the epicenter). The first three stories of the building are concrete, and the remaining 27 stories are of moment steel frame. The building is supported on wedge columns as shown in Figure 3-7 and sustained only nonstructural damage from the earthquake.

Figure 3-7: 30-story cylindrical hotel sustained only nonstructural damage.
