9.4.4 Concrete Masonry Walls

9.5 ROOF FRAMING & CONNECTIONS

9.6 BRACING & DIAPHRAGMS

10 CASE STUDIES – REHABILITATION

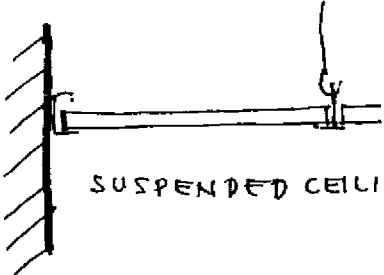
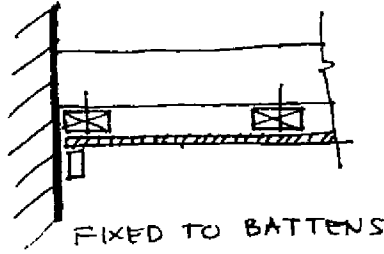
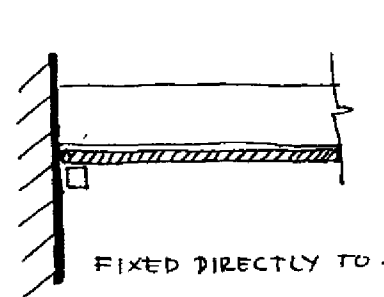
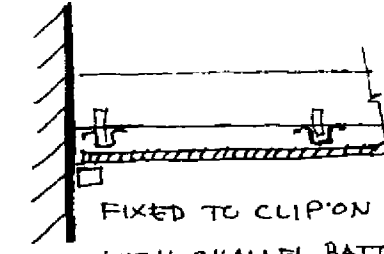
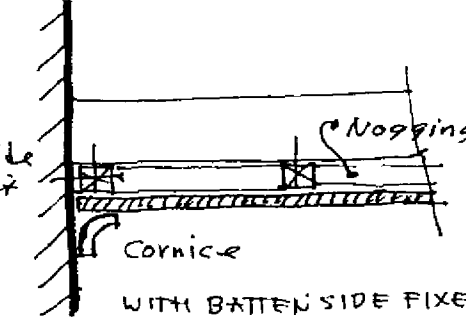
CEILING SHEETING AS DIAPHRAGMS

<p>SUSPENDED CEILING</p>	Strength per m ² kN/m ²	Strength 10.0m length kN/m ²

<p>FIXED TO BATTENS</p>	ZERO	0

<p>FIXED DIRECTLY TO JOISTS</p>	0.5-1.7	5-17

<p>FIXED TO CLIP ON CHANNELS WITH CHANNEL BATTEN SCREWED</p>	0.7-1.5	7-15

<p>FIXED TO CLIP ON CHANNELS WITH CHANNEL BATTEN SCREWED</p>	0.1-0.2 0.6-1.0	1-2 6-10

<p>WITH BATTEN SIDE FIXED AND NOGGING TO JOINTS WITH CORNICE GLUED</p>	1.8-2.9	18-29

University tests of the Cyclone Testing Station in Townsville, Australia, have revitalised interest in the contribution that properly constructed ceilings can make to the integrity of the building by providing in the ceiling plane, significant resistance to the forces tending to bend the external walls.

Most ceilings, erected without consideration of the fact that the construction and its fixings are so important, can expect the ceiling to have an equivalent design strength of from zero to 0.8 kN/m.

With the better fixing methods, the design load can be increased up to 1.5 to 2.9 kN/m with better placement of sheet and more nails, holding the ceiling sheets to the

1. Plasterboard on clip on metal furring channels with fixings at 300 cc to perimeter and field.
2. Ditto but with furring channels screwed to joist, a big improvement.
3. Ditto but with pine timber battens.
4. Fibre cement sheeting fixed directly to ceiling joists.
5. Ditto but fixed to battens
6. Ditto fixed, but with edge batten also fixed to wall to add to strength.
7. Hardboard sheeting with perimeter fixings at 100 cc, field fixings at 300 cc fixed to battens with cross noggings between battens at end joints

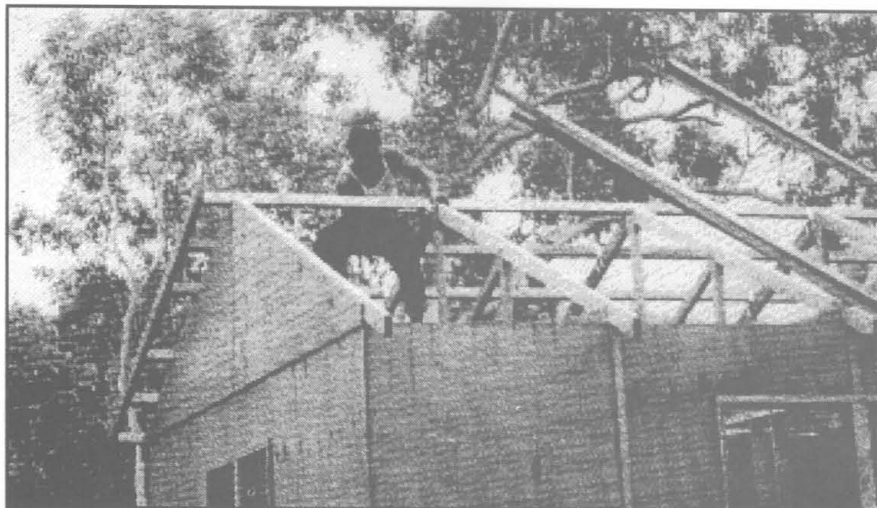
After the cyclone and damage assessment review, the Government identified some weakness in the designs for the new houses and it was decided to make available a house for full scale testing (refer Eaton & Reardon 1985).

- A unique joint venture developed.
- The Tongan Government provided the house.
- The Commission of the European Community financed the cost of the house materials
- The New Zealand Government funded the cost of a travel for a Tongan official to visit Australia to erect the house at the test site at James Cook University of North Queensland, Townsville, Australia, to Tongan standards.
- The Australian Government funded part of the testing in conjunction with the Cyclone Structural Testing Station (CSTS) at the University.
- The British High Commission to Tonga provided the liaison.
- The British Building Research Establishment (BRE) acted jointly with the Testing Station in regards to recommendations and testing.

After the full scale testing, simple but effective solutions with roof batten location and more secure fixing methods were identified that would enable the house to be modified to resist maximum cyclone winds of over 60 m/s.
