# CHAPTER EIGHT

## CASE HISTORIES

### EXAMPLES OF MAJOR MUDFLOW DISASTERS

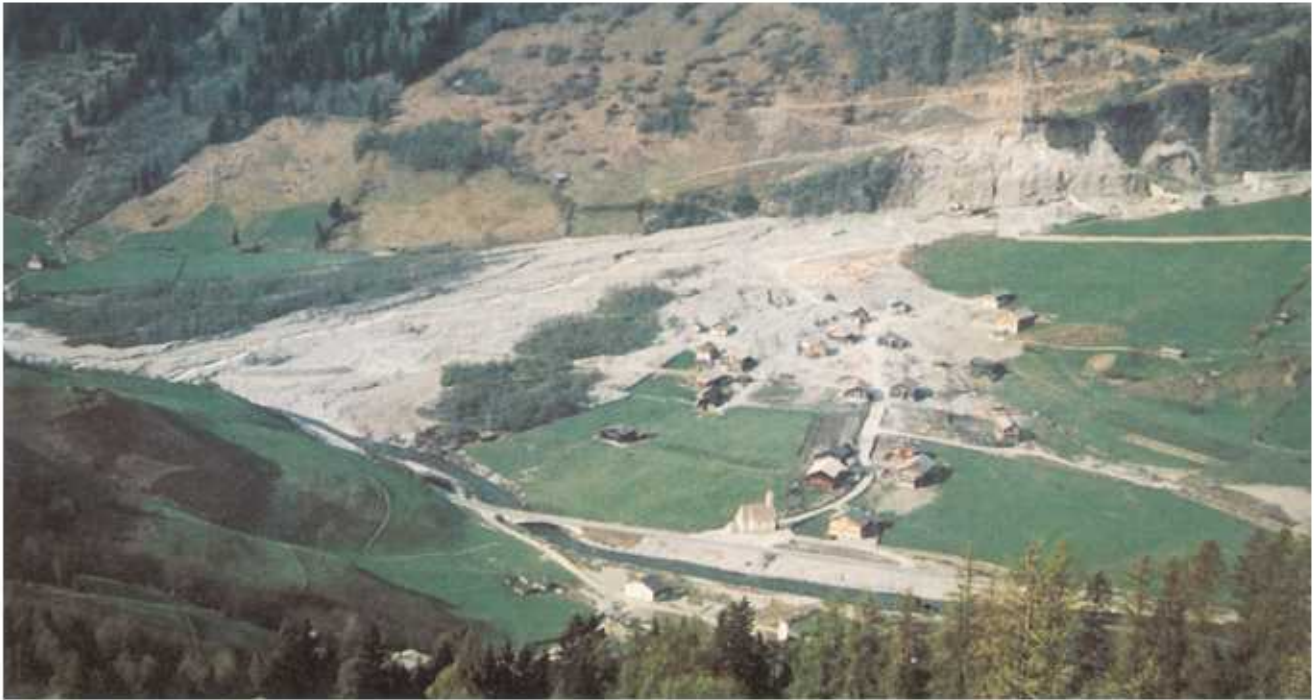
FIGURE 8.1 Putschall village on the alluvial cone of the Gradenbach torrent in the Moell Valley, Carinthia, Austria, buried by floods and debris flows during 1965 and 1966. Photo: G. Kronfellner-Kraus.

The heavy rainfall of 154 mm in September 1965, and 221 mm in August 1966, caused unprecedented floods. During these two events, the torrent transported altogether 1.3 million m<sup>3</sup> of material to the alluvial cone of the Moell River. The village of Putschall, which was situated on the alluvial cone, was buried (*Fig. 8.1*) and the village of Doellach, situated further down the valley, was heavily damaged. The Moell Valley highway was also destroyed.

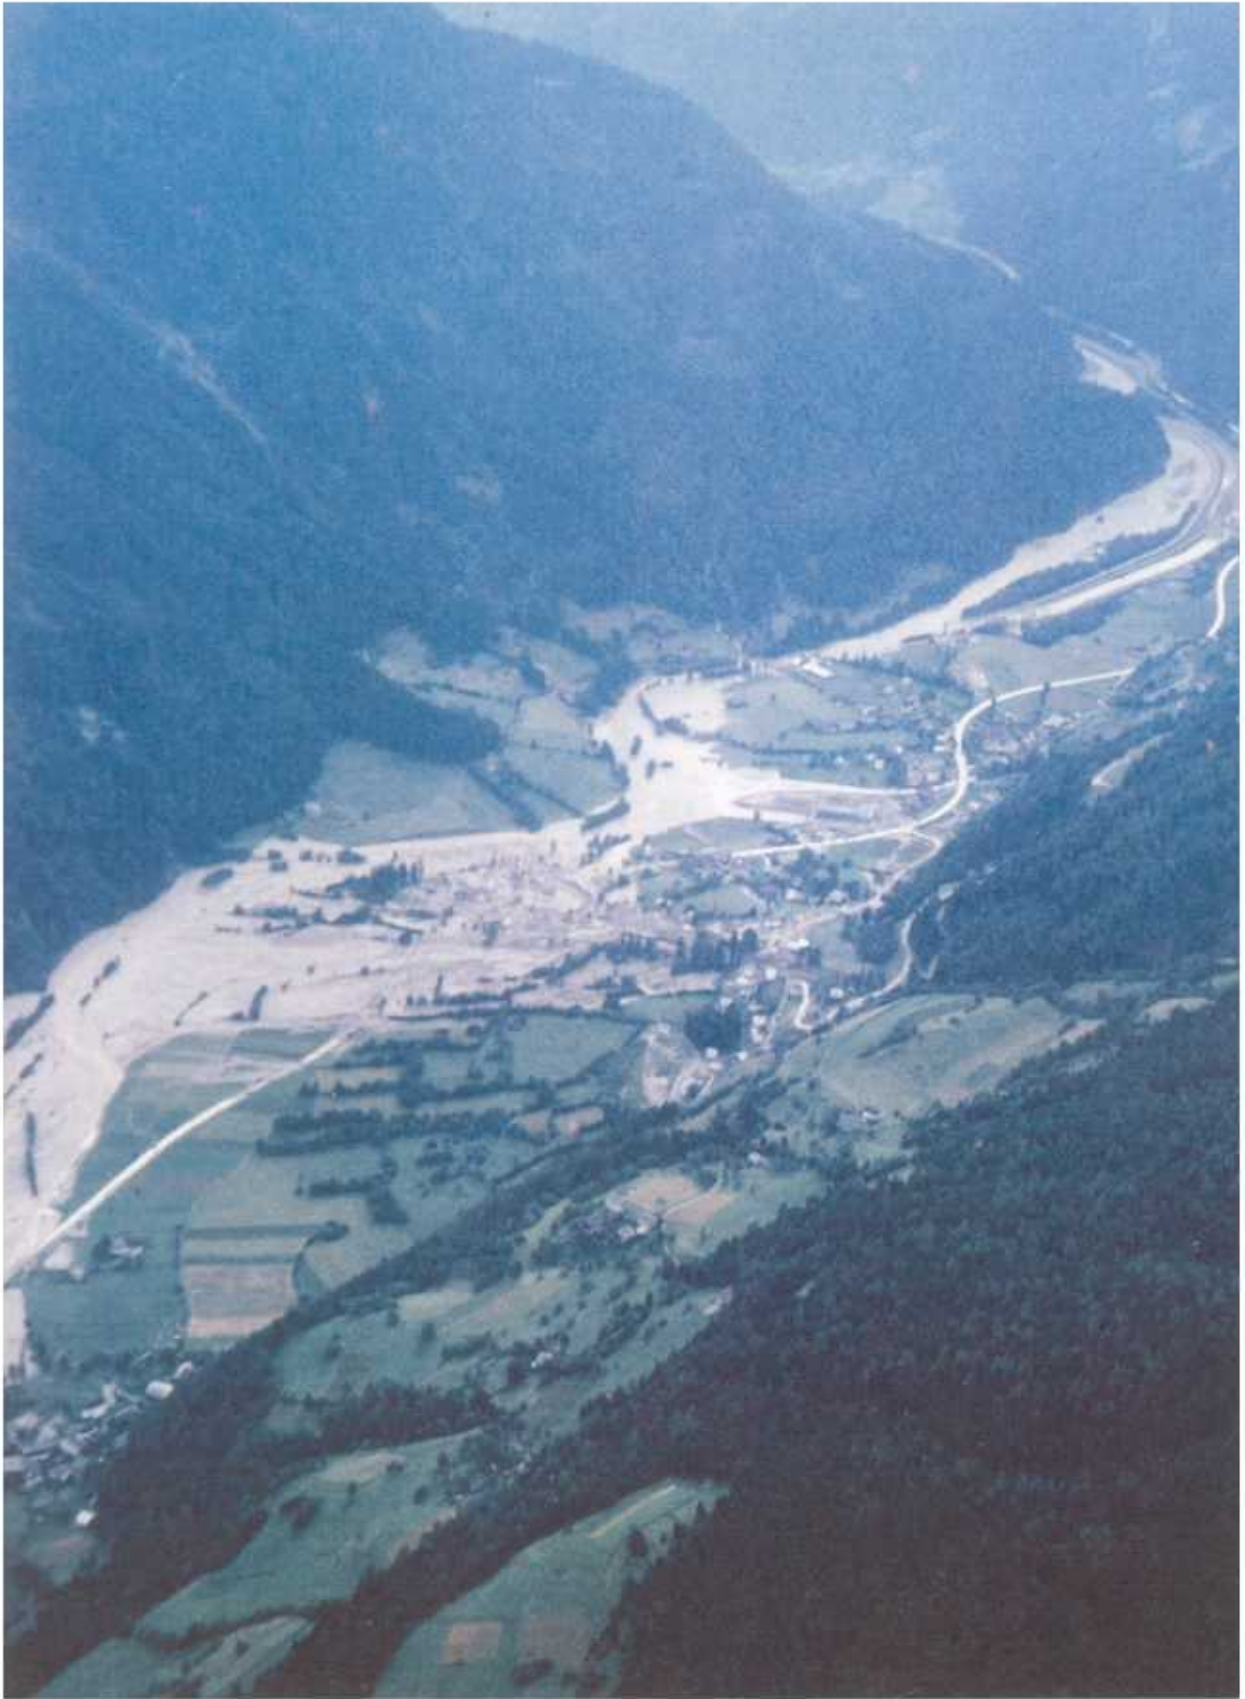
FIGURE 8.2 Kleindorf village built on the alluvial cone of the Wollinitzbach torrent in the Moell Valley, Carinthia, Austria, destroyed by a debris flow on 19 August 1966. *Photo: G. Kronfellner-Kraus.*

Following a heavy rainfall of 195 mm on 17-18 August 1966, catastrophic debris flows came down the mountain during the night of 19 August, killing three persons and burying the greater part of the village of Kleindorf (Fig. 8.2). About 300,000 m<sup>3</sup> of material came down to the alluvial cone and into the Moell River.

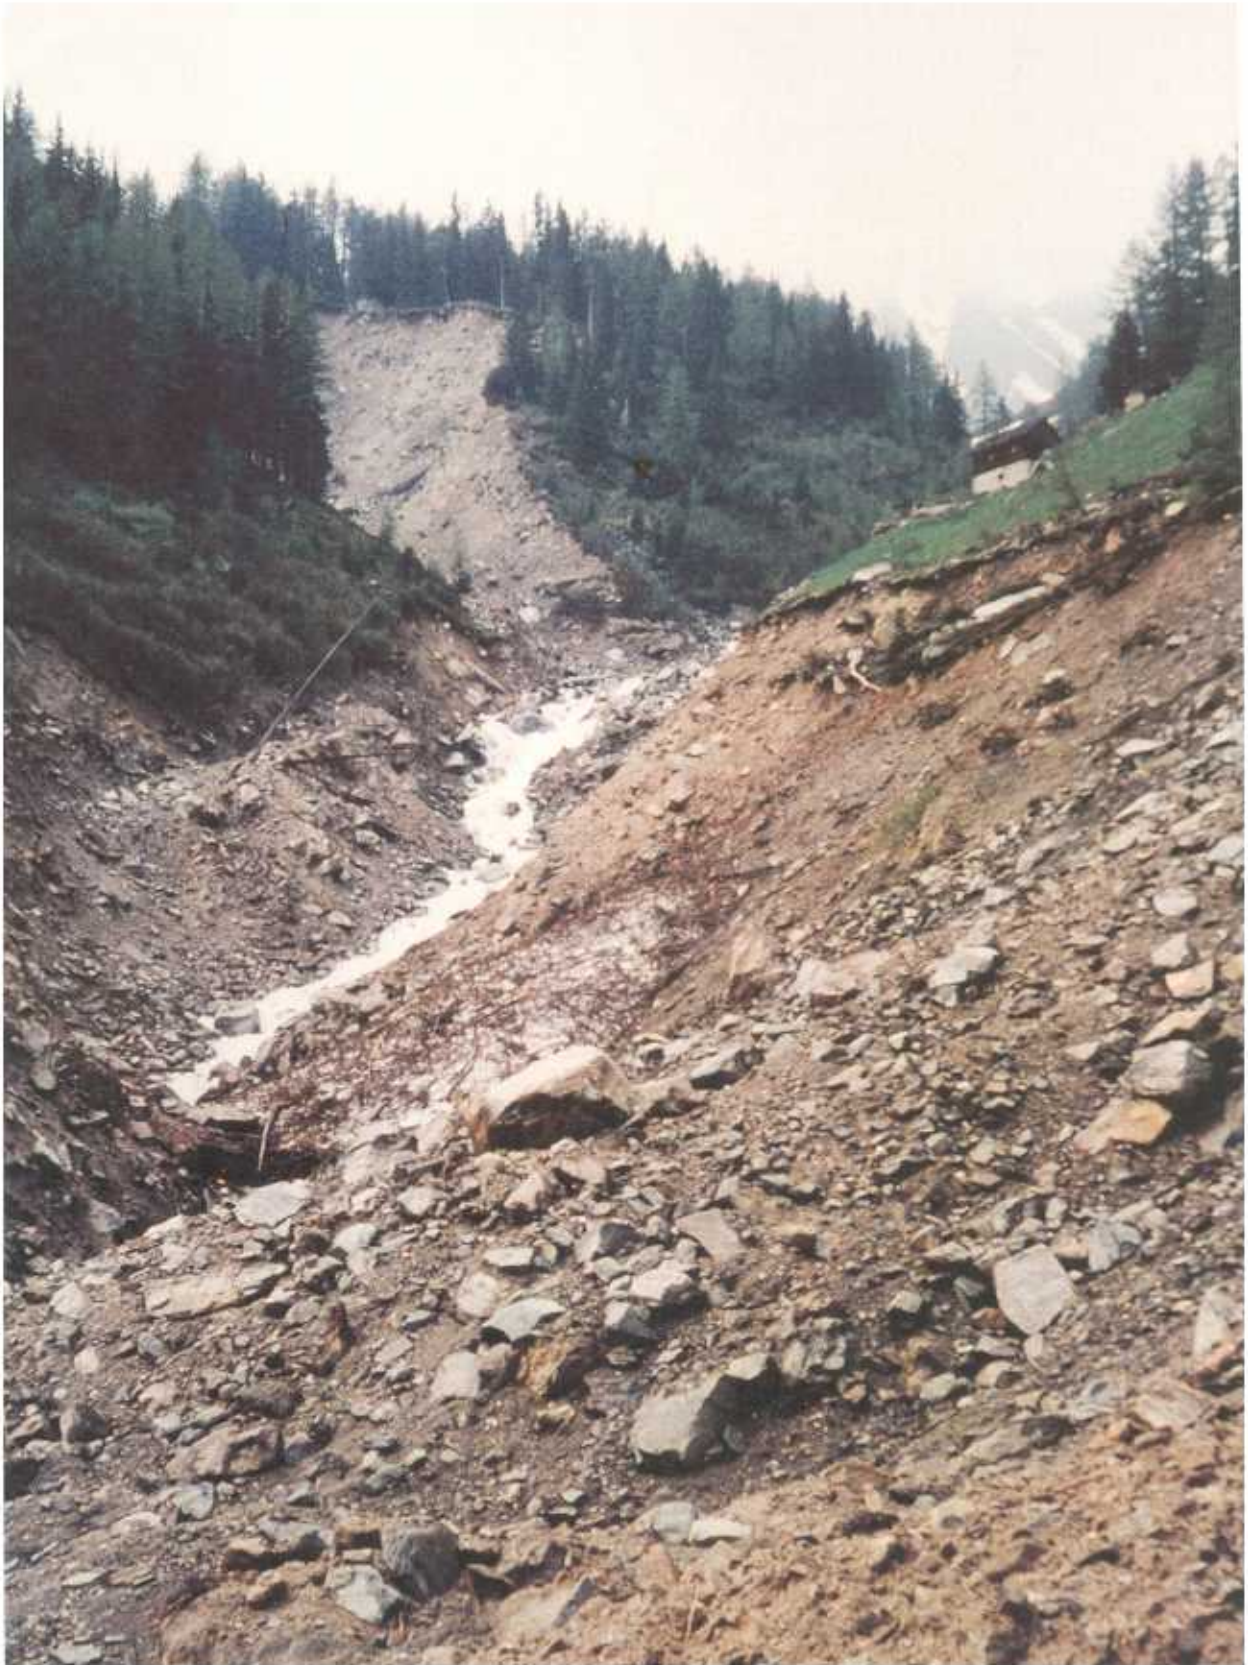
FIGURE 8.3 Erosion scars in Wollinitzbach, Austria: eroded left bank at Gruberhütte and the mouth of the shell-shaped erosion scar in the background on the right bank. *Photo: G. Kronfellner-Kraus.*

In the Wollnitzbach region, systematic control measures were begun after the mudflow events described above. They comprised the draining of the terrain around erosion scars (Fig. 8.3) in the upper catchment and the diversion of all surface water from the scars by pipes, channels and horizontally-drilled drains. A series of check dams was installed in the stretch of the torrent where erosion was active. An open dam was built at the outlet of the ravine in order to remove boulders and timber debris which threatened the settlement on the alluvial cone. On the alluvial fan, the stream was controlled by training walls and sills.

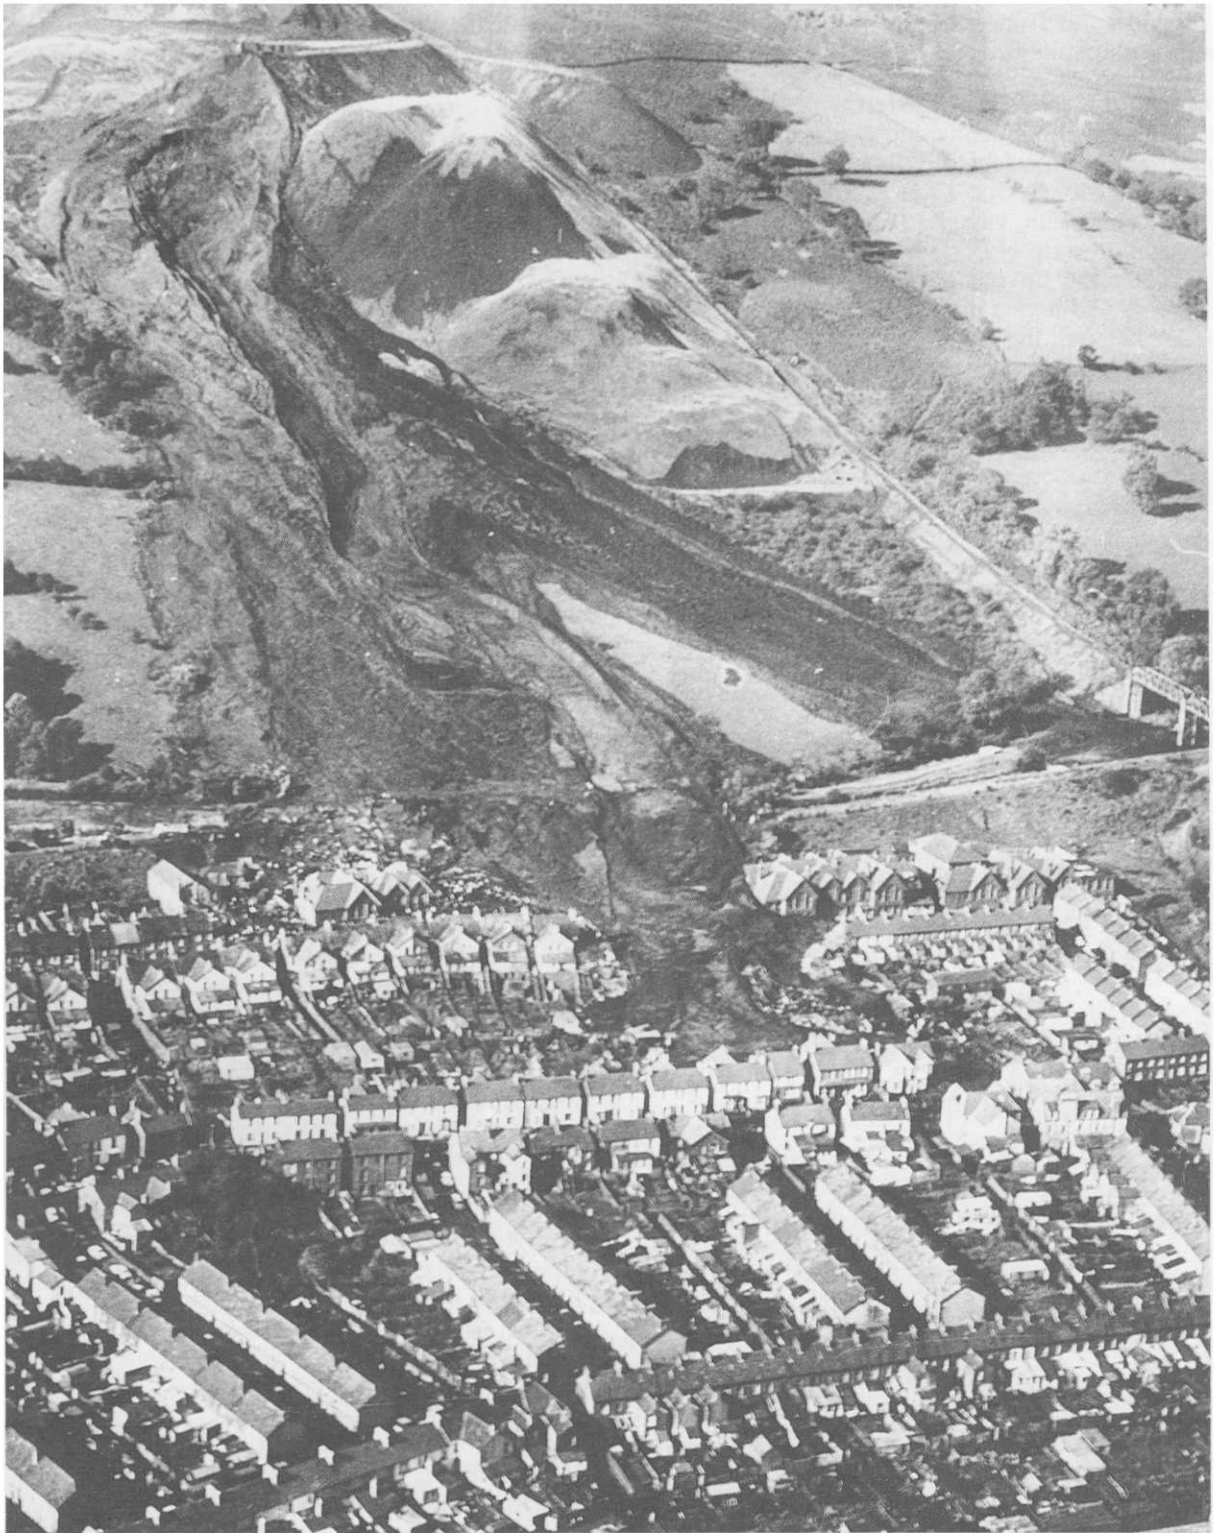
FIGURE 8.4 Aberfan, South Wales, United Kingdom. A huge mass of colliery rubble lies on the western edge of the coal-mining village. (Courtesy: Times Newspapers Ltd)

Investigations showed that Merthyr Mountain consists mainly of fissured pennantite sandstone overlaid by drift material and intersected by layers of relatively impermeable mudstone. One such layer, associated with the Brithdir coal seam, gave rise to a line of springs and was located under tip No. 7, which was one part of the series forming the tip complex on Merthyr Mountain. This tip contained a vast quantity of loosely-tipped, uncompacted material, the lower part of which had become saturated over the years (Fig. 8.4). A shear displacement along a surface adjacent to the natural ground, with reduced resistance to sliding, caused the tragic accident.

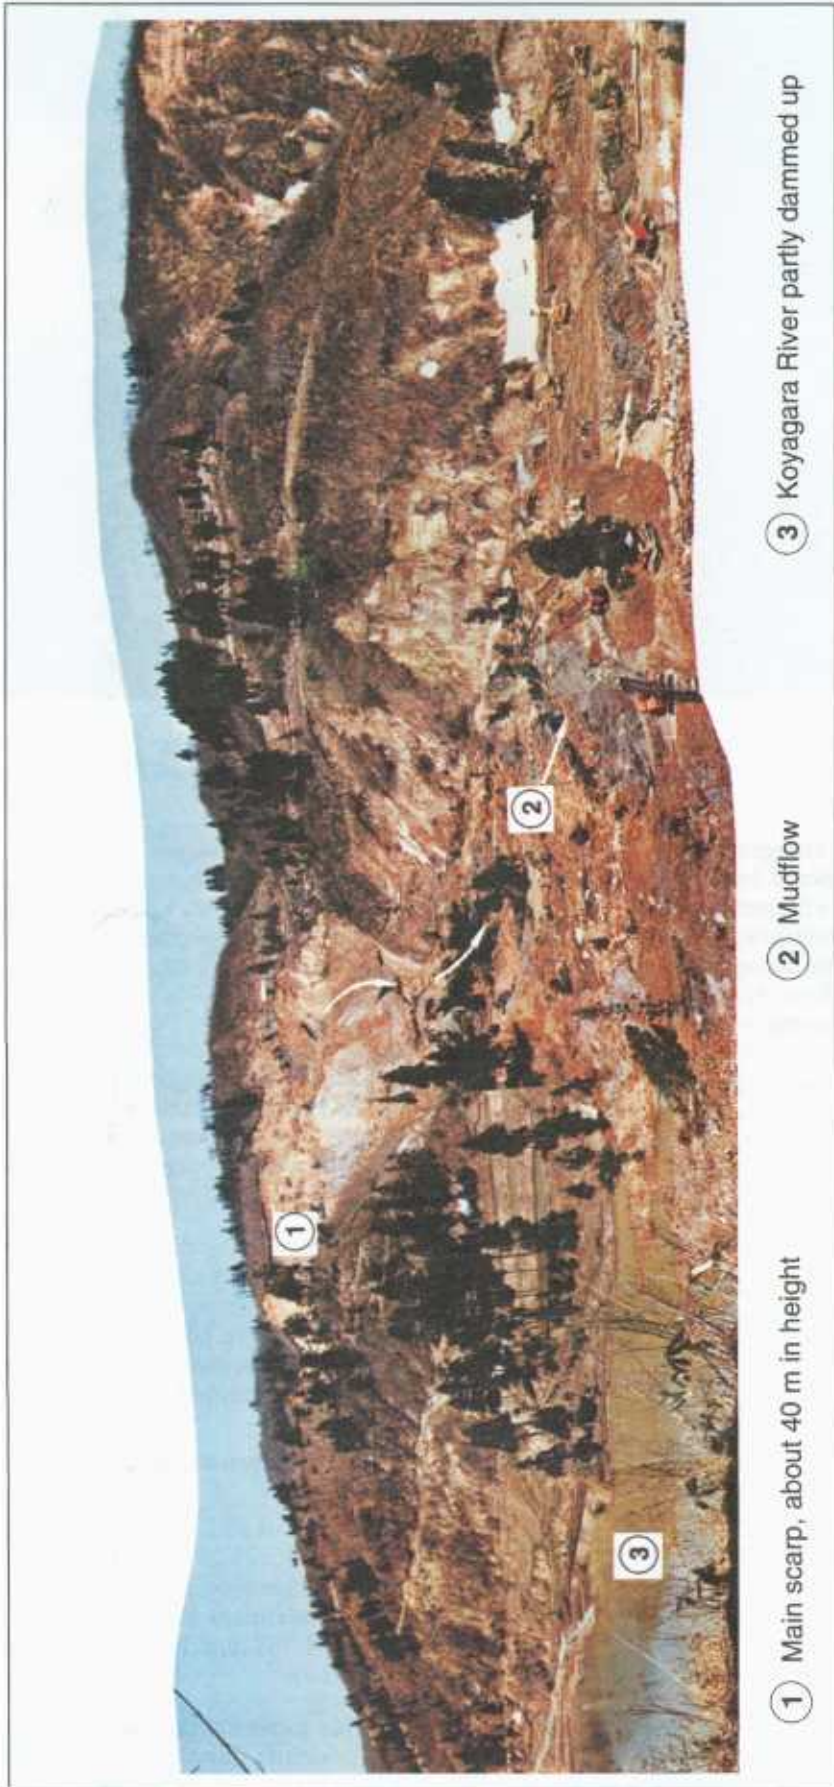
FIGURE 8.5 General view of the Mizusawashinden landslide of 26 April 1969, in Niigata Prefecture, Japan. Photo: Niigata Prefecture Government.

- (a) The highest part of the area was oval in shape. The edge coincided with the upper limit of a potential landslide block which could be identified on aerial photographs taken before the slide;
- (b) In the middle sector, material which had slid down passed through a long, narrow and steeply-dropping gully, 50 m wide and 200 m long;
- (c) The bottom sector formed a natural dam, 5 m high, 110 m wide and 300 m long

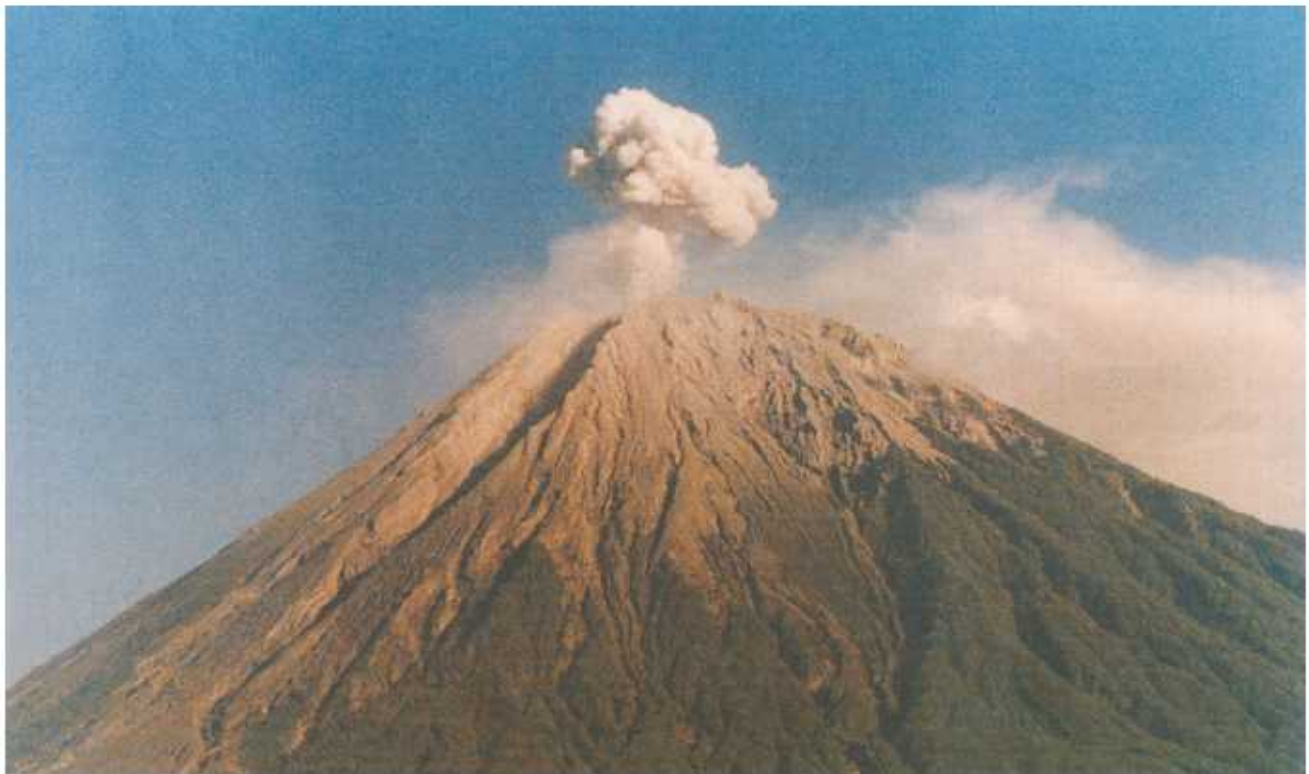
FIGURE 8.6 Mt. Semeru, East Java, Indonesia: Two major gullies can be seen on the left and at the centre. A number of rills incise the slopes between gullies. The landslide which triggered the mudflow occurred in the jungle on the right. Photo: I. Surya.

Mt. Semeru, also known as Mt. Mahameru, is located in the eastern part of Java Island (Figs. 8.6 and 8.7) It rises to an elevation of 3,676 m and is the highest active volcano on the island. Mt. Semeru was not always active, however. The prolonged activities of 1855 to 1913 were followed by a long period of quiescence. As a result, people began to settle in the lahar-devastated areas. The population density around Mt. Semeru is 488 per km<sup>2</sup>.

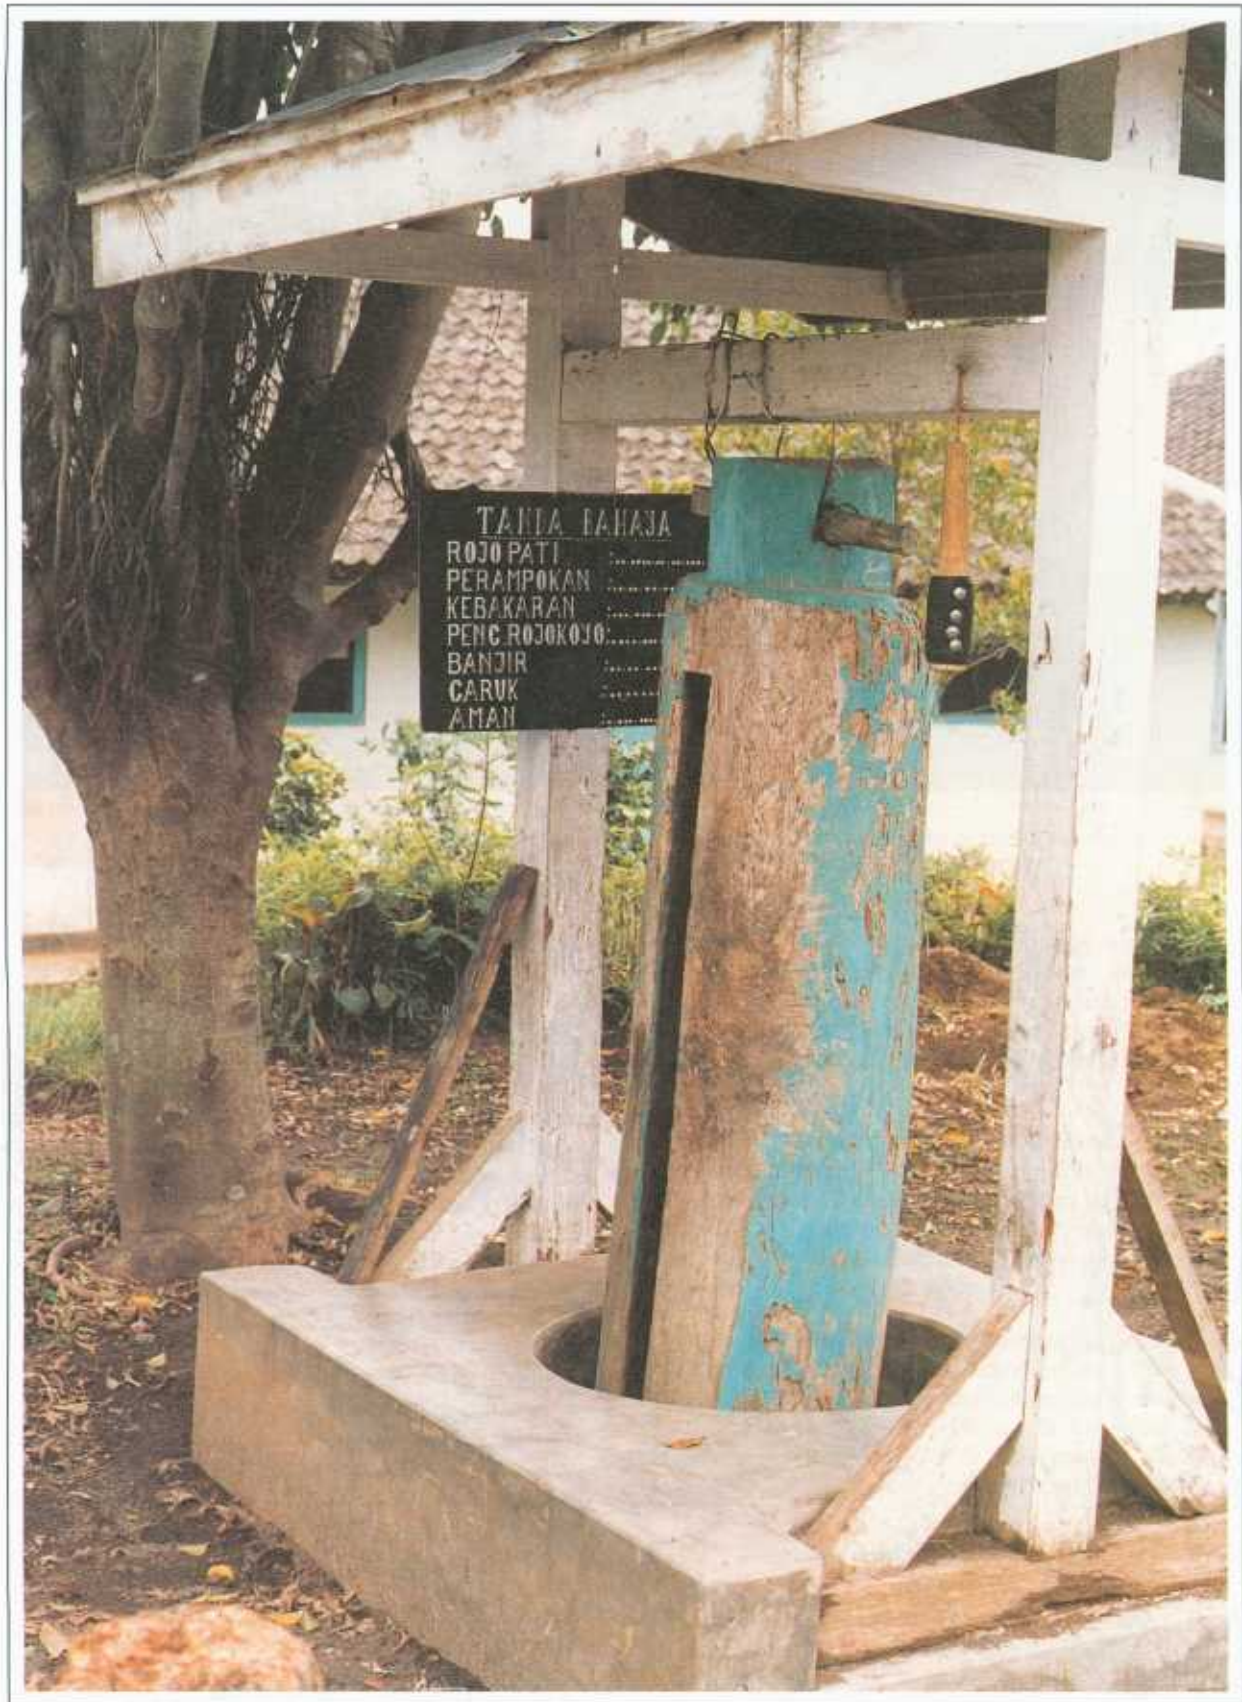
FIGURE 8.8 Example of a tong-tong, a device used for lahar warning in Indonesia. Photo: M. Watanabe.

When the mudflow hit in 1981, no one had time to strike a tong-tong, a wooden gong-like device used to give lahar warnings (Fig. 8.8). Even if a tong-tong had

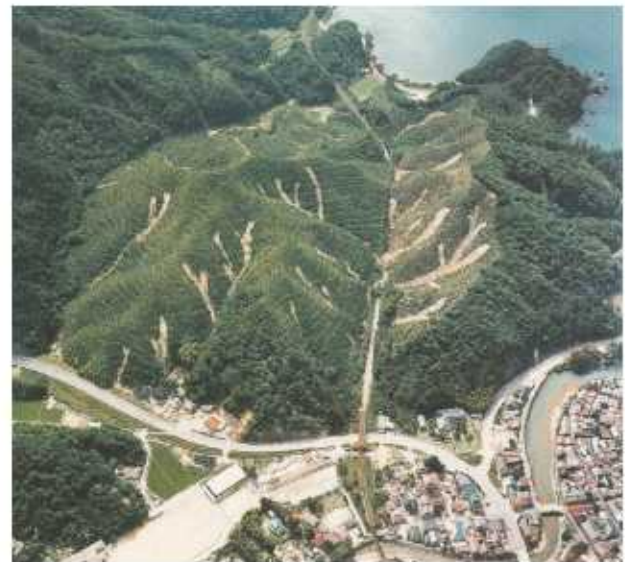
FIGURE 8.11 Remarkable contrast between clear-cut slopes and slopes with forest cover in terms of slope stability. Location: Nagasaki, Japan. Photo: M. Watanabe.

no precautionary provisions for the new housing developments in these regions. The possibility of debris flows was not taken into account during the building of the existing structures. Denuded hillsides, undercut slopes and high embankments without any reinforcement lowered the resistance of the landscape to torrential rainfall (Fig. 8.11). By contrast, some slopes with sufficient forest cover suffered no damage.
