### 8.2.2. Izu Peninsula, Japan (1978)

### 8.2.3. Mt. Ontake, Japan (1984)

### 8.3. Mudflows (lahars) caused by volcanic eruptions

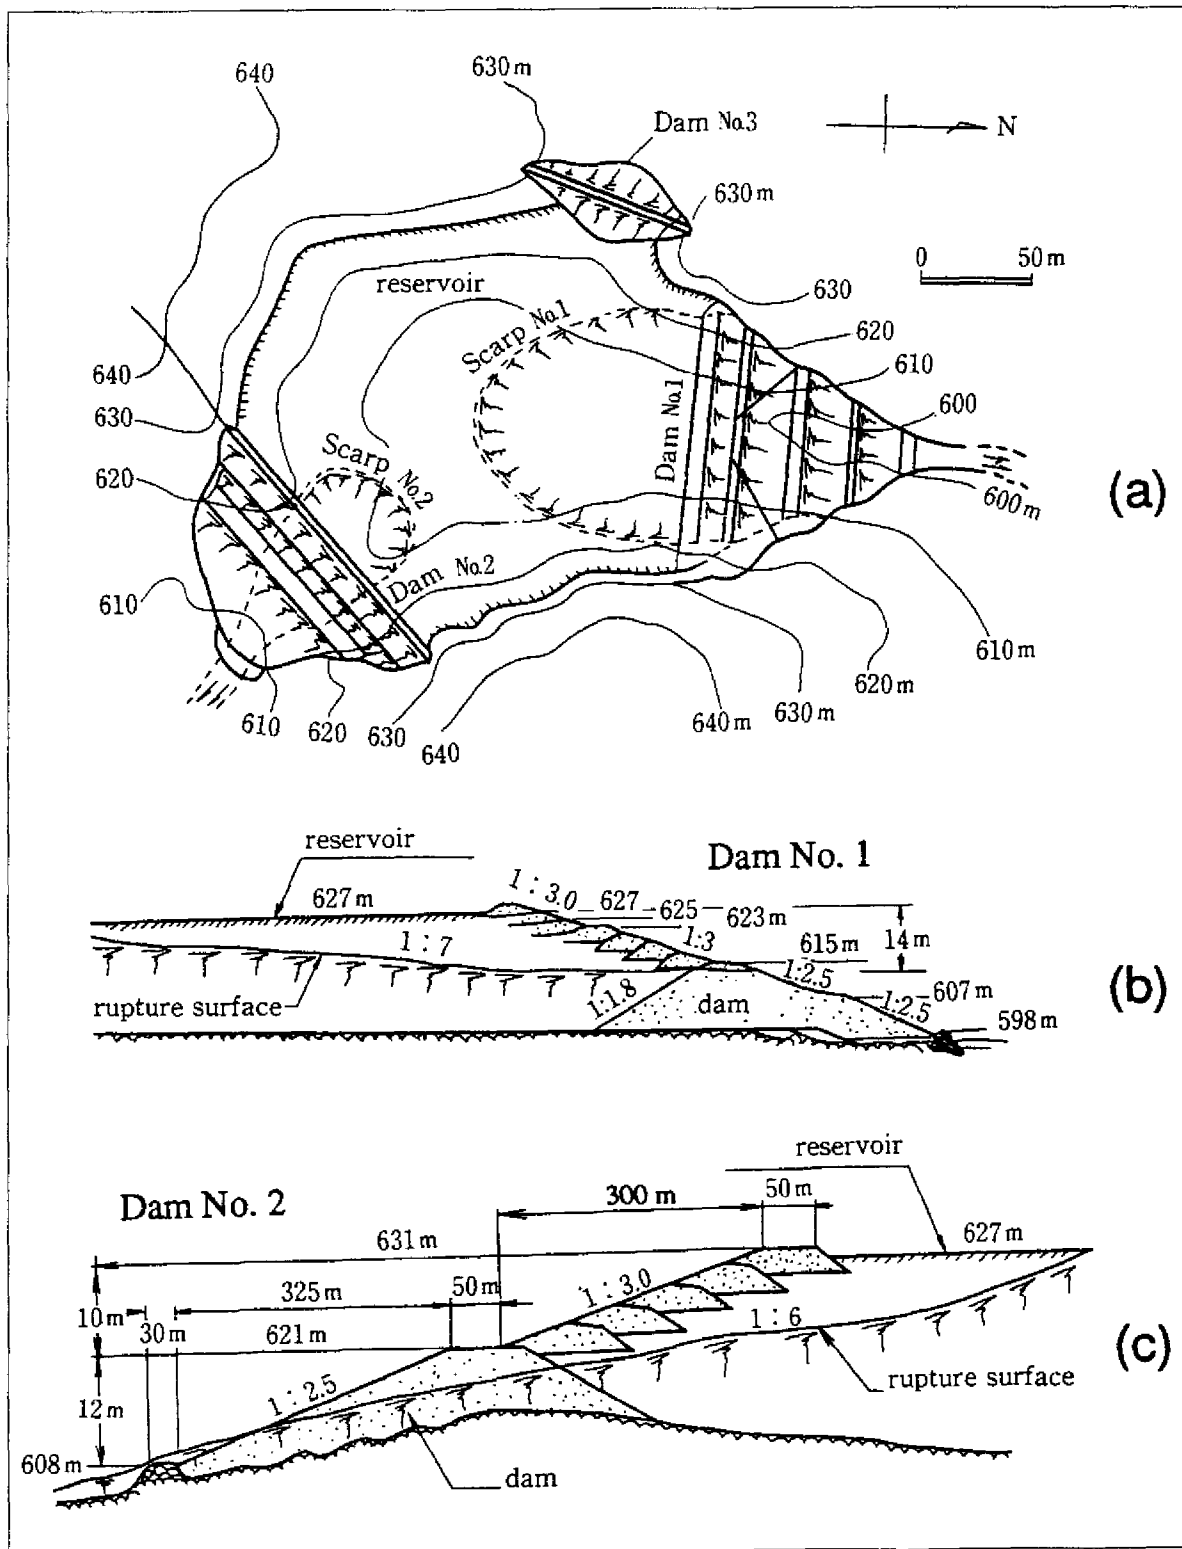
FIGURE 8.23 Liquefaction of sludge which had been retained by the tailings dams in Hozuki Valley, Shizuoka, Japan: (a) Lay-out of the dams; (b) Cross-sectional profile of dam No. 1; (c) Cross-sectional profile of dam No. 2.

On 14 January 1978, an earthquake of magnitude 7.0 on the Richter scale triggered a mudflow, which contained poisonous chemicals and heavy metal compounds, on the Izu Peninsula in south-central Japan. This mudflow event was the result of the collapse of one of the three dams belonging to the Hozuki Valley plant of a gold-mining operation (Fig. 8.23).

Why were there differences in the modes of failure of the three dams? The downstream faces of dam No. 1 and dam No. 2 were stepped, and were built with materials whose characteristics and properties may have been inappropriate for the purpose. The dam in the Noro Valley basin, however, was on a firm foundation, equipped with a stable wall and provided with facilities to drain the dam body.

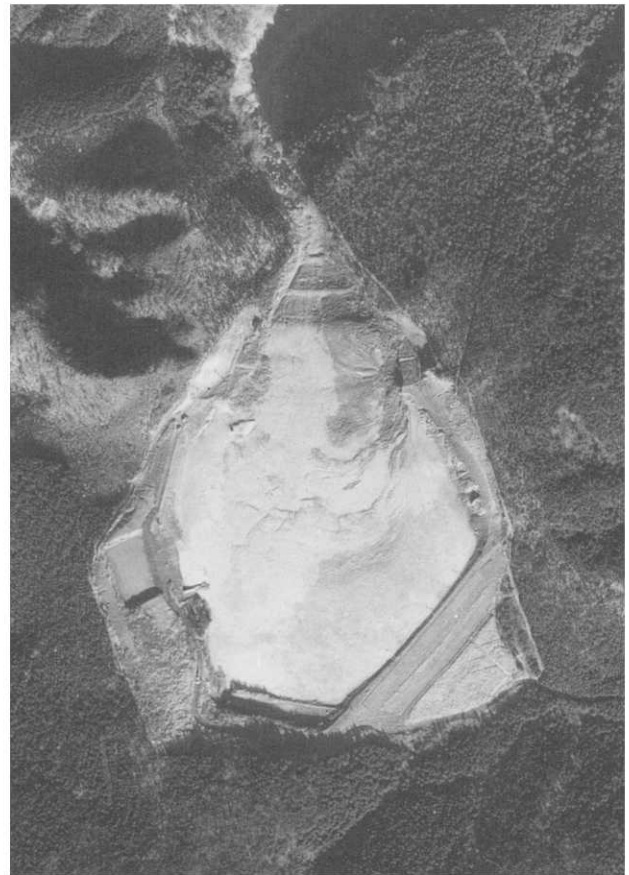
FIGURE 8.24 Hozuki Valley: Collapse of sludge dam No. 1. Photo: S. Hatano.

This initial earthquake, which occurred at 1224 hours on 14 January caused dam No. 1 to fail. The dam breached with a tremendous roar, and within 6 minutes a mudflow containing 80,000 m<sup>3</sup> of sludge had travelled as far as 2 km downstream (Fig. 8.24).

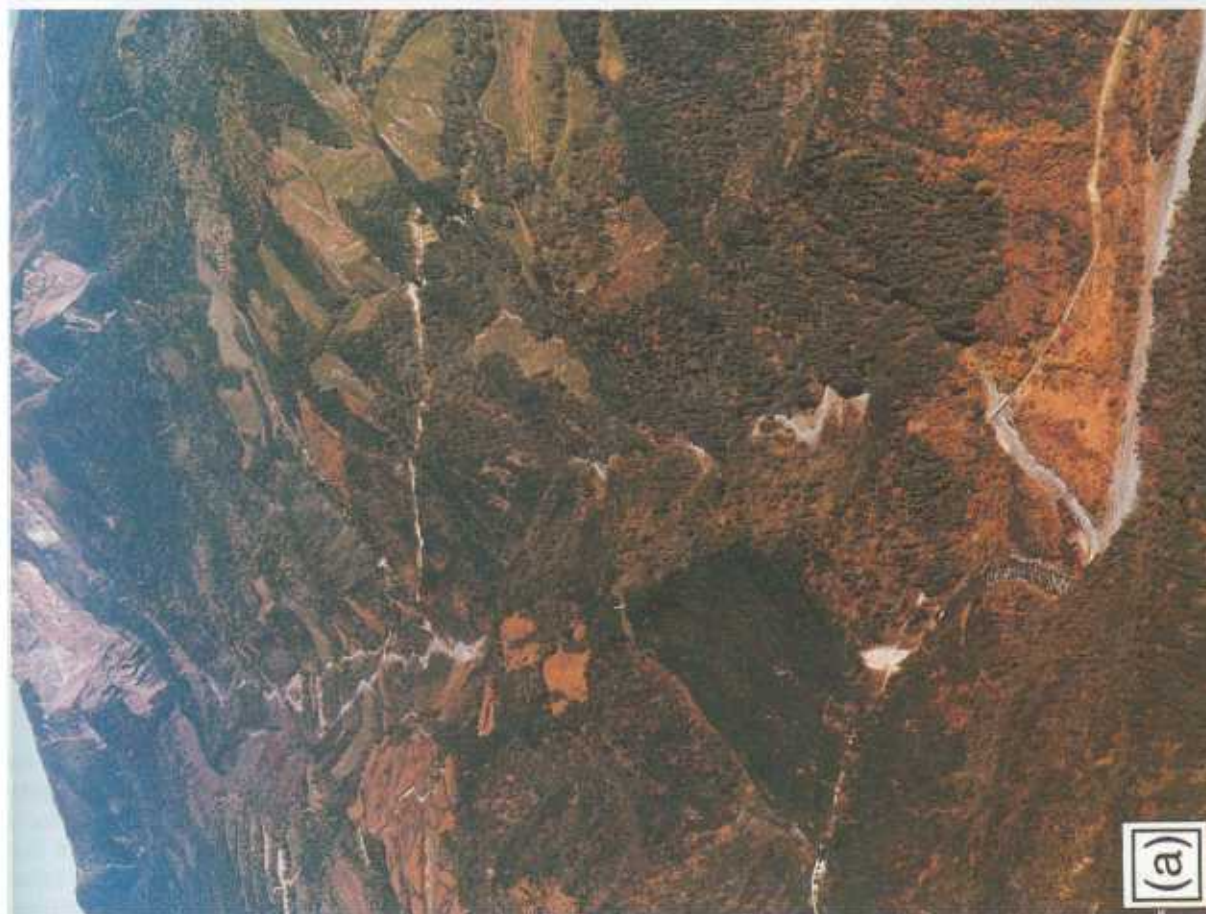
FIGURE 8.26 Mt. Ontake, Nagano, Japan: (a) before the debris avalanche of 1984,  
*Photo: Taiyo Air Survey.*

At around 0900 hours on 14 September 1984, an earthquake of magnitude 6.8 on the Richter scale triggered a massive landslide on the southern slope of Mt. Ontake Volcano (3,060 m high) in central Japan. The epicentre was located just below the village of Otaki. The landslide was 1,300 m long, 420 m wide and 160 m in depth (Fig. 8.26). The landslide developed into a huge debris avalanche with a volume of 34 million m<sup>3</sup>, and caused 29 deaths. The avalanche blocked the flow of the Otaki River and created a natural dam. About two thirds of the moving mass flowed down the river at high speed. The one third remaining initially dammed the upper reaches of the valley and then passed rapidly down the river.

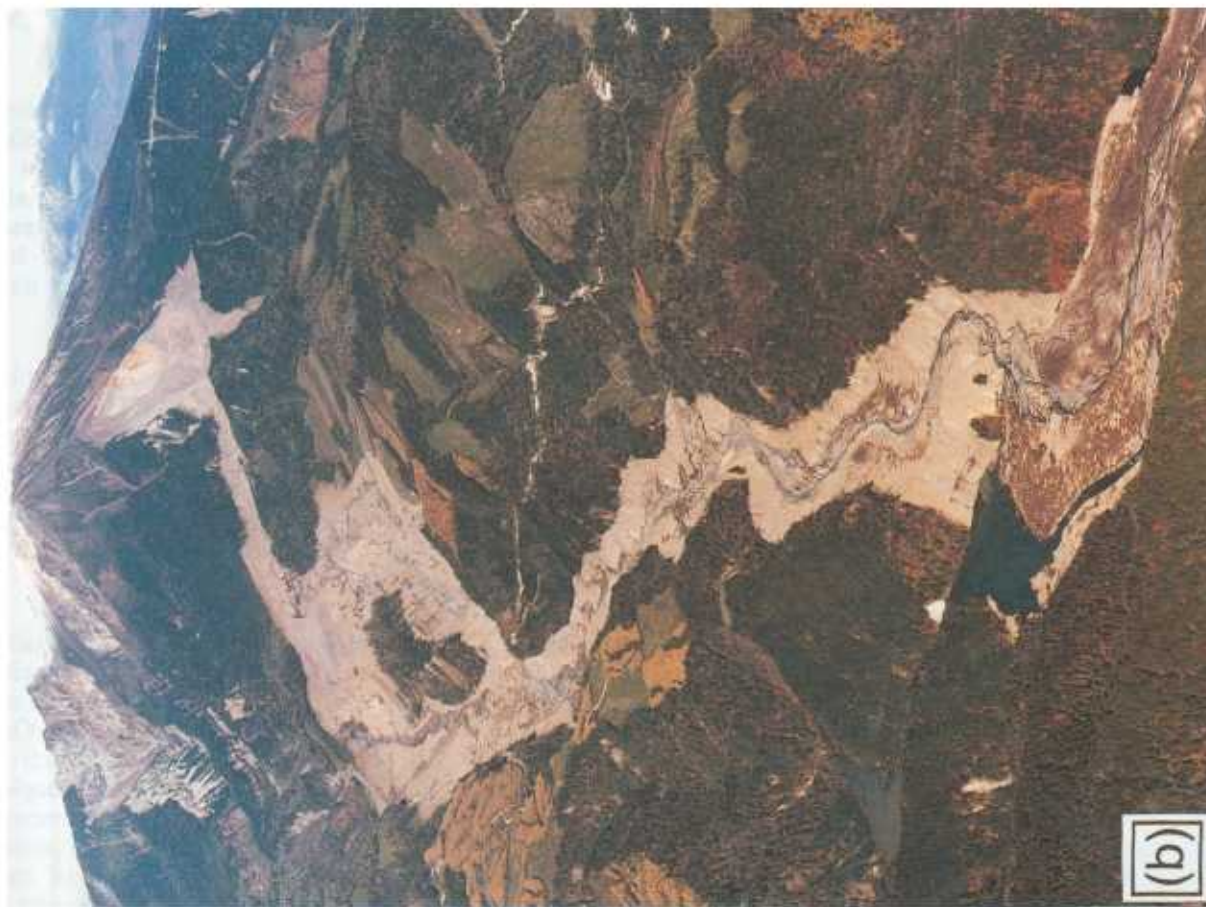
FIGURE 8.26 Mt. Ontake, Nagano, Japan: (b) after the debris avalanche of 1984.

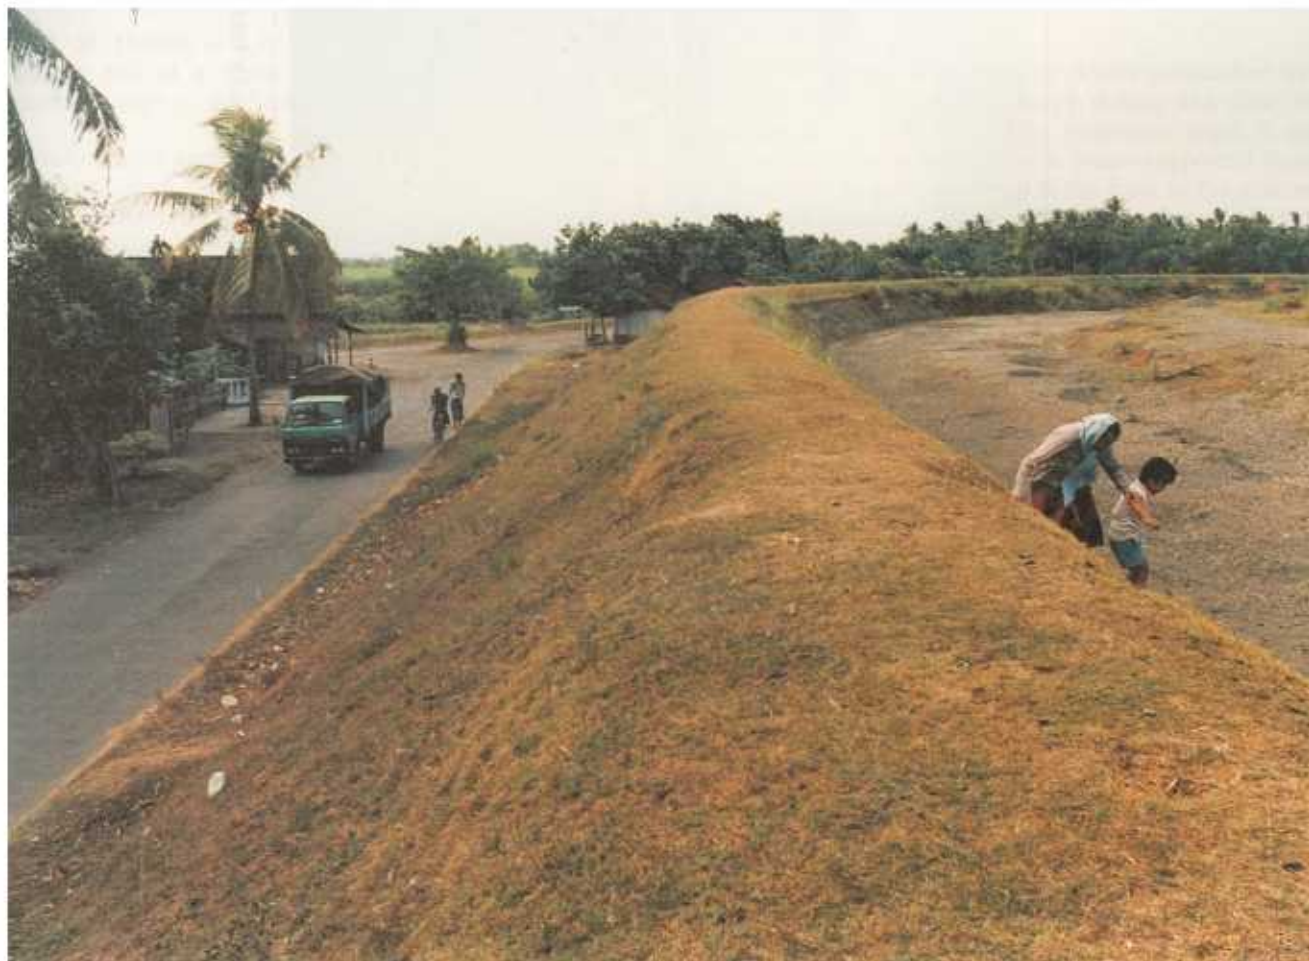
FIGURE 8.32 Brantas River. The bed level rose up to the ceiling level of a nearby house on the alluvial fan, after deposition by lahars from Mt. Kelut. Location: East Java, Indonesia. Photo: M. Watanabe.

An area of 45 km<sup>2</sup> was covered with volcanic material carried by the primary lahars. The lahar that reached the city of Blitar (Fig. 8.32) travelled at a speed of 43 km/h. Its average speed over the reach from Badak to Blitar City was 23 km/h.

The loose material carried down by the secondary lahars in Mt. Kelut raised the bed of the Brantas River (see Fig. 8.32). As a result, large areas are flooded during the rainy season. With a gradient of 1 per cent, the river bed
