8.3.3. Mt. St. Helens, USA (1980)

8.3.4. Nevado del Ruiz, Colombia (1985)

8.3.5. Mt. Pinatubo, Philippines (1991)

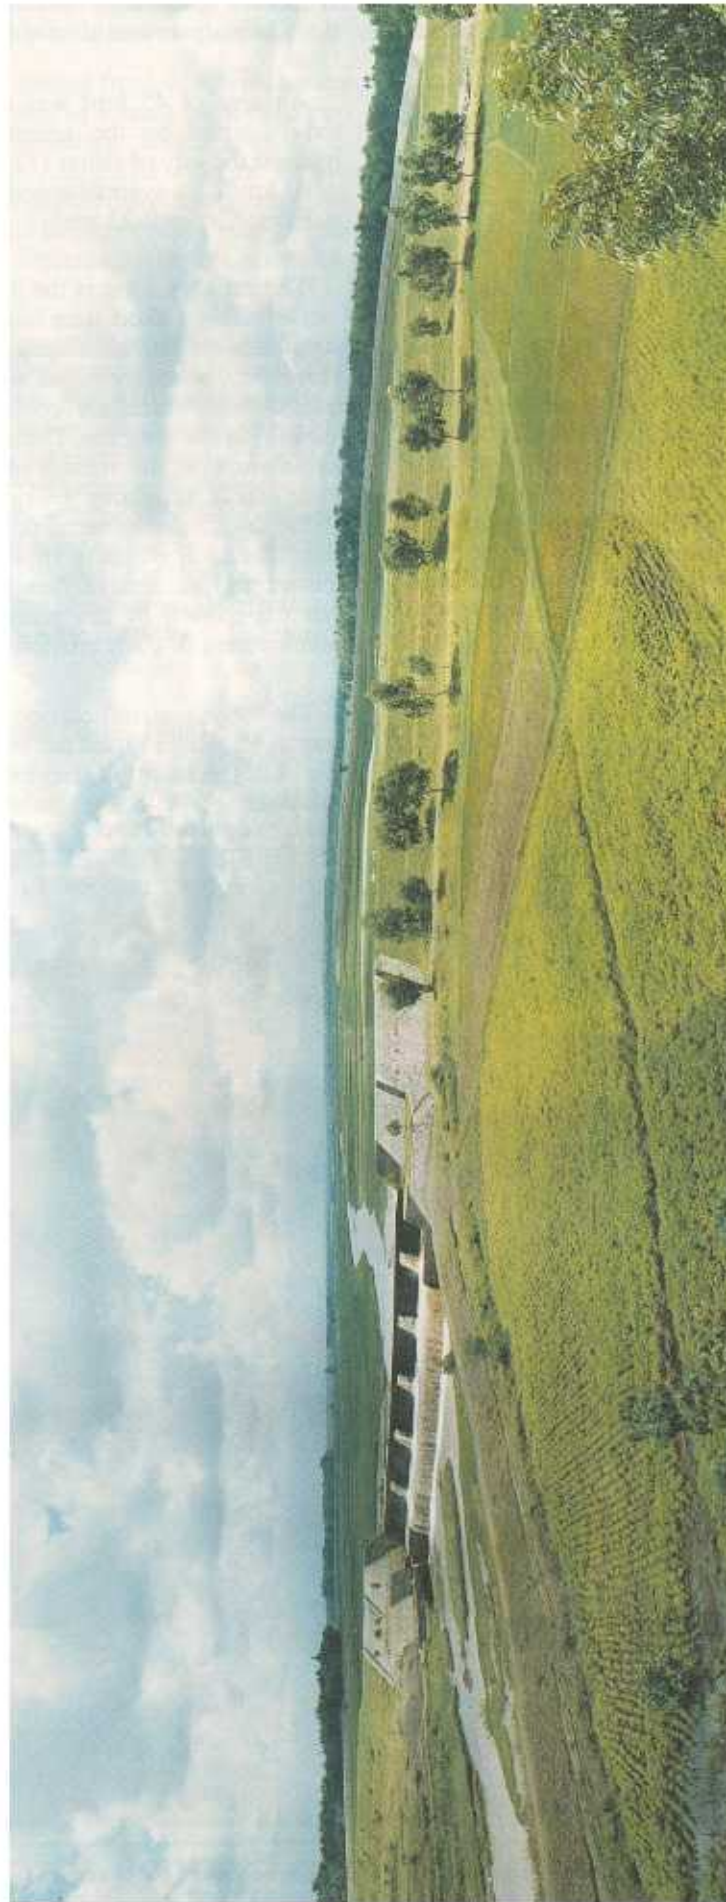
FIGURE 8.33 Mt. Kelur Sand pocket on the Konto River. It is used as a paddy-field in the dry season. Location: East Java, Indonesia. Photo: I. Suryo

To minimize the volume of loose volcanic material entering into the Brantas River, a series of check dams and sand pockets with a total storage capacity of 40 million m³ has been constructed (Suryo and Clark, 1985). The lahar deposit area created by the 1966 eruption is bounded by dykes whose purpose is to trap the material transported by secondary lahars. The resulting deposits are used for agricultural purposes during the dry season (Fig. 8.33).

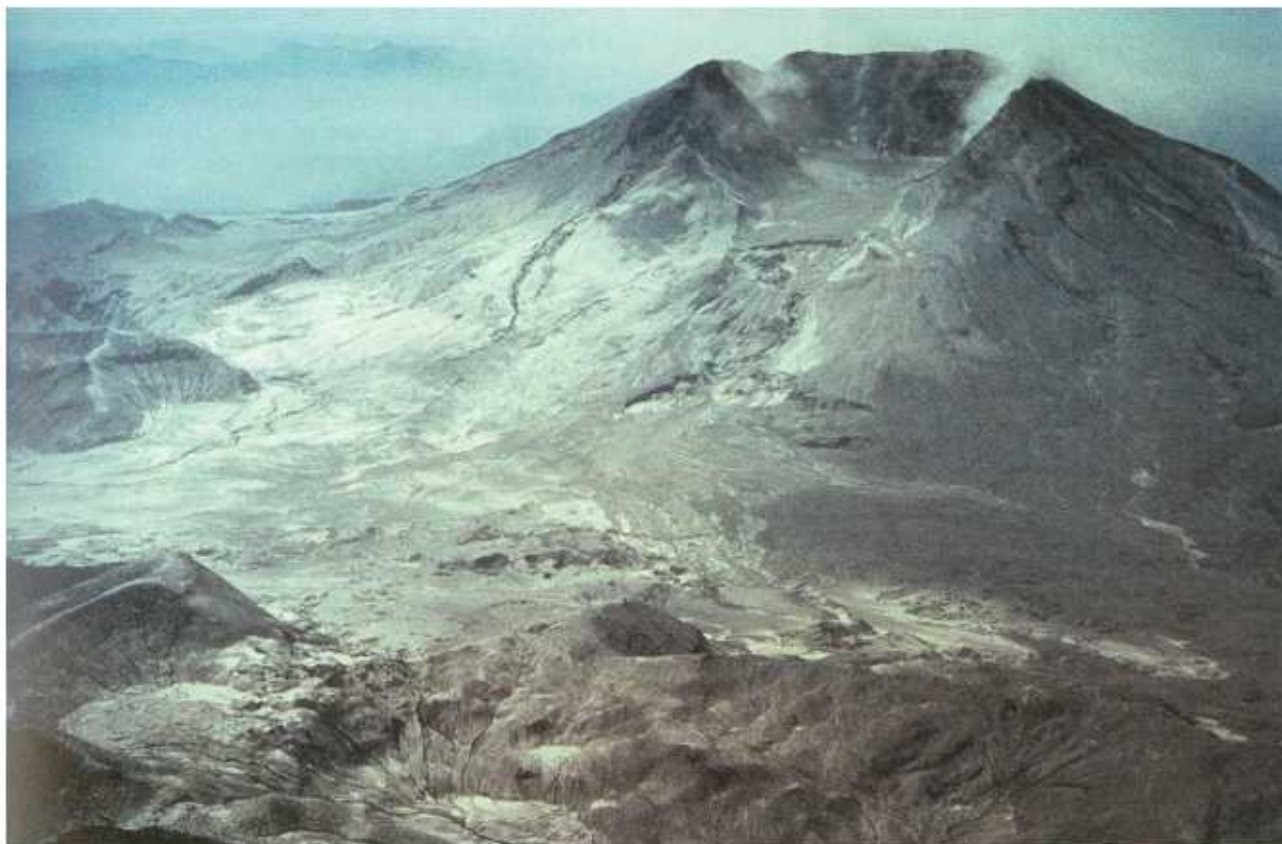
FIGURE 8.35 Significantly altered landscape resulting from the 1980 eruption of Mt. St. Helens. (Courtesy: US Geological Survey, Photo Library, Denver, CO).

Much of the material displaced by the eruption exploded or slid in a north-by-north-westerly direction, primarily into the North Fork Toutle River and the South Fork Toutle River. From there, debris from huge mudflows then swept down the Toutle River itself and into the Cowlitz River. Eyewitnesses described the front of the mudflow as a high wall rushing down the river. One hundred and twenty-three houses and many bridges were destroyed. The eruption significantly altered the landscape of the Toutle-Cowlitz Valley (Fig. 8.35).

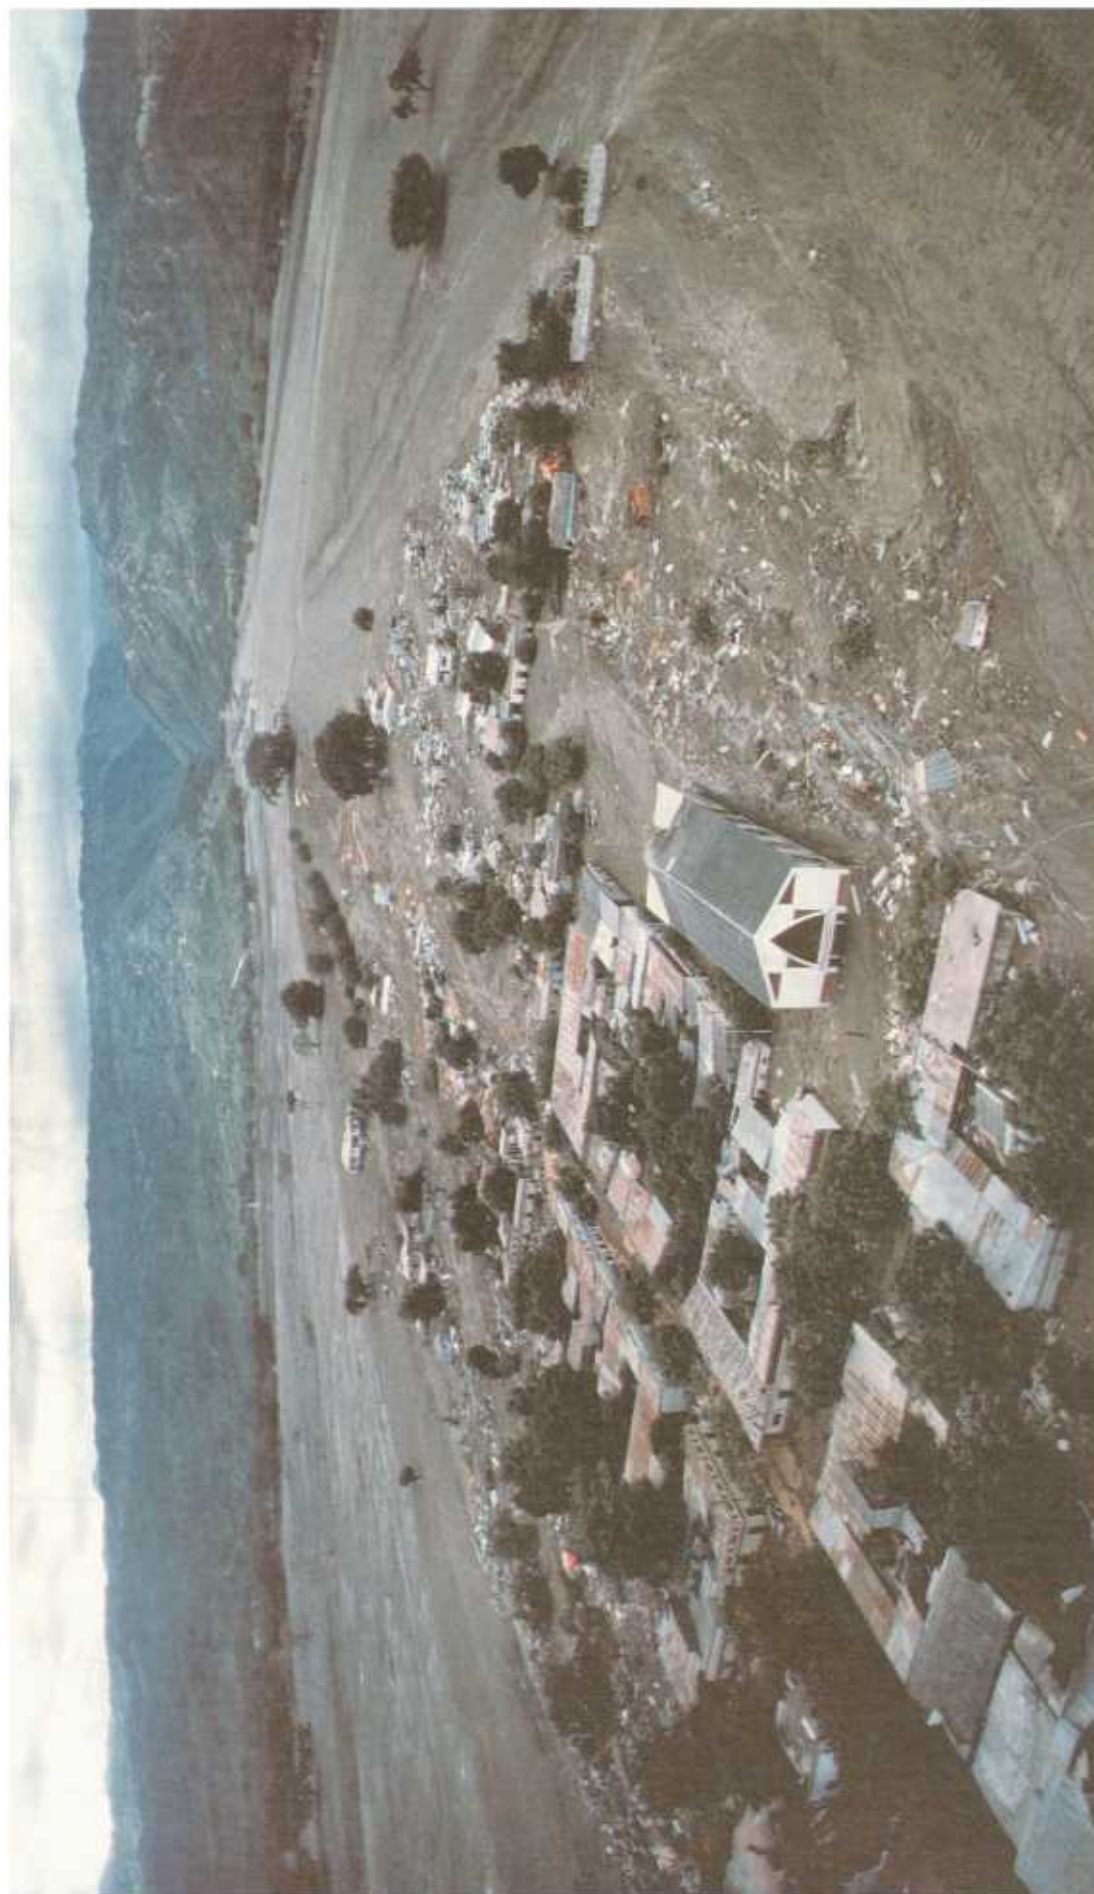
FIGURE 8.40 Armero, Colombia, after the 1985 mudflow (Courtesy: Steven L. Raymer, National Geographic Society). Photo: National Geographic.

A violent mudflow hit Armero at 2335 hours and continued to engulf the area for two hours. The mudflow, which had a speed of as much as 72 km/h and which was up to 12 m deep, destroyed all the buildings in its path. Both the course and the area inundated by the mudflow coincided with those shown on the hazard map (Fig. 8.39). The mud and debris covering Armero amounted to a volume of 15.8 million m³ spread over 30.6 km² (Fig. 8.40).

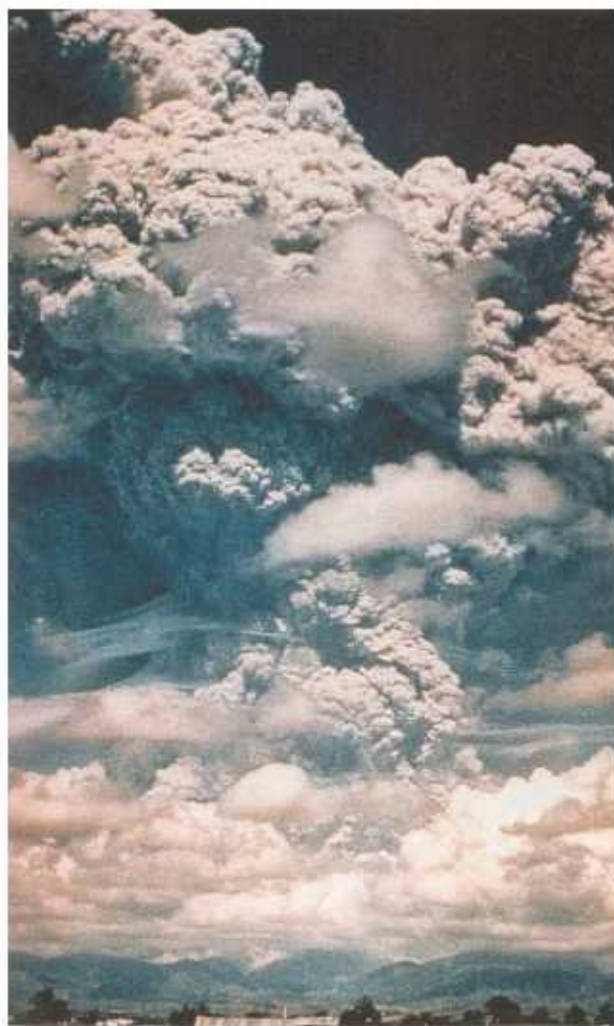
FIGURE 8.41 Powerful eruption of Mt. Pinatubo, July 1991. (Courtesy: C. G. Newhall, NOAA, National Geophysical Data Center, Boulder, Colorado, USA).

The 1991 eruptive phase started on 2 April with a series of small phreatic explosions which emitted steam and small quantities of ash from a zone of vents. The first powerful explosion occurred on 12 June, followed by the most intense phase on 15 June (Fig. 8.41). These explosions produced heavy ashfall and pyroclastic flows. The latter swept over an area of more than 100 km² and extended as far as 15 to 16 km from the vent, with travel speed estimated at about 80 km/h. In some canyons, the thickness of these pyroclastic flows reached 200 m. Ashfall (tephra) reached a thickness of about 50 cm near the vent of the volcano and decreased to about 20 cm at 40 km distance (Fig. 8.42). The

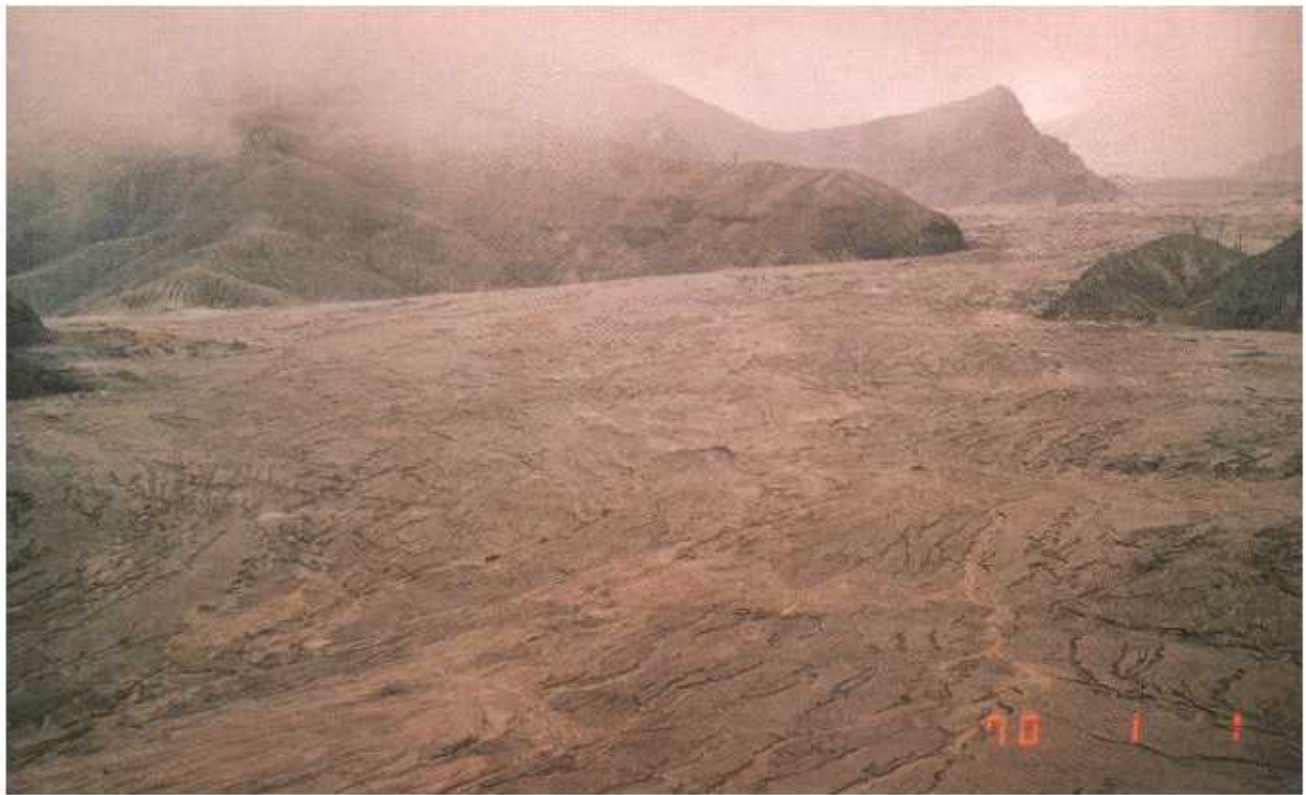
FIGURE 8.43 Mt. Pinatubo. Pyroclastic deposits (primary lahars) in the watersheds of the Pasig, Abacan and Sacobia Rivers. Photo. M. Watanabe, 1991.
