8.4. Mudflows caused by dam failures or glacial lake breaches in high mountains

8.4.1. Mudflows in the Basins of the Lesser and Greater Almatinka Rivers, Kazakstan

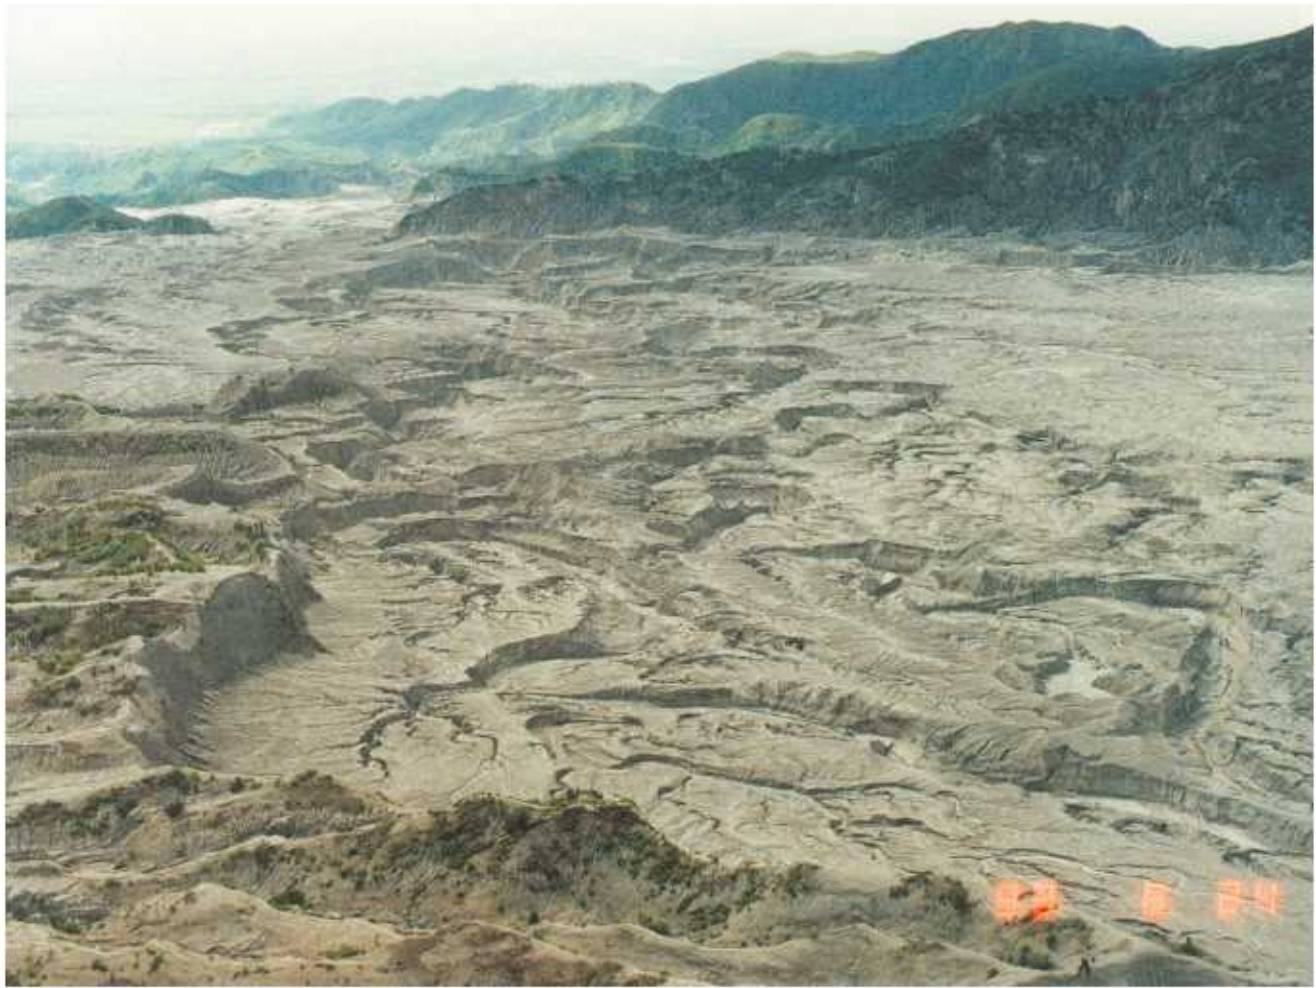
FIGURE 8.45 Mt. Pinatubo. Erosion features in the pyroclastic deposits of the watersheds of the Pasig, Abacan and Sacobia rivers. Photo: M. Watanabe, 1992.

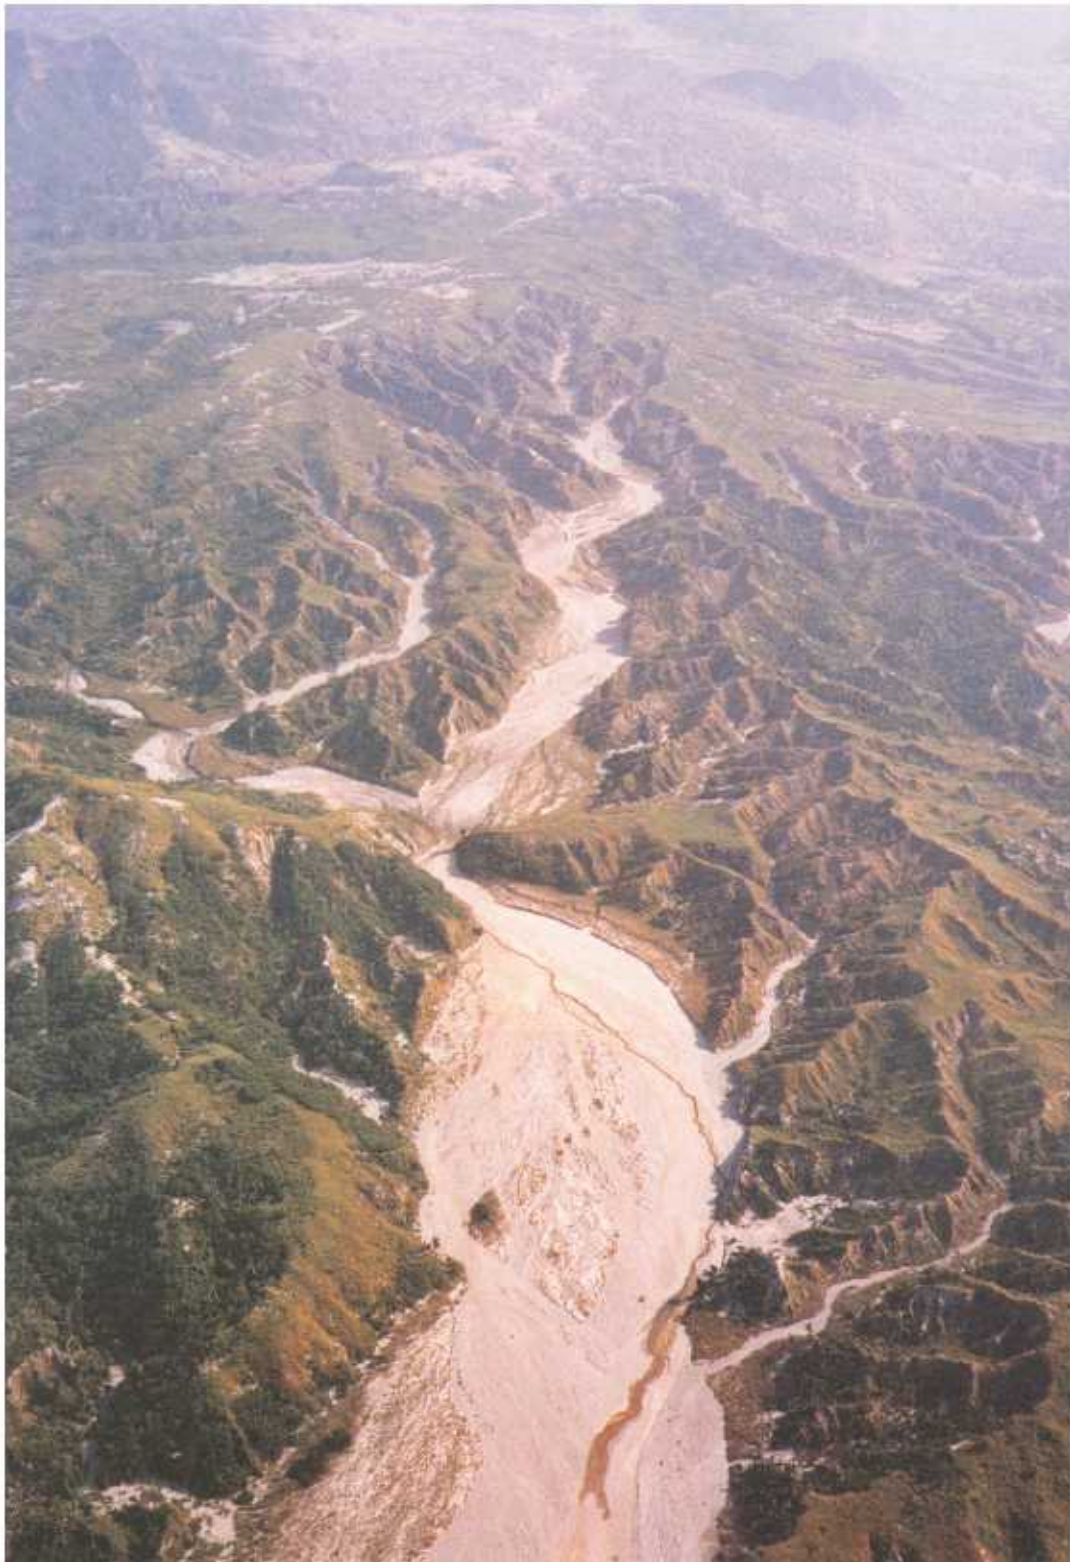
FIGURE 8.46 Mt. Pinatubo. Typical first-year lahar in the upper reaches of one of the rivers draining the western side of the volcano. *Photo: R. P. Brenner, 1992.*

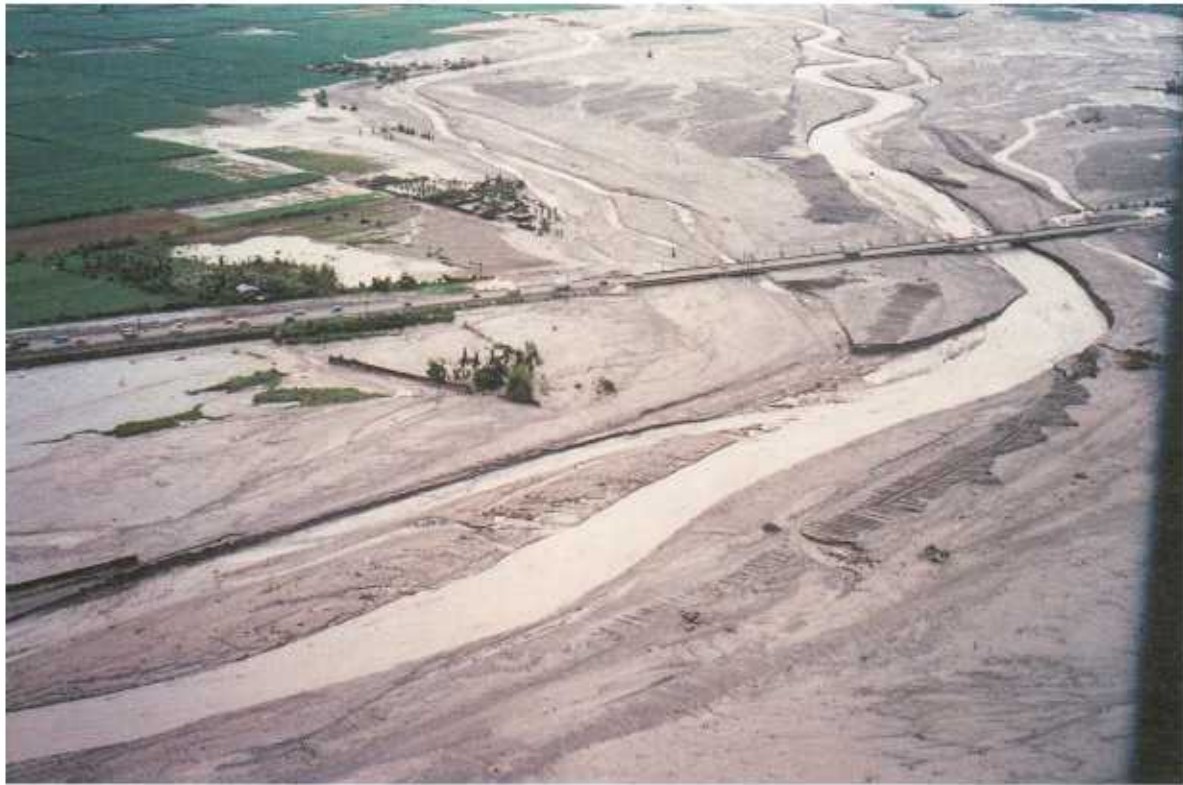
FIGURE 8.47 Mt. Pinatubo. Lahar in the lower reaches of the fan causing widespread damage to the infrastructure. *Photo: M. Watanabe.*

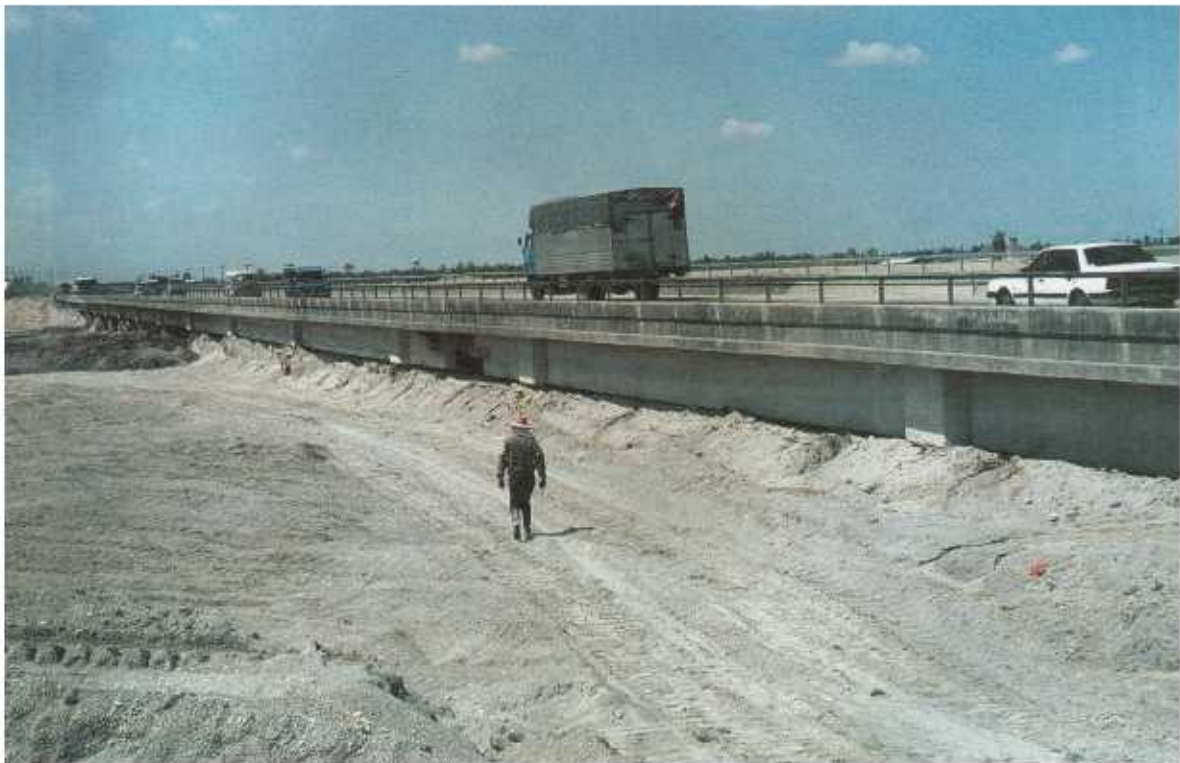
FIGURE 8.48 Upstream side of Capaya bridge over Abacan River at about km 80 from the Manila-Mabalacat Expressway. The lahar has filled the river channel up to the underside of the bridge deck. Location: Central Luzon, Philippines. *Photo: R. P. Brenner, 1992.*
