## 3 General Assessment/Characterization of Damages

### 3.1 Flood Damage Observations

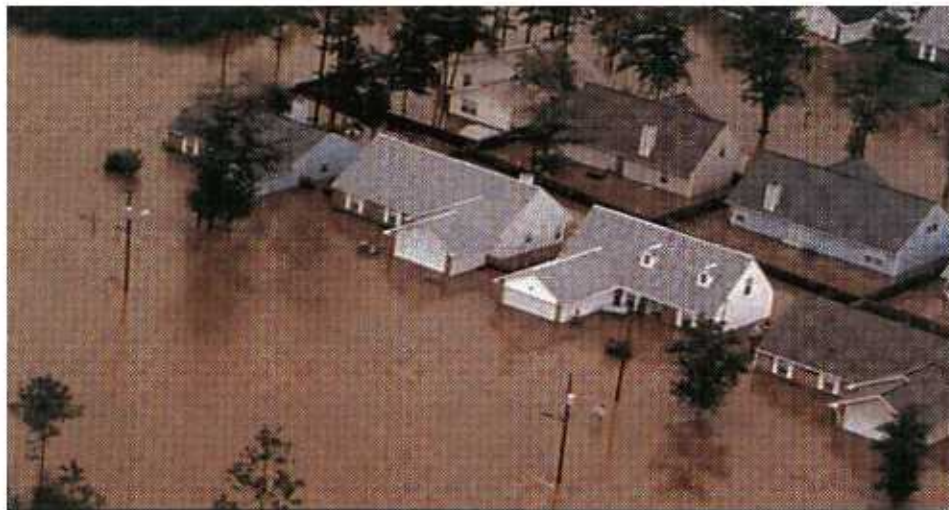
**FIGURE 3-1** Houses inundated by 2 to 3 feet of floodwaters in the Florida Panhandle.

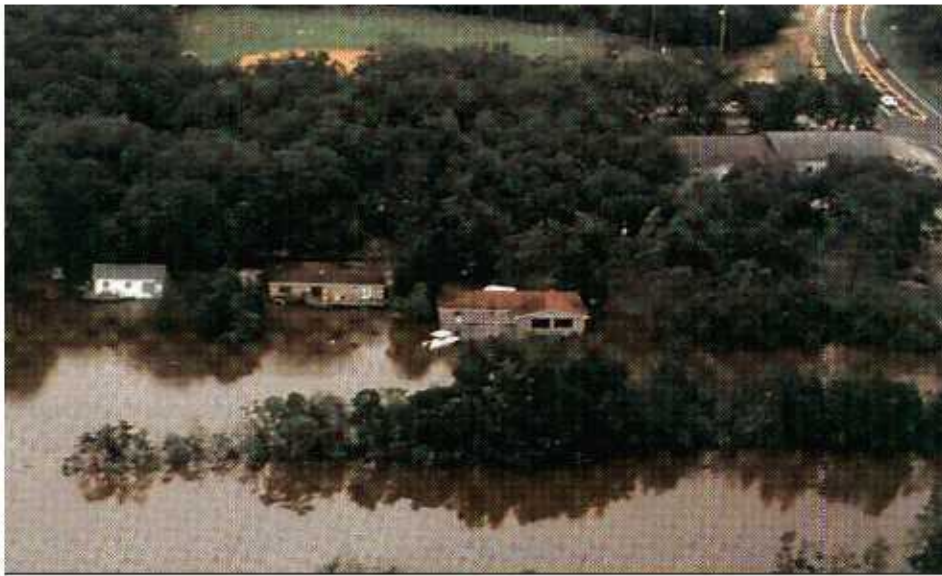
**FIGURE 3-2** Typical flooding to homes in low-lying areas.

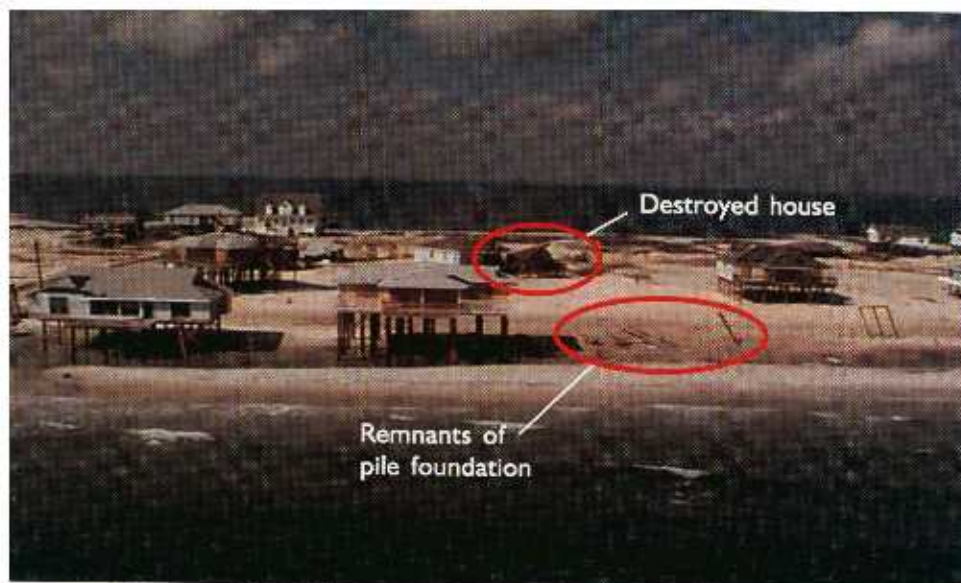
Building damage was concentrated on the front row of houses. Houses set back and properly elevated on deep pilings suffered little damage. The most severe damage caused to structures by coastal surge was observed on Dauphin Island, Alabama. Pile foundations on several Dauphin Island homes failed due to a combination of erosion and inadequate pile embedment, resulting in the collapse of structures (Figure 3-4). From Gulfport to Biloxi, Mississippi, minimal damage due to coastal surge was observed (Figure 3-5). Few homes are sited on the open coast and little overwash was evident.

**FIGURE 3-4** Front-row house separated from its foundation and destroyed by the storm on Dauphin Island, Alabama. Note the properly elevated and set back house on the right fared very well.

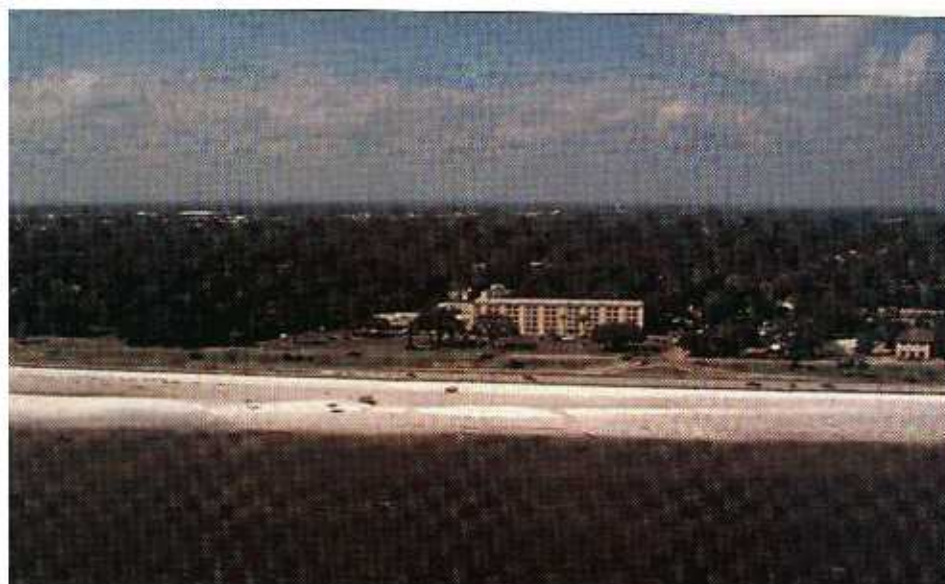
**FIGURE 3-5** Mississippi Gulf Coast near Biloxi. Minimal coastal surge damage or overwash was observed.

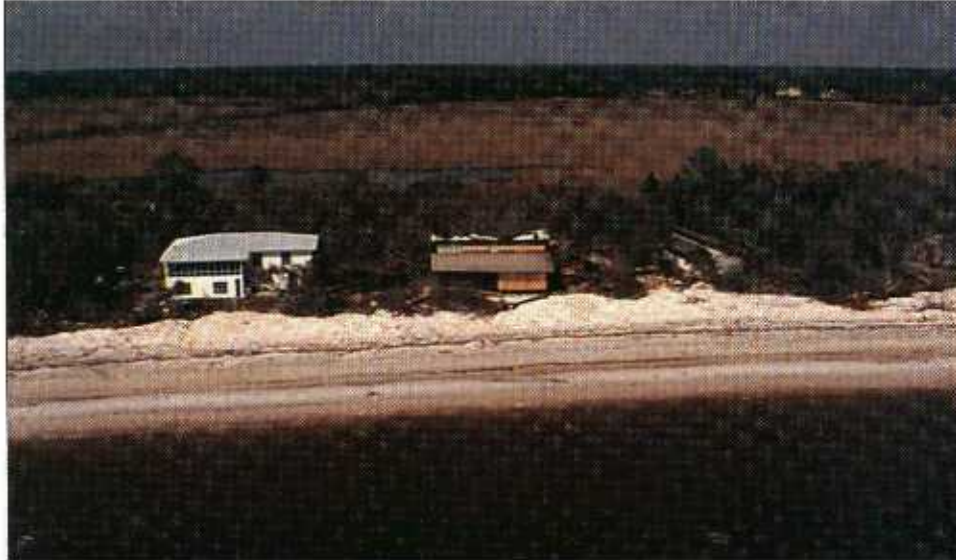
Coastal areas from Gautier to Pascagoula, Mississippi suffered some damage (Figure 3-6). Along Mobile Bay in Alabama, coastal surges severely damaged fishing piers and boatlifts. In addition, scour behind bulkheads caused some damages to front-row buildings (Figures 3-7 and 3-8). In the Florida Panhandle, limited structural damage was observed. Significant sand deposition, however, required extensive cleanup efforts (Figure 3-9).

**FIGURE 3-6** Overwashed sand accumulation and minor structural damage near Gautier, Mississippi.

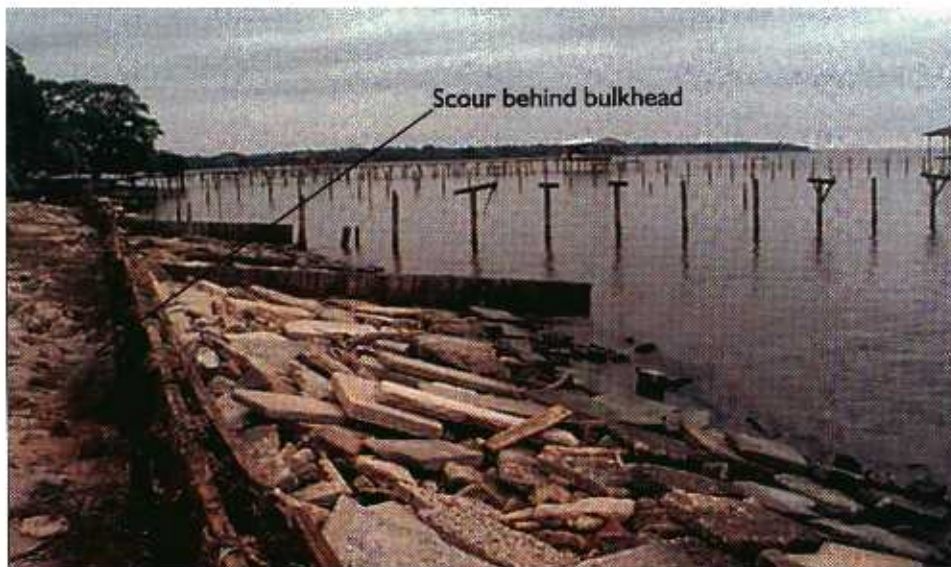
**FIGURE 3-7** Remnants of fishing piers in Mobile Bay near Fairhope, Alabama. Note scour behind the bulkhead on the left.

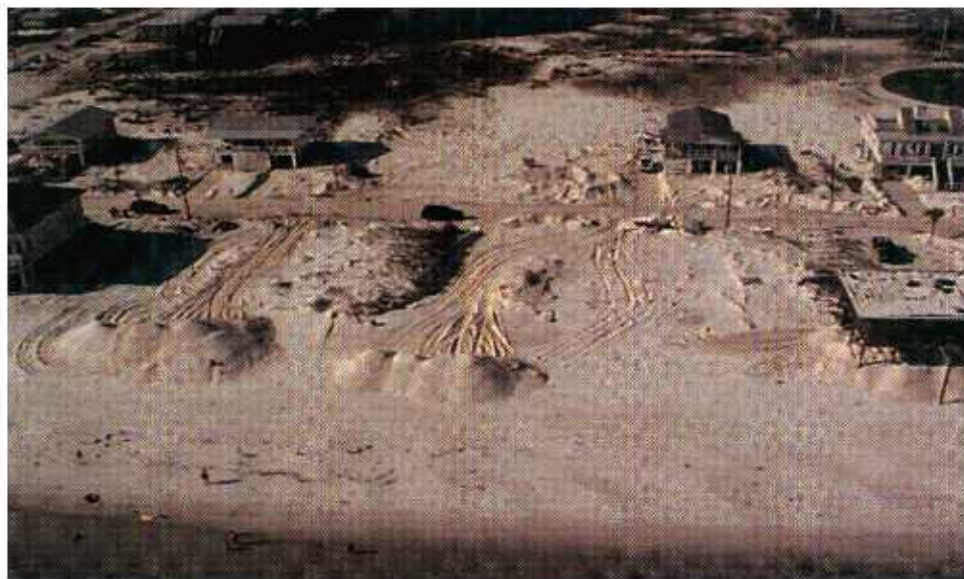
**FIGURE 3-9** Sand accumulation from overwash in Pensacola Beach, Florida.

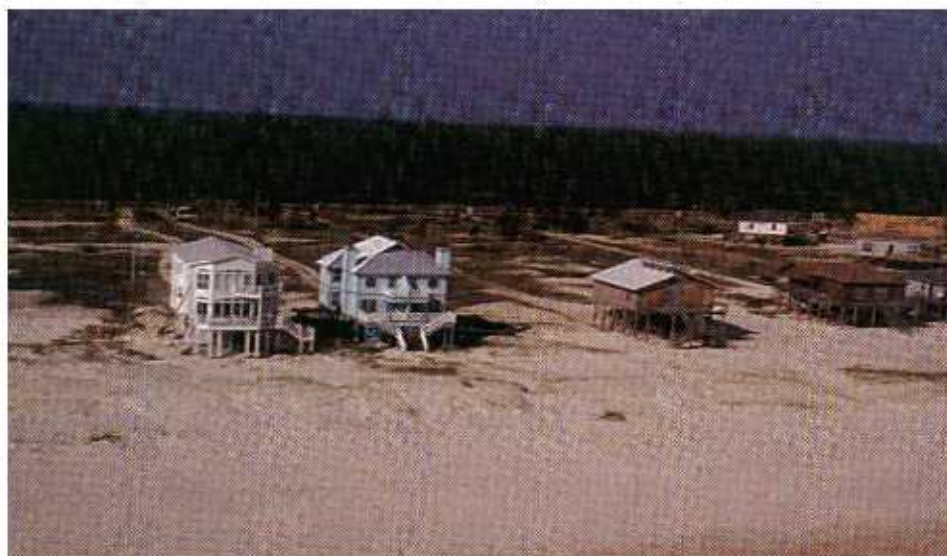
Pre-FIRM structures are those built before the effective date of the first FIRM issued by FEMA for the community in which the structure is located. Similarly, a post-FIRM structure is one built after the effective date of the first FIRM. In general, the effective date of a FIRM corresponds approximately to a community's adoption of floodplain management ordinances incorporating NFIP regulations for new construction and substantial improvements of buildings in special flood hazard areas (SFHAs). These regulations include the requirement for elevation of residential structures in SFHAs. In general, the BPAT observed that post-FIRM, elevated structures set back from the shoreline performed well during Hurricane Georges (Figure 3-10).

**FIGURE 3-10** Properly elevated and set back houses sustained little damage.

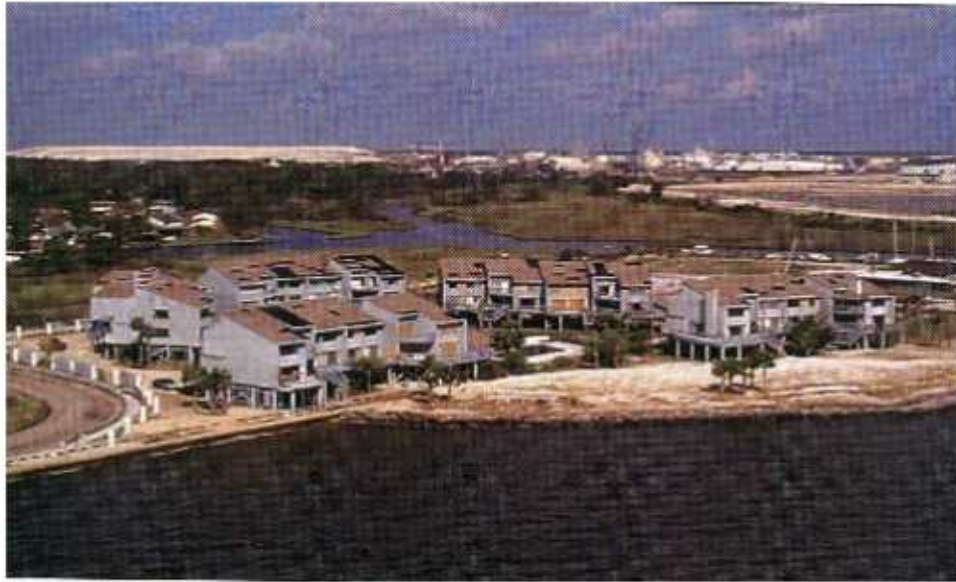
Hurricane Georges did not cause significant wind-related structural damage along the Gulf Coast. Buildings along the open coast suffered minor wind damage, including loss of sections of composition roof shingles and siding (Figure 3-11).

**FIGURE 3-11** These condominiums near Pascagoula, Mississippi suffered wind damage to roofing shingles and siding.

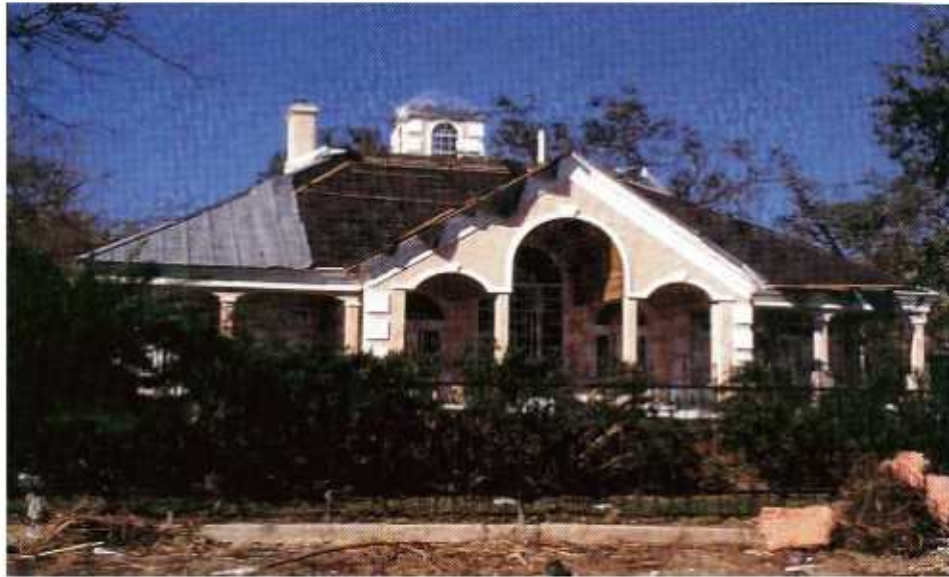
Many homes that lost their roofs were susceptible to further interior damage from subsequent rainfall. Wind damage in inland areas included damage to trees and signs. The most severe inland wind damage occurred to signs, roofs, and trees in the Pascagoula, Mississippi area (Figure 3-12).

**FIGURE 3-12** Wind damage to roofs and trees in Pascagoula, Mississippi.
