## 5 Florida Observations

### 5.1 Flood Observations: Damages and Successes

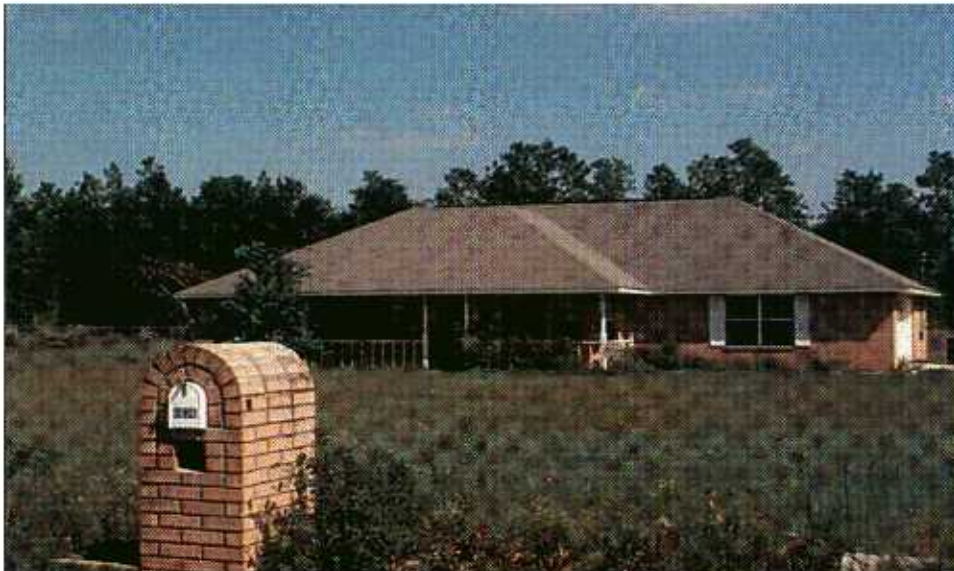
The BPAT visited sites of riverine flooding along the Yellow and Shoal Rivers in Okaloosa and Santa Rosa Counties. The home shown in Figure 5-1 was flooded by several feet of water and is typical of the pre-FIRM, at-grade houses located in these areas.

**FIGURE 5-1** Repetitively flooded home slated for acquisition under FEMA's HMGP.

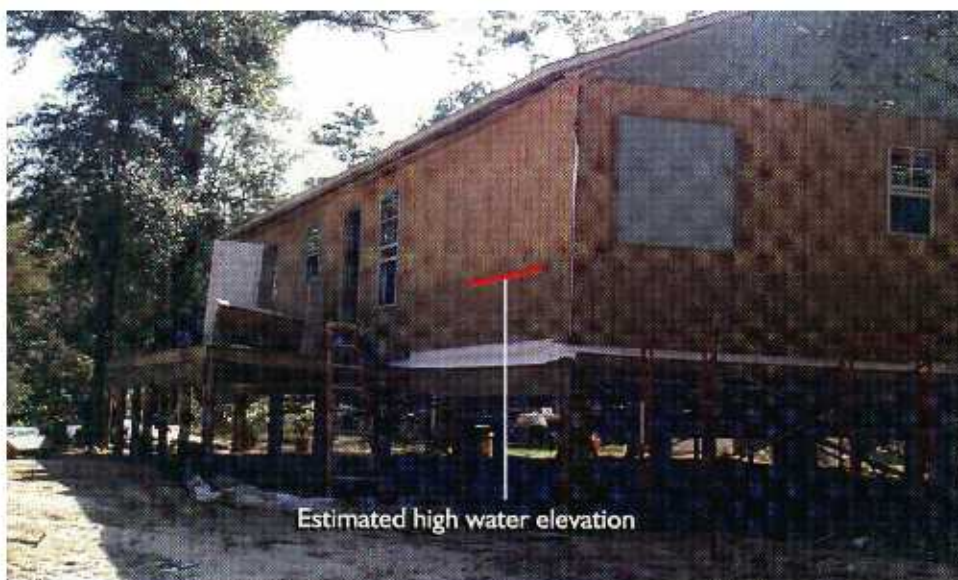
In accordance with the County's NFIP compliant floodplain management requirements, the replacement home shown in Figure 5-2 was recently built to the BFE with a Small Business Administration (SBA) disaster loan after flooding damaged it earlier this year. Floodwaters exceeded the BFE, reaching approximately 3 feet above the first-floor elevation. While the construction of the home to the BFE reduced the damages from Hurricane Georges — and will protect against damage from less intense, future storms — a residual risk still remains from floods exceeding the BFE. A freeboard requirement would have further reduced the risk of flooding. Fortunately, a condition of the SBA loan required the property owner to maintain flood insurance coverage on the home. Proceeds from the insurance claim will help the homeowner recover from this flood.

**FIGURE 5-2** A high water mark is visible approximately 3 feet above the first floor elevation. The house, located along the Shoal River in Okaloosa County, suffered little damage because insulation and wallboard had not yet been installed.

The BPAT assessed damage from riverine flooding on the Shoal River that exceeded the base flood level by several feet. Homes elevated to the BFE flooded when water levels exceeded the BFE, as was the case with the home in Figure 5-2. Homes built outside, but adjacent to, the SFHA were flooded when water levels exceeded the limits of the SFHA. Homes in Figure 5-3 were built in the last five to seven years and they experienced significant flooding and damage when water levels exceeded the BFE and the limits of the SFHA.

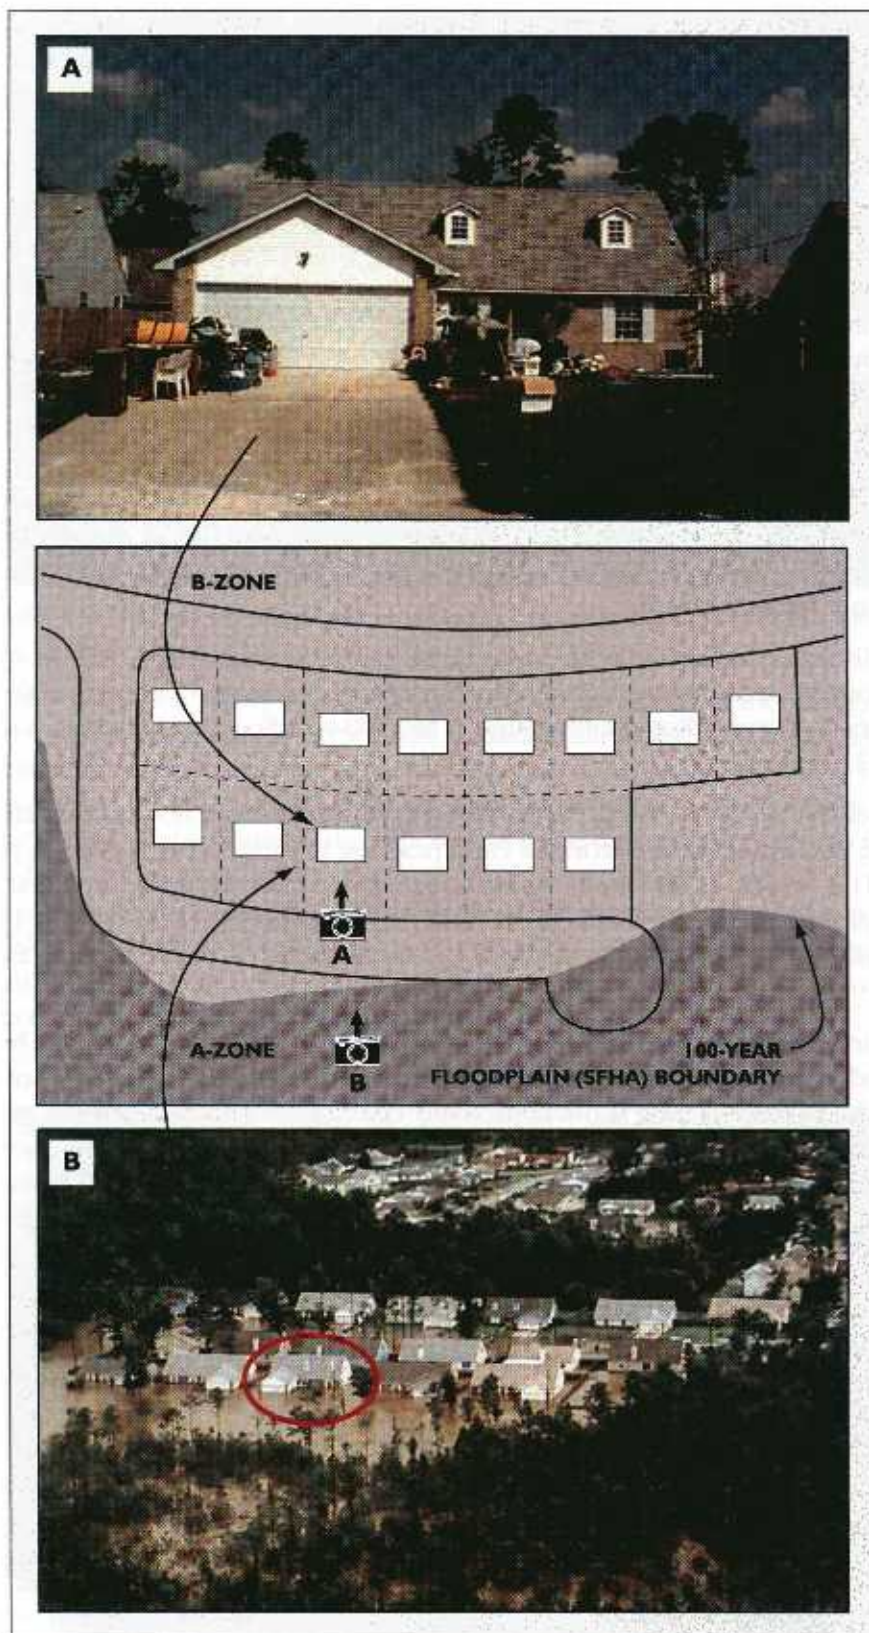
While locating homes directly adjacent to but outside the SFHA may eliminate both the mandatory flood insurance purchase requirement and floodplain management construction requirements, the risk of flooding is not completely eliminated. This residual risk, without the financial protection of flood insurance coverage, left many homeowners whose flooded homes were located outside the SFHA, ill-prepared to recover from flood damage caused by Hurricane Georges.

**FIGURE 5-3** The home pictured above is one of approximately 10 homes in this subdivision which experienced flood depths of 2 to 3 feet when the water levels exceeded the BFE and extended beyond the limits of the SFHA.

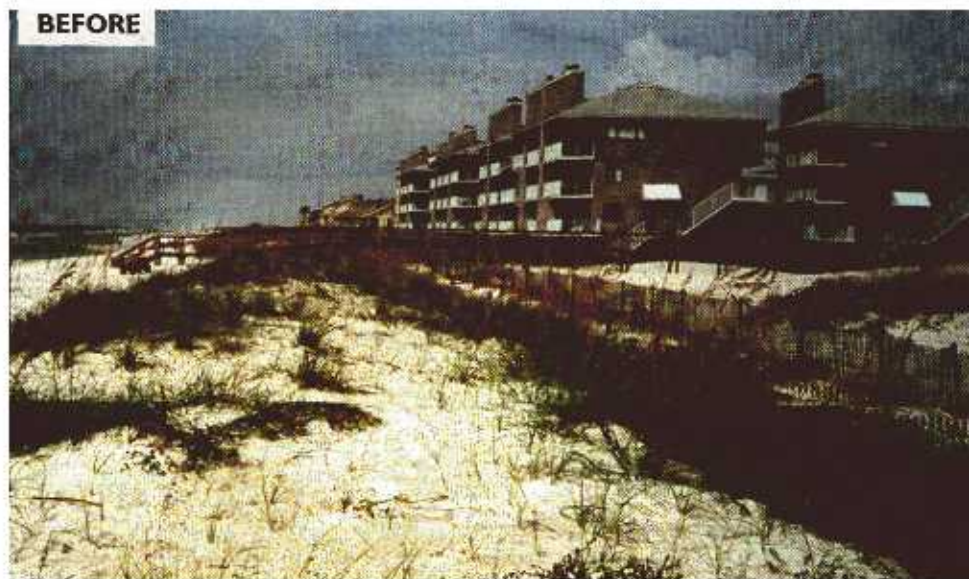
In Pensacola Beach, prolonged wave attack and storm-surge flooding associated with the hurricane eroded most of the primary dune system and narrowed the beach (Figures 5-4 and 5-5). Overwash was significant, but not as severe as experienced during Hurricane Opal. Vertical sand accretion beneath some structures was 3 to 5 feet. Even after Hurricane Georges, Pensacola Beach remains relatively wide with scattered residual dunes. Offshore sandbars were observed migrating back onto the beach in some locations.

**FIGURE 5-4** Pensacola Beach before Hurricane Georges.

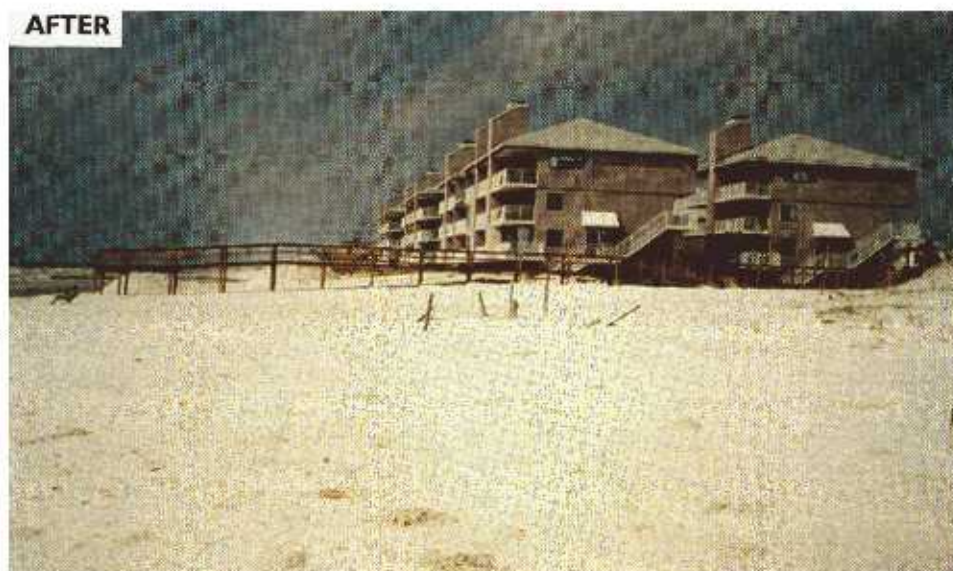
**FIGURE 5-5** Pensacola Beach after Hurricane Georges. Note the loss of dune and vegetation in the foreground of the photo.

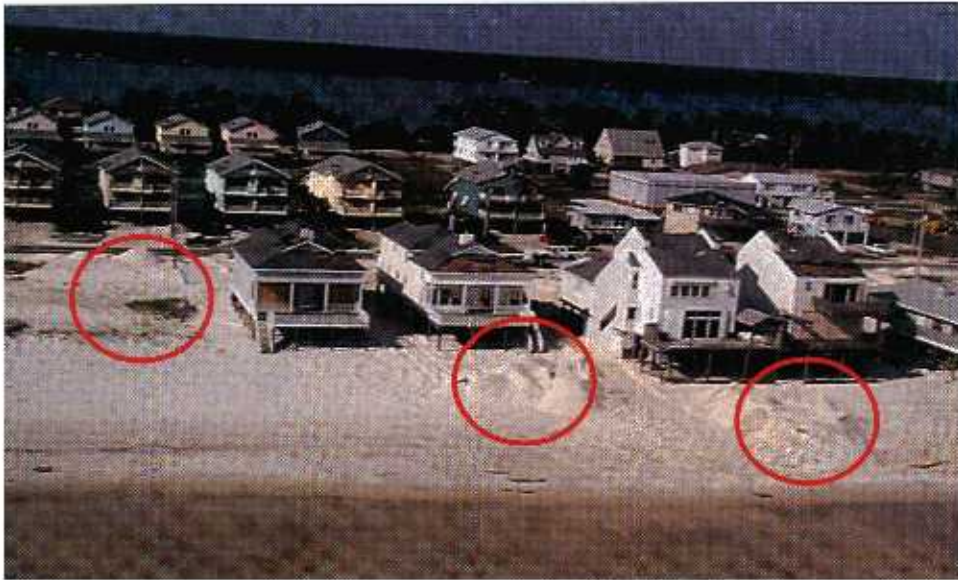
Much of the sand that was washed inland buried roads, utilities and lower areas of buildings. As shown in Figure 5-6, homeowners removed excess sand.

**FIGURE 5-6** Excess sand (circled) from beneath houses and on roadways that was returned to the beach.

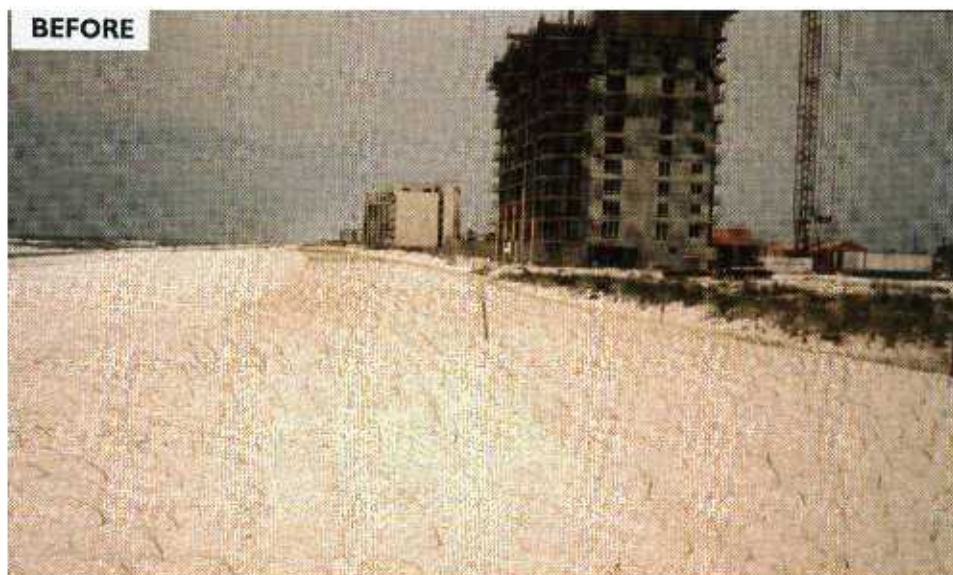
The volume of overwashed sand made the road from Pensacola Beach to Navarre Beach impassable. Reportedly, significant portions of the post-Hurricane Opal reconstructed dune in Navarre Beach were lost (Figures 5-7 and 5-8).

**FIGURE 5-7** Navarre Beach before Hurricane Georges.

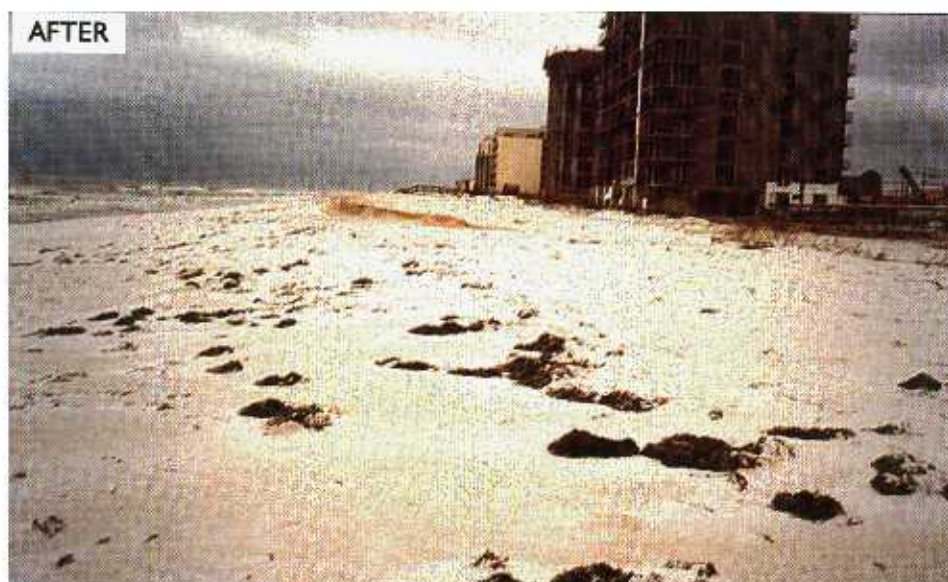
**FIGURE 5-8** Navarre Beach after Hurricane Georges. Note the loss of revegetated dune.

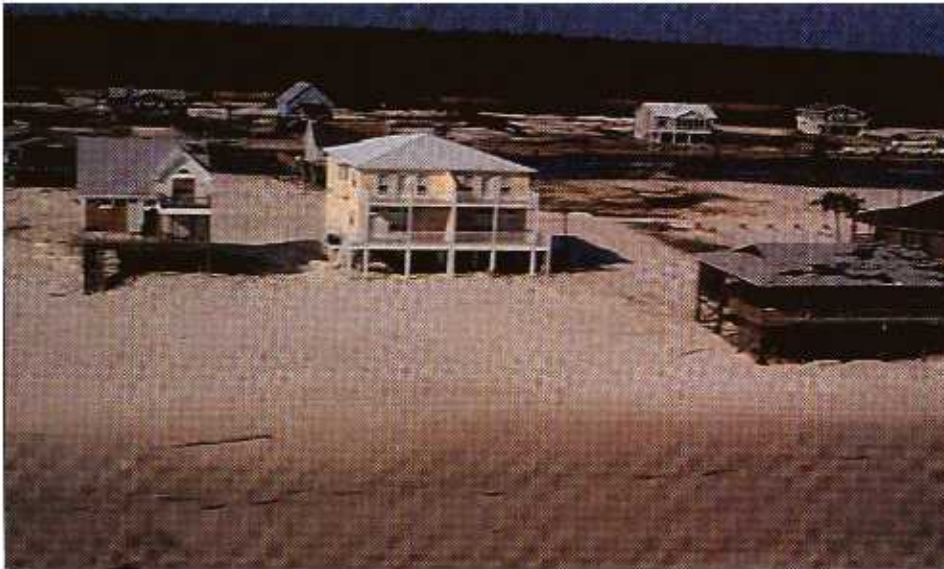
In Pensacola Beach, post-FIRM elevated structures performed well, suffering only residual damage to storage, access, and parking areas below the first floor (Figure 5-9). In V-Zone areas, the BPAT observed minimal enclosures below the first floor of elevated structures. Breakaway walls, where observed, performed as intended.

**FIGURE 5-9** The structures to the left were elevated and set back and performed well.

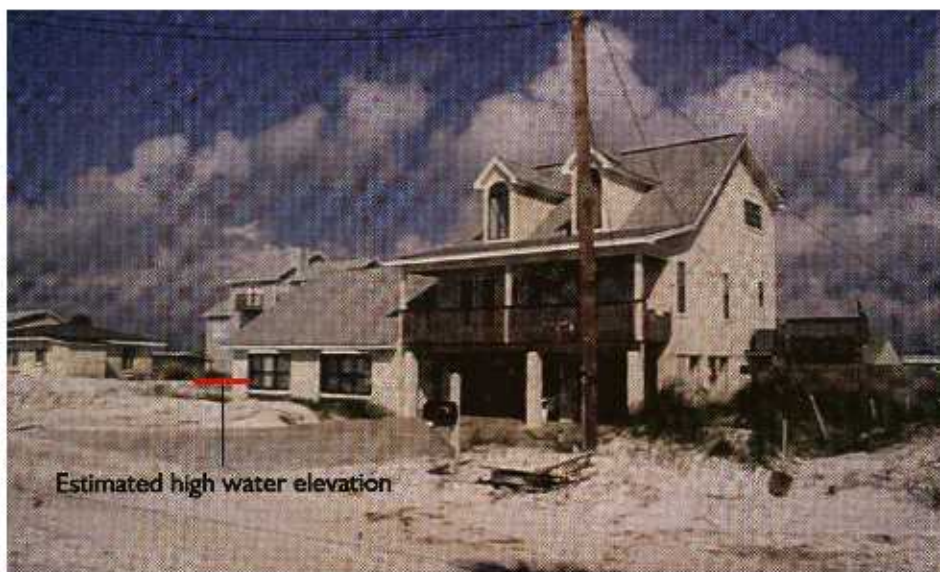
The house in Figure 5-10 clearly illustrates the reduction in flood damages that occur when homes are properly elevated. The elevated addition suffered no damage while the pre-existing, at-grade portion of the home suffered extensive flood damage from overwash.

**FIGURE 5-10** An existing slab-on-grade home was expanded with a properly elevated addition.

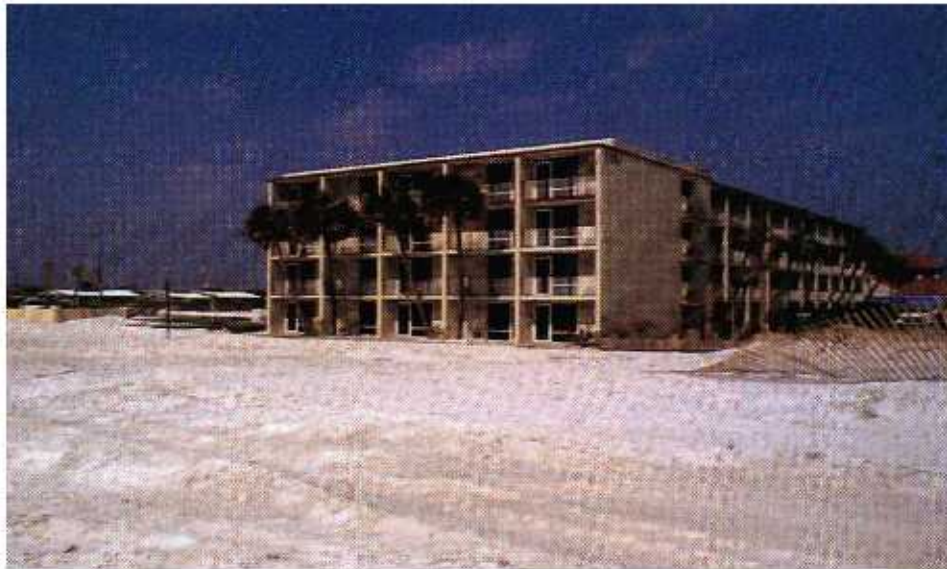
The BPAT also investigated the performance of several Pensacola Beach hotels. Older, pre-FIRM buildings, such as the hotel in Figure 5-11, suffered flood damage. Flood and rain damage forced the hotel in Figure 5-11 to close for repairs. The property management company reported that it would be closed for three to four months, forcing the layoff of approximately 50 housekeeping and support staff. In contrast, newer hotels with elevated first floors in compliance with the current floodplain management ordinance suffered minimal damage (Figure 5-12). The hotel in Figure 5-12 suffered minimal damage and was able to continue operations without disruption.

**FIGURE 5-11** An older hotel that suffered significant damage to the interior due to storm surge and roof leakage.

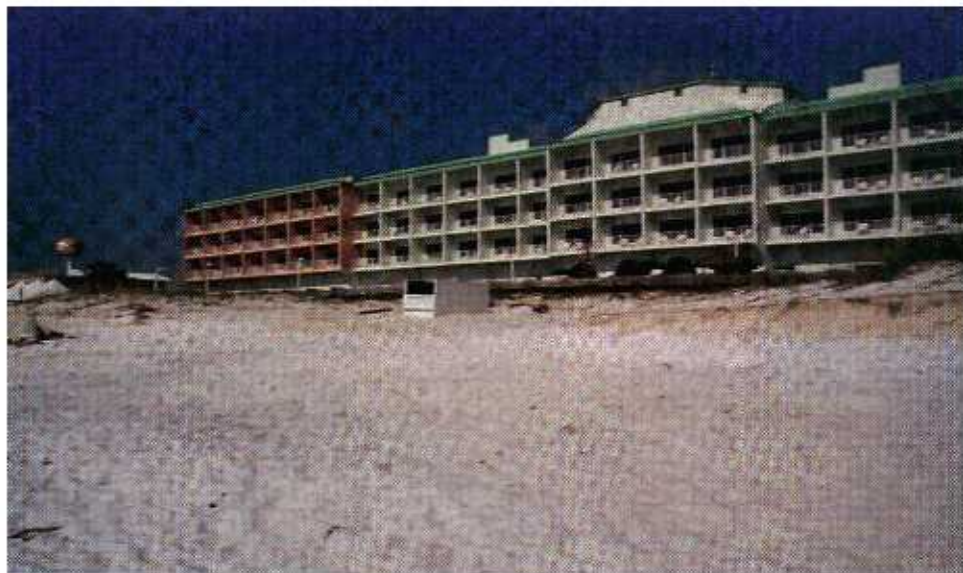
**FIGURE 5-12** A newer hotel with an elevated first floor that suffered minimal damage.

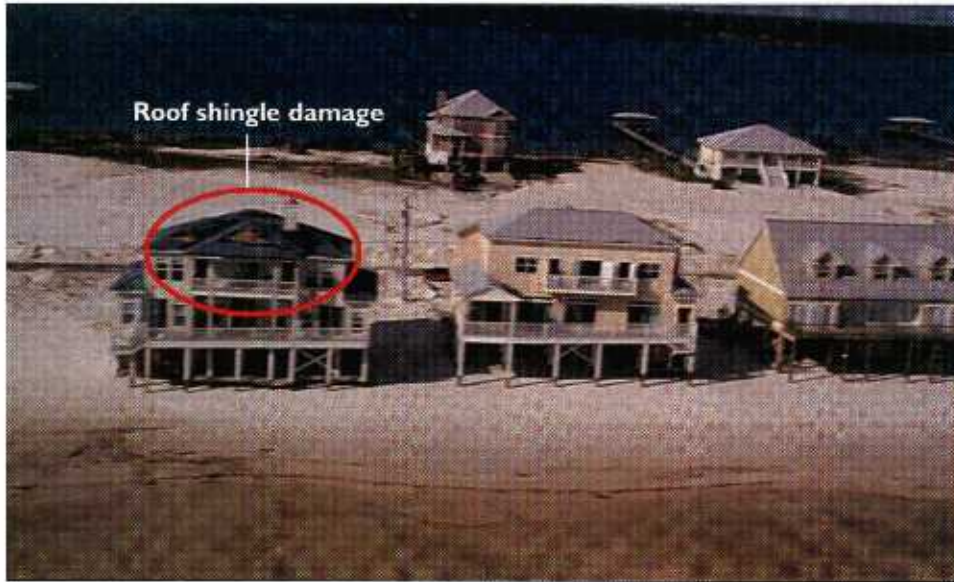
In general, Hurricane Georges caused minimal wind damage in Florida. Buildings highly exposed along the open coast suffered some wind damage, including loss of sections of composition roof shingles and small sections of siding, which allowed rain infiltration to damage building interiors and contents (Figure 5-13).

**FIGURE 5-13** The house on the left suffered wind damage to roofing shingles.

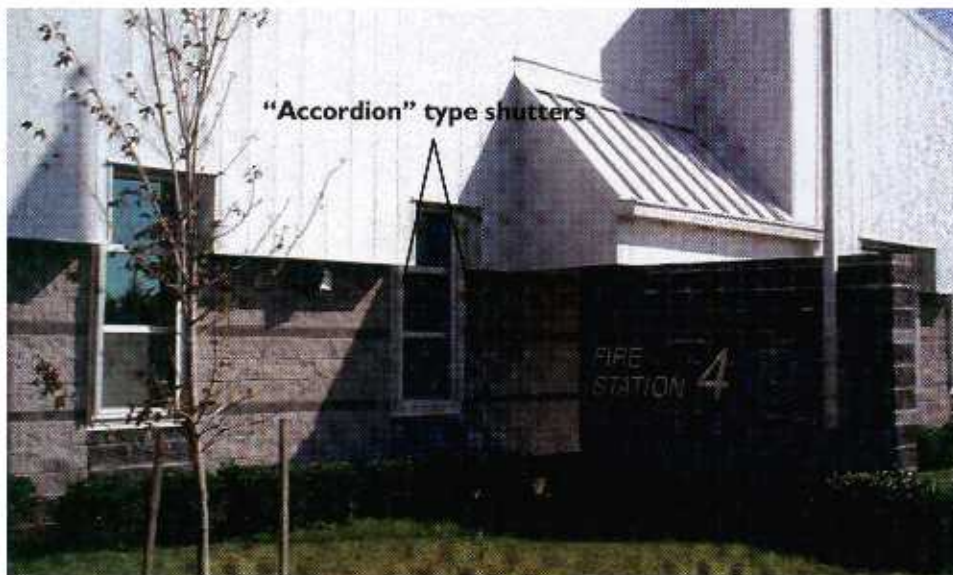
The BPAT assessed the performance of several window and door shutter projects funded under FEMA's HMGP. The shutter projects were applied to public buildings, including municipal office buildings, fire stations, and police stations. While there was little evidence that wind forces and airborne debris caused damage to windows and doors in the area, buildings with shutters showed no damage and provided a safe and secure shelter facility during the hurricane (Figures 5-14 to 5-16).

**FIGURE 5-14** Window shutters on the Pensacola Fire Station No. 4.
