## CHANNEL CHANGE IN SOUTHERN ARIZONA-- IMPLICATIONS FOR FLOODPLAIN MANAGEMENT

Marie S. Pearthree  
Pima County Department of Transportation  
and Flood Control District

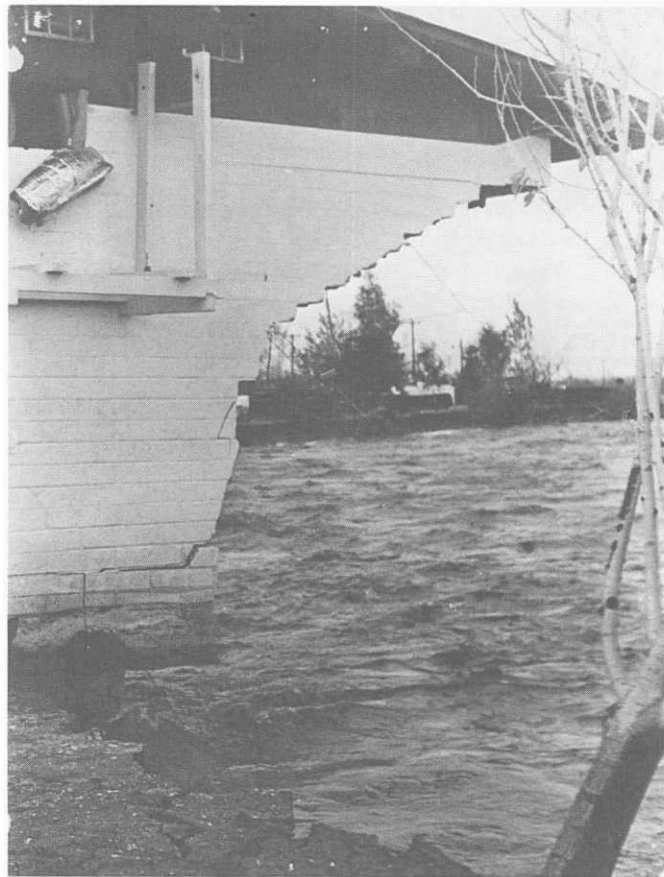
FIGURE 4. House being undercut by Rillito Creek in December, 1965. Photograph taken by L.O. "Pat" Henry, courtesy of Special Collections, University of Arizona Library.

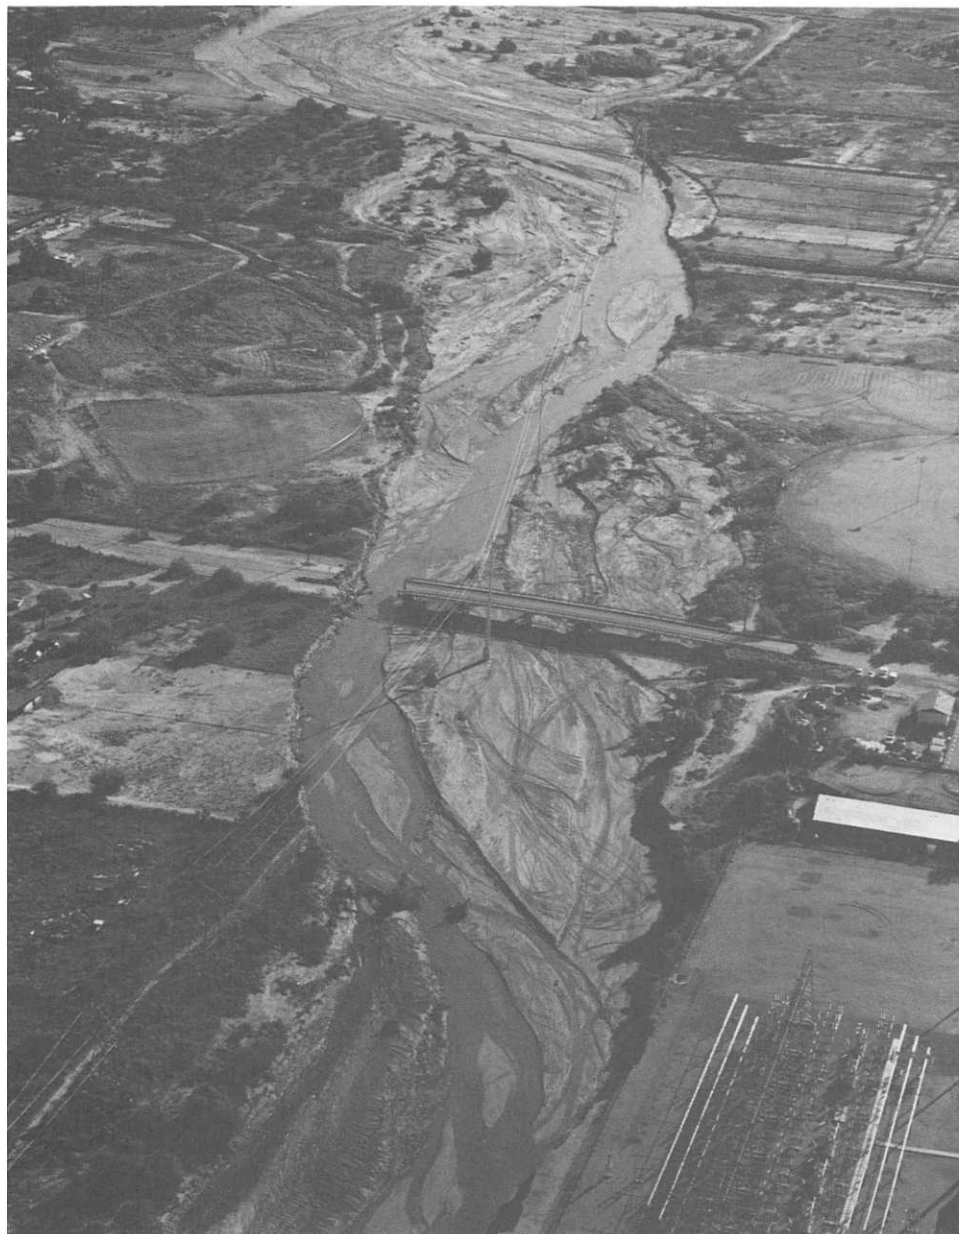
FIGURE 5. Damage to the northern (left) abutment of the Dodge Road bridge across Rillito Creek caused by channel bank erosion and lateral channel migration in October, 1983. Note the threat to the electric utility station on the opposite bank downstream. Photograph by Peter Kresan.

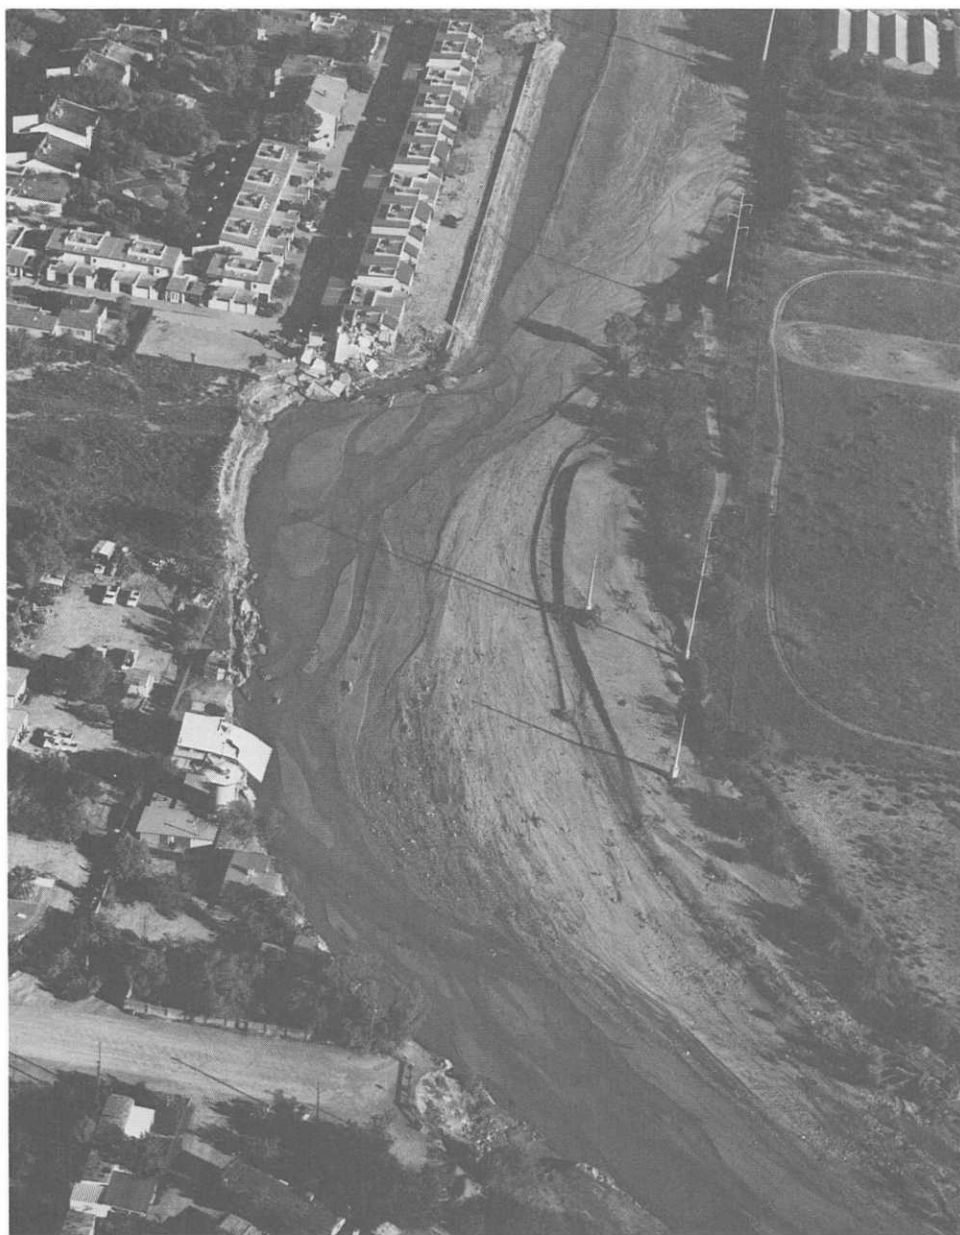
FIGURE 6. Damage to the Pima Park Townhomes caused by lateral migration of a prominent meander bend of Rillito Creek. Erosion occurred behind the soil cement bank protection shown adjacent to the townhomes, leading to its failure. Photograph by Peter Kresan.
