Bhaise Bridge

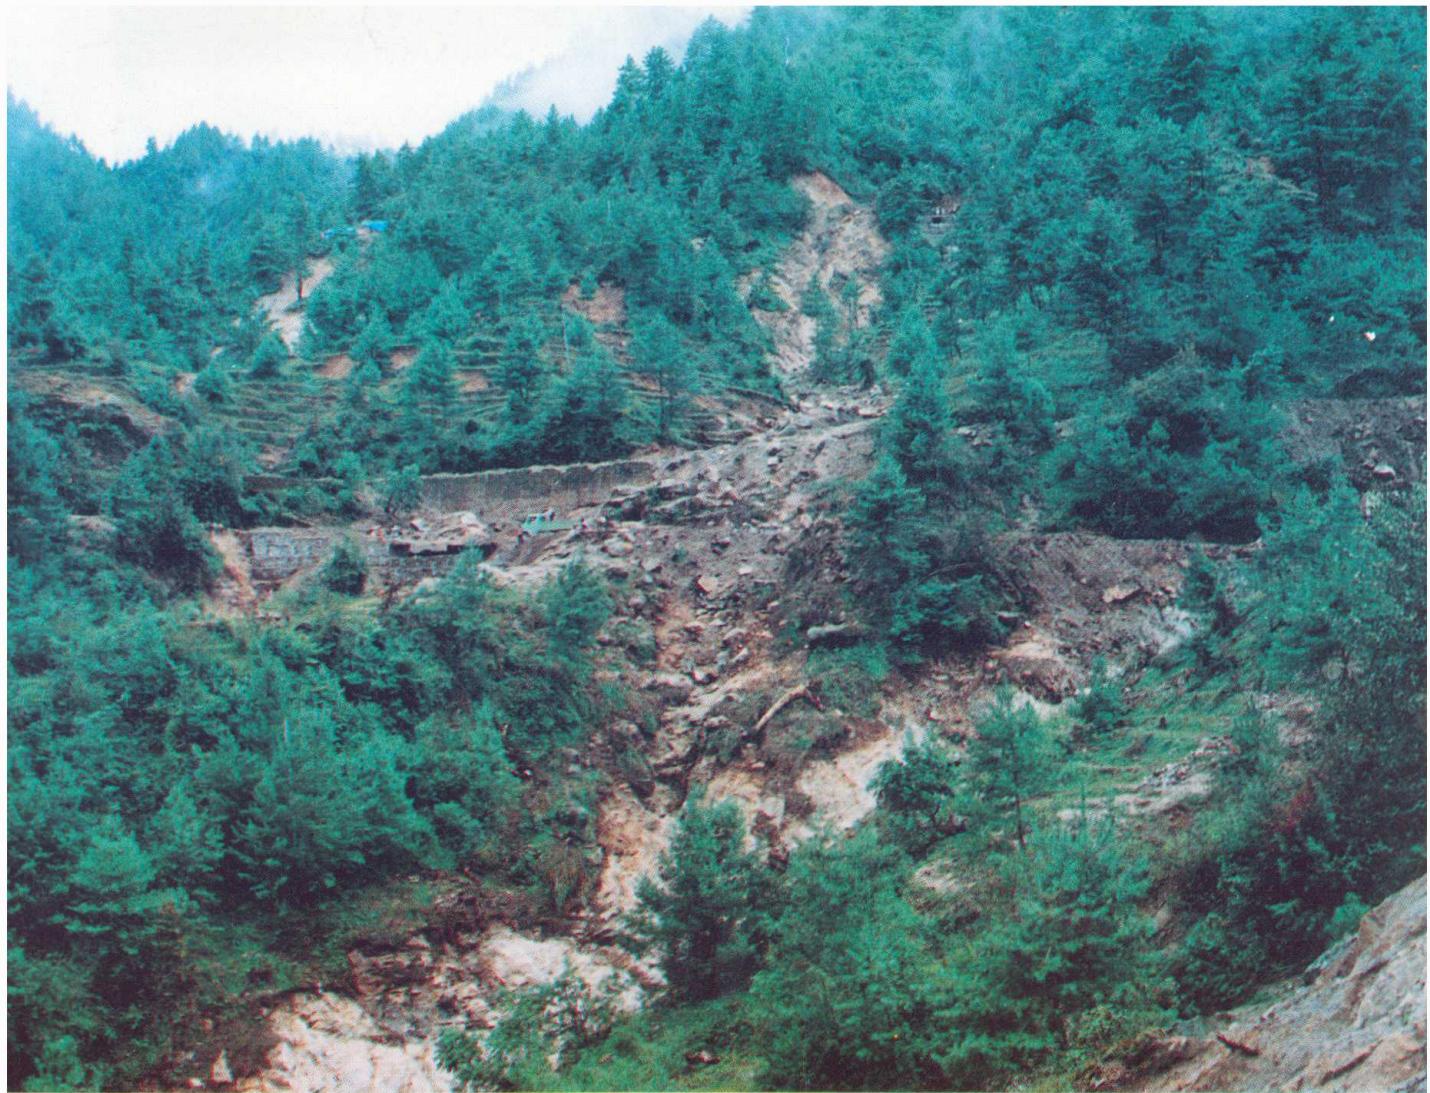
Section of Tribhuwan Highway damaged by debris flow near Palung
