Damage to buildings

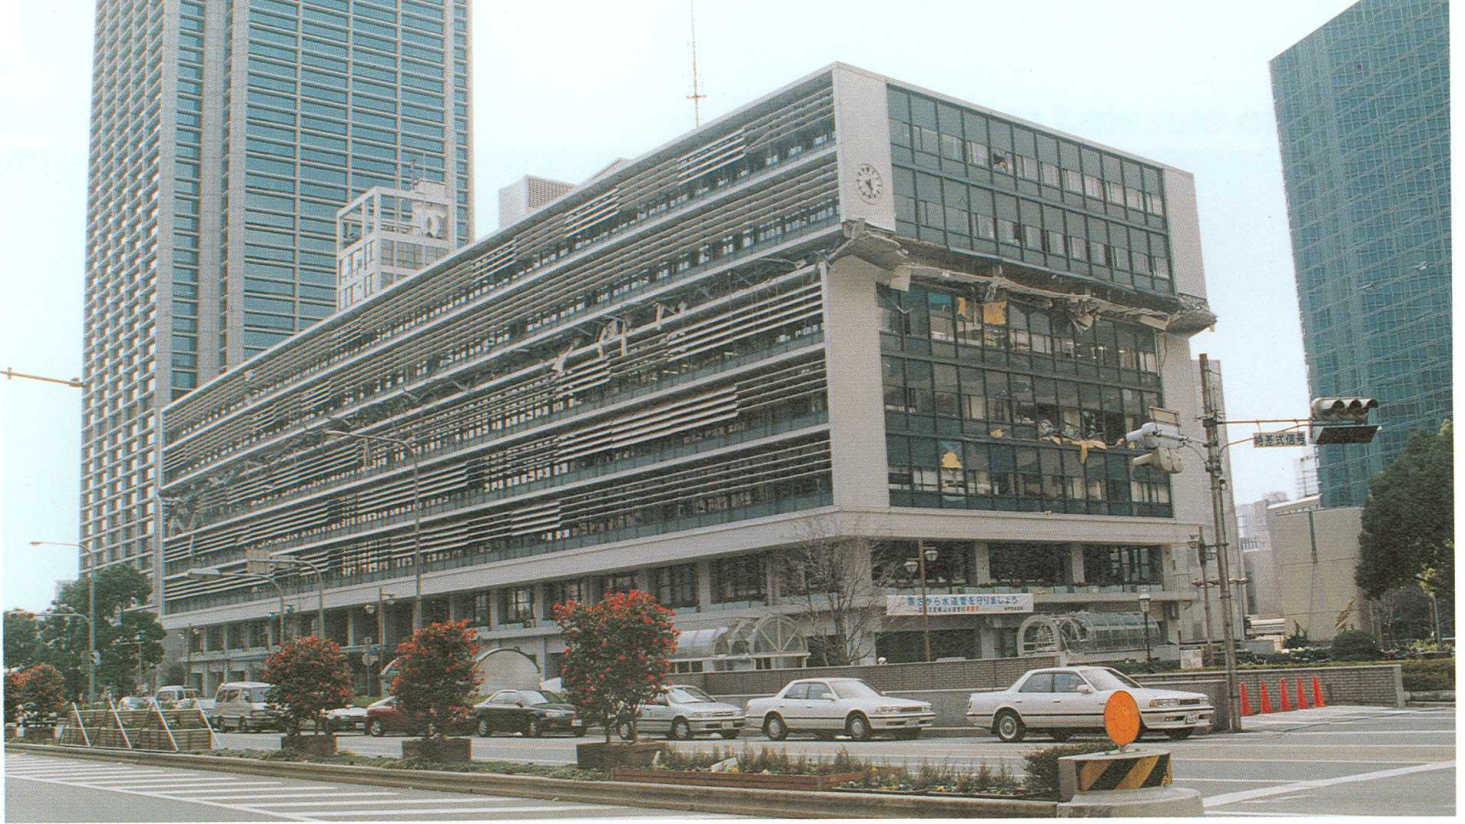
▲The Kobe municipal office building whose sixth floor was collapsed. There were some other buildings whose certain floors were destroyed.

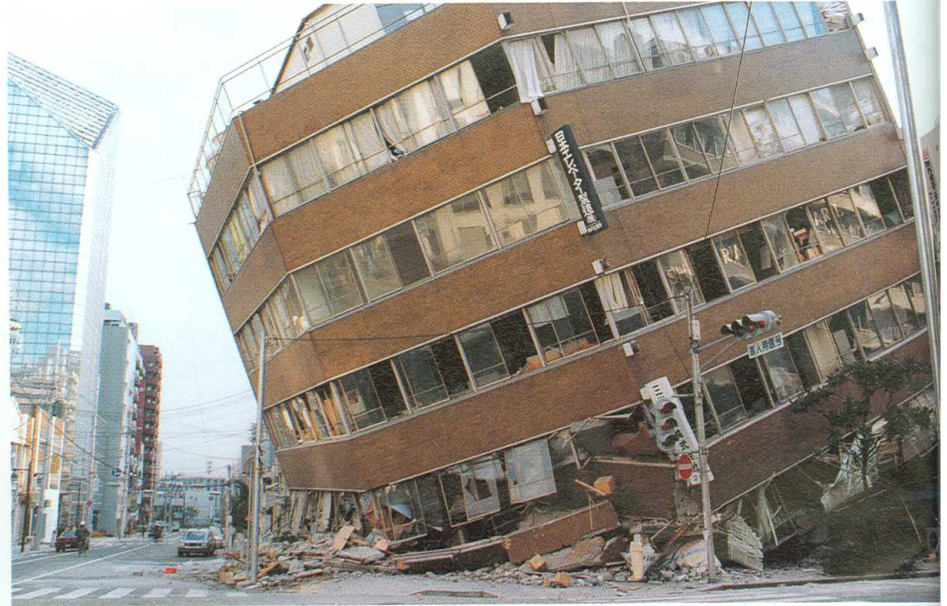
▲ A damaged building. The first floor was crushed. Damage like this was observed in most buildings with fewer walls on the first floor, such as parking places and shops.

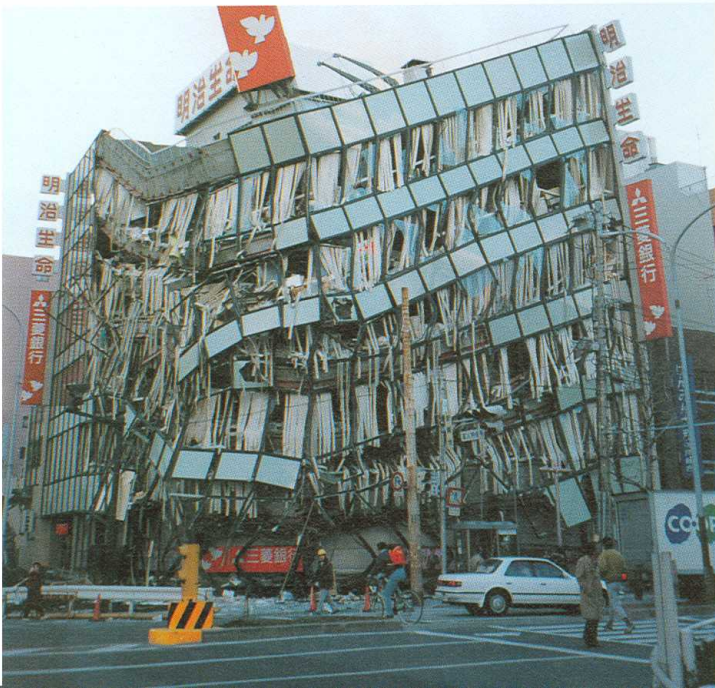
◀ A damaged building.
