# ***COST AND BENEFITS OF DISASTER MITIGATION IN THE CONSTRUCTION INDUSTRY***

***Paper Prepared<sup>1</sup> for the  
Caribbean Disaster Mitigation Project Workshop  
Trinidad: 14-16 March, 1995***

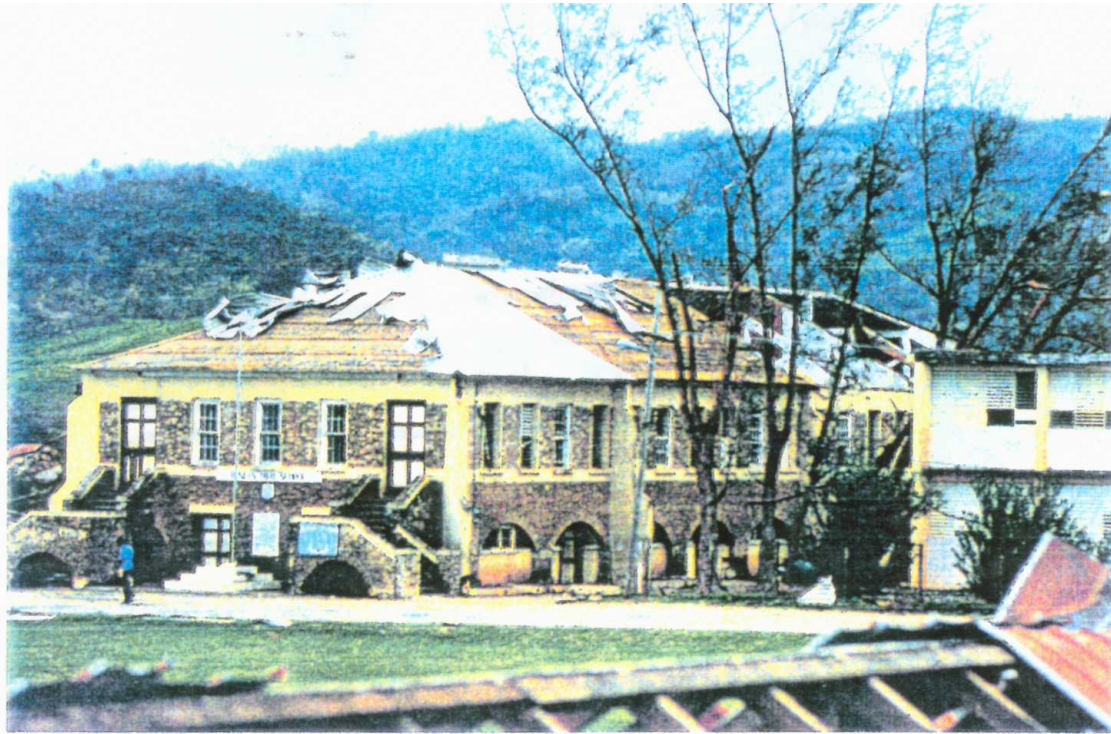
*Figure 2: Hurricane Gilbert (1988) - Damage to Roof of Classroom Block at Ruseas High School in Luvea (N.Coast, Jamaica)*

The benefits of disaster mitigation as achieved through improved structural resistance of buildings applies equally to both the threats presented by Hurricanes and Earthquakes. The evidence from the aftermath of Hurricane Gilbert in Jamaica shows that the “benefit” of a secure roof was not only related to the replacement cost of the roof element of the building, but also encompassed the consequential loss to the contents of the building, and the relocation costs of moving to and renting alternative accommodation until repairs were accomplished. *Figures 1 and 2* show the impact of hurricane devastation.

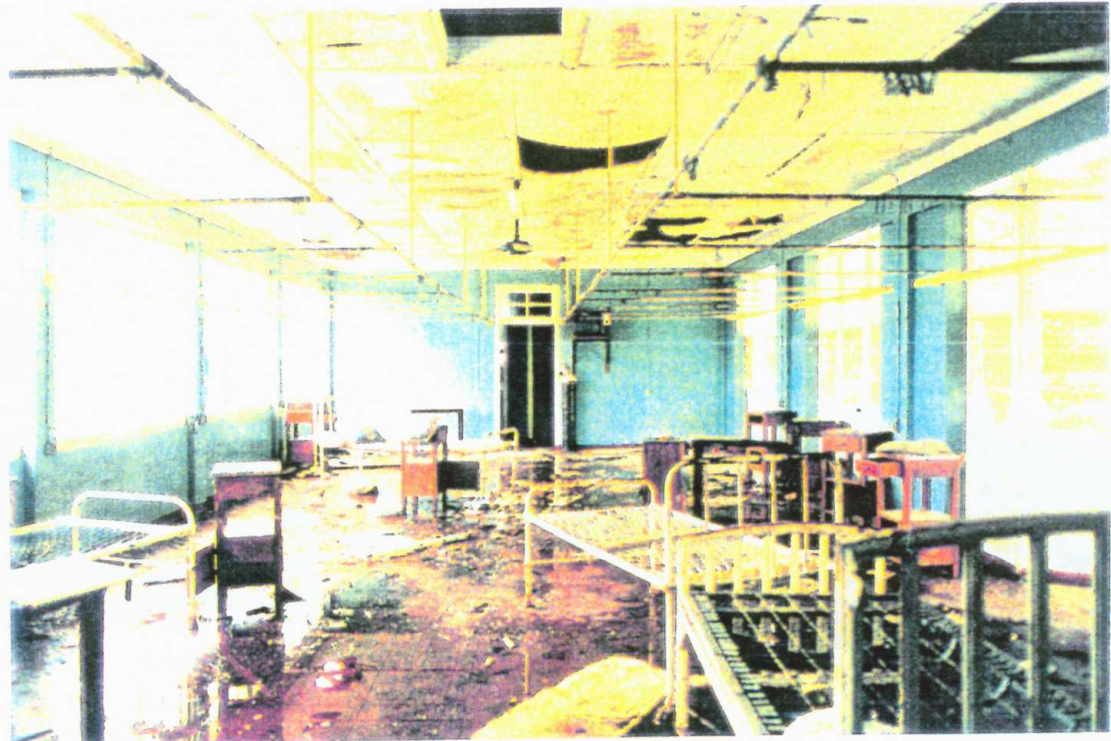
*Figure 3: Interior Damage to Male Ward of the Noel Holmes Hospital Caused by Loss of Roof Sheetting - Hurricane Gilbert (1988)*

The loss of the roof of a building may represent up to 15% (single story) of the replacement cost of the building. When it is considered that consequential losses, such as water damage to the contents and finishes (paint-work), can easily represent another 15% of the cost of the building, the repair/replacement cost of total roof loss is likely to be in the order of 30% of the replacement cost of a single story building. This does not include the relocation cost for the occupants, which relate to the annual rental rates of a building (usually 5% - 10% of its current value), for the duration of the repairs. The benefit of having a roof detailed to successfully resist hurricane wind loads therefore far outweigh the small initial cost to upgrade the fixing details and roof cladding to ensure adequate performance. *Figures 3 and 4* show damage as a result of the 1993 Woodford (Jamaica) earthquake.

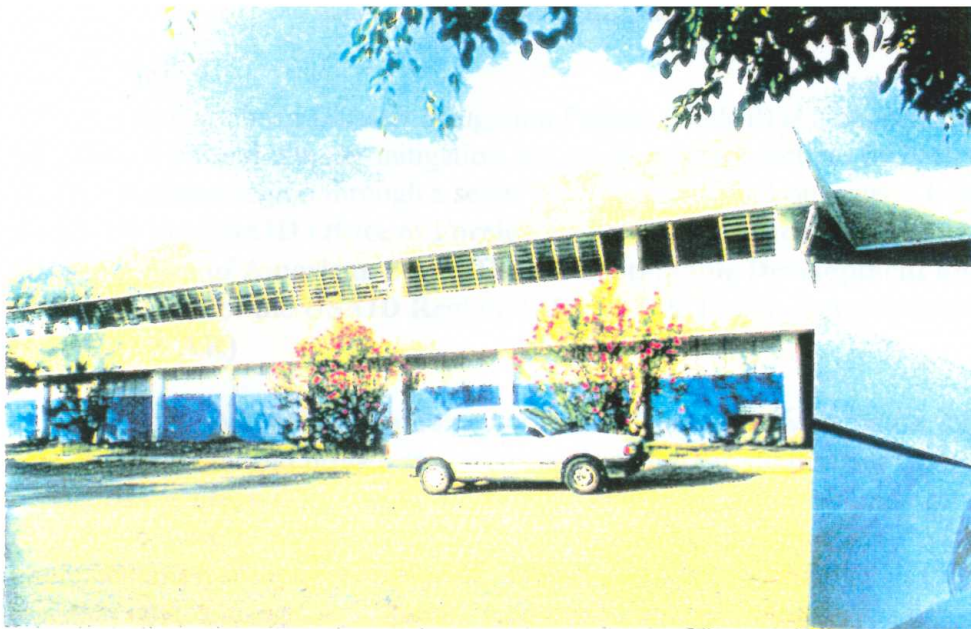
*Figure 4: Above, Two Story Classroom/Library Building at Jamaica College, Kingston. Inset, shows Upper Level Column Damage Caused by Adjoining Wall Restraint. [Woodford (Jamaica) Earthquake].*

Of particular note was the impact of inadequate shear reinforcement in short columns. Such columns were either "designed" as short columns or inadvertently behaved as short columns due to the restraining action of adjoining block walls. In cases such as these, it is best to alter the building at the design stage, so as to remove the potential "short column effect". This requires careful review of the architectural drawings, including elevations, by the design Engineer and a willingness by the design team to modify elements which present undue hazards.

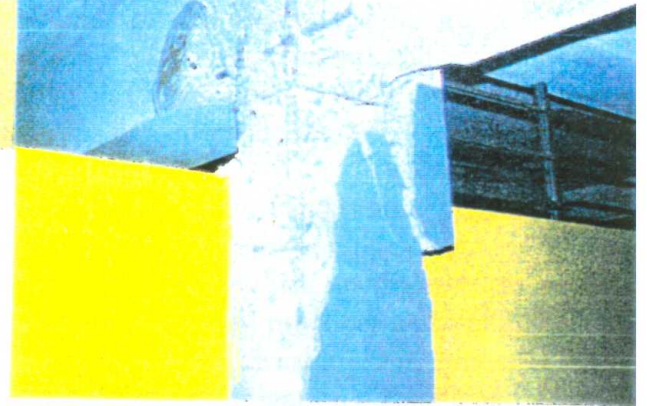
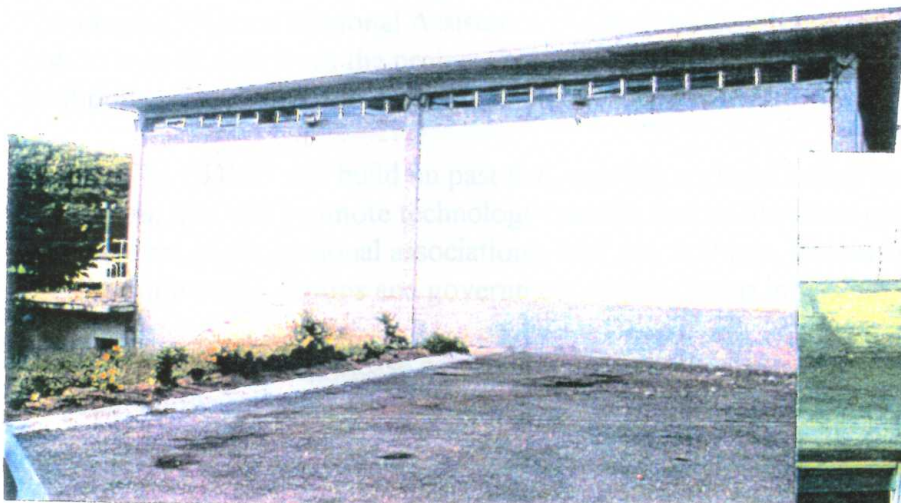
*Figure 5: Building Housing Water Treatment Plant in Kingston. Walls on Exterior Restrain Columns and Cause "Short Column" Effect. Inset Shows Damage to Centre Column. [Woodford (Jamaica) Earthquake].*
