## **APPENDIX D**

### **Photographs**

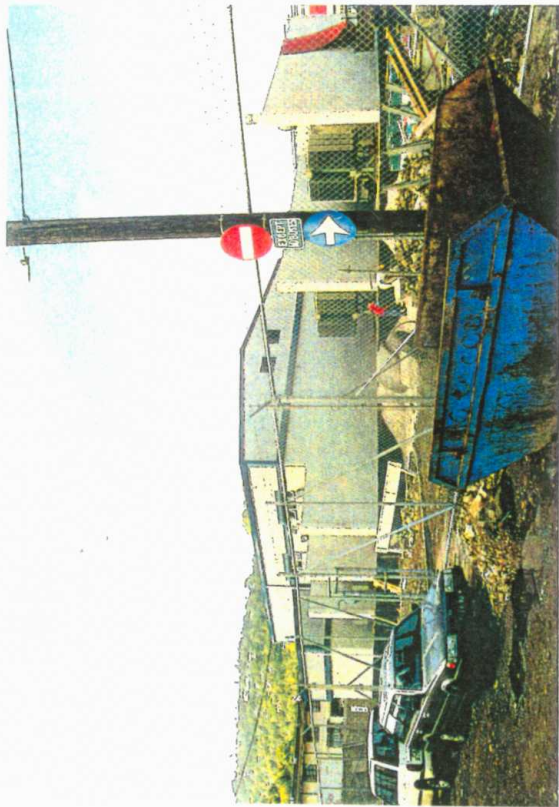
Photo 1: Castries sub-station: Currently under construction, most of the equipment to be used here was stored at Union and was damaged during the floods. Construction is now behind schedule.

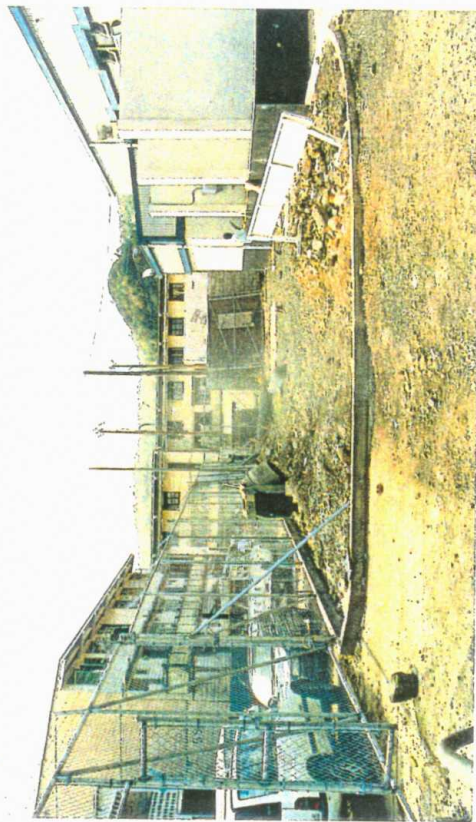
Photo 2: Castries sub-station compound - no significant flooding was reported to have occurred inside the compound. However the adjacent road was said to have been under about 12" of water.

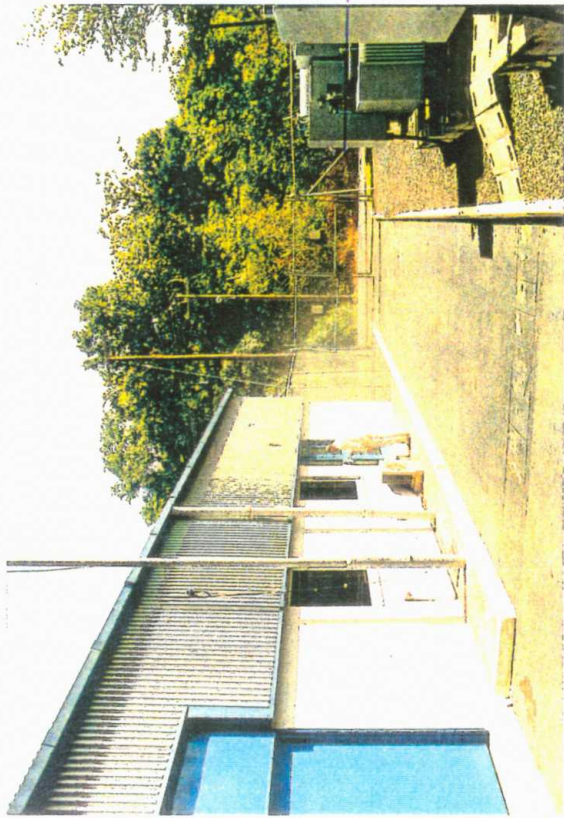
Photo 3: Union sub-station: water levels during the flood were reported to have been at least 5' to 6' above floor level. The approximate water level outside the building is indicated on the photograph.

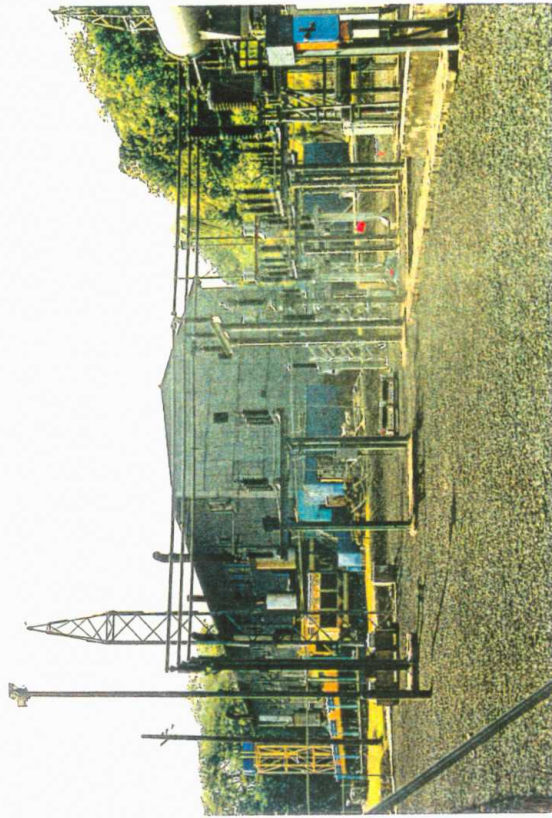
Photo 4: Union power station, on higher ground than the substation, was not affected by the flood. However, the generating facilities had to be shut down after the sub-station was flooded.

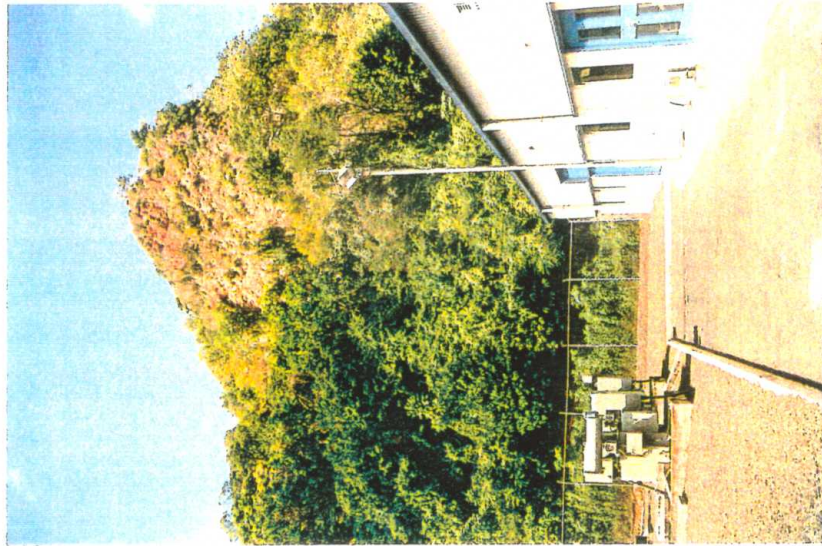
Photo 5: This cliff face, behind the sub-station at Union, forms the southern side of the Choc River valley.

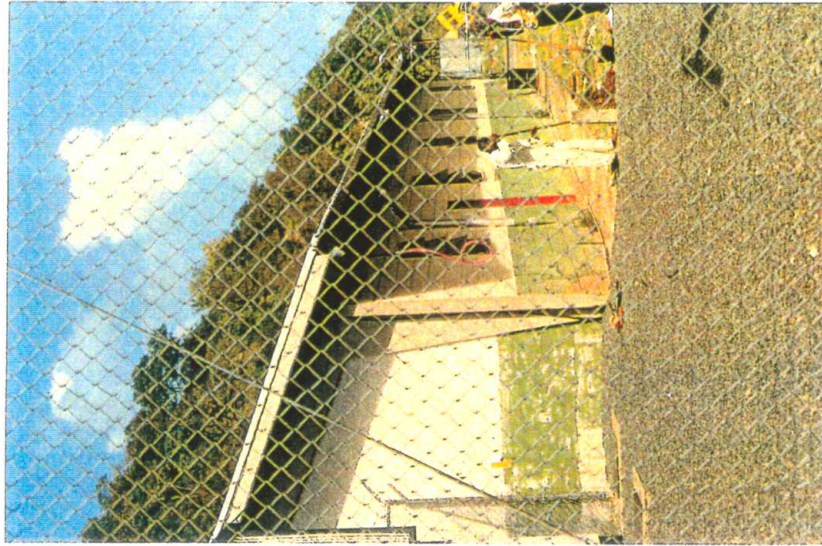
Photo 6: The storehouse at Union is not normally used to store any significant items, however, the Castries sub-station equipment was stored here at the time of the flood.

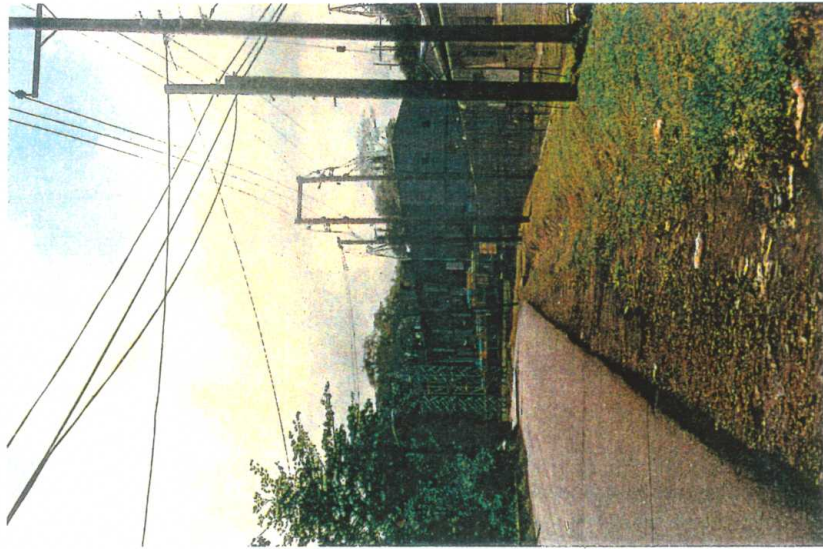
Photo 7: Drainage ditch outside the power station. The Choc River is located on the left hand side of the road. The river bed is about 10' to 12' below road level.

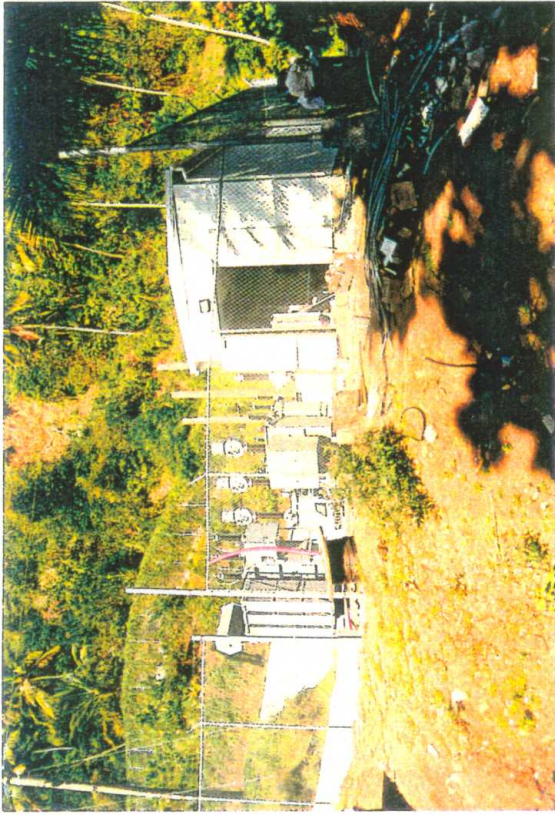
Photo 8: The small sub-station under construction near Soufriere.

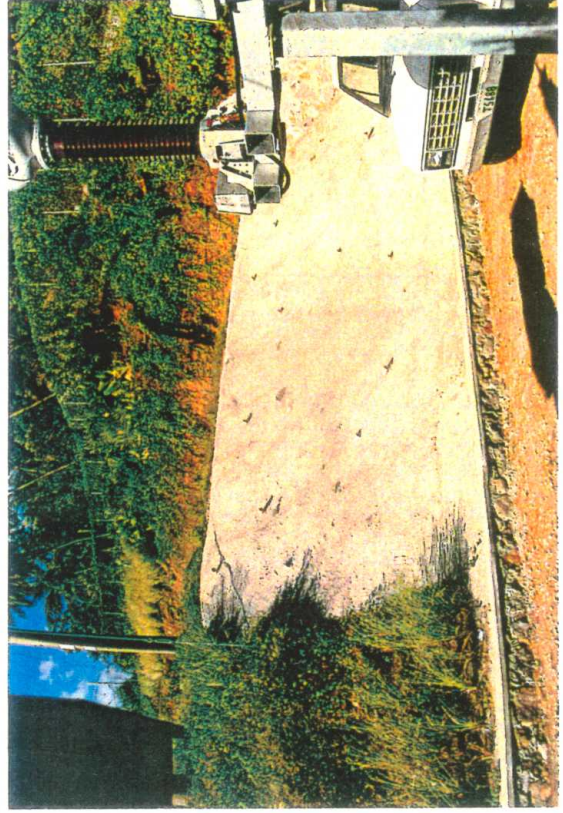
Photo 9: Retaining wall at the rear of the Soufriere sub-station.
