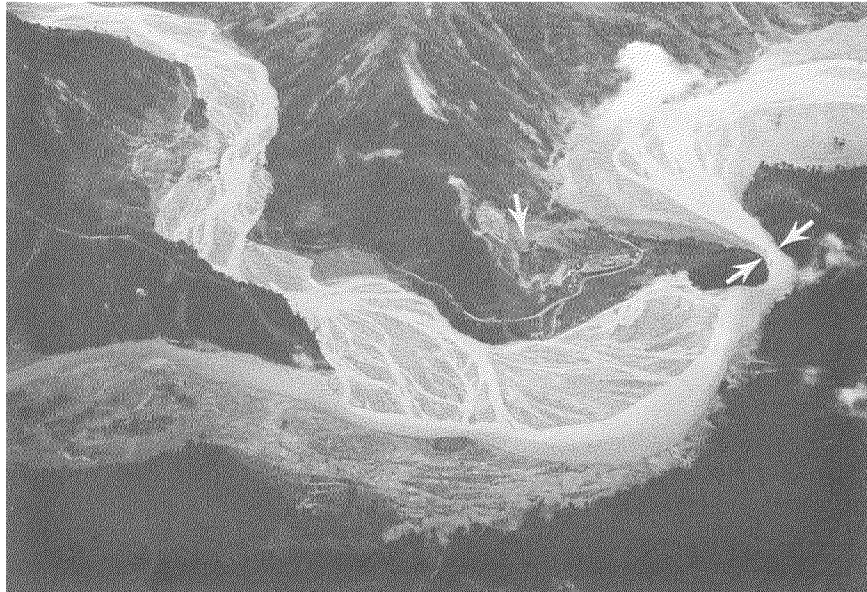
FIGURE 1.6 Aerial view of the confluence of the Quijos River (lower left) and the Salado River (upper left) to form the Coca River (flowing to the right). Postearthquake braided debris-flow and flood deposits are as much as 15 m thick in the valley bottoms. Bedrock constriction of the Coca River (indicated by two arrows near right edge of photo) probably caused short-lived damming of the river, which contributed to upstream flooding and rapid sedimentation. Note landslide (single arrow near center of photo) that badly damaged the Salado pumping station on the Trans-Ecuadorian oil pipeline.

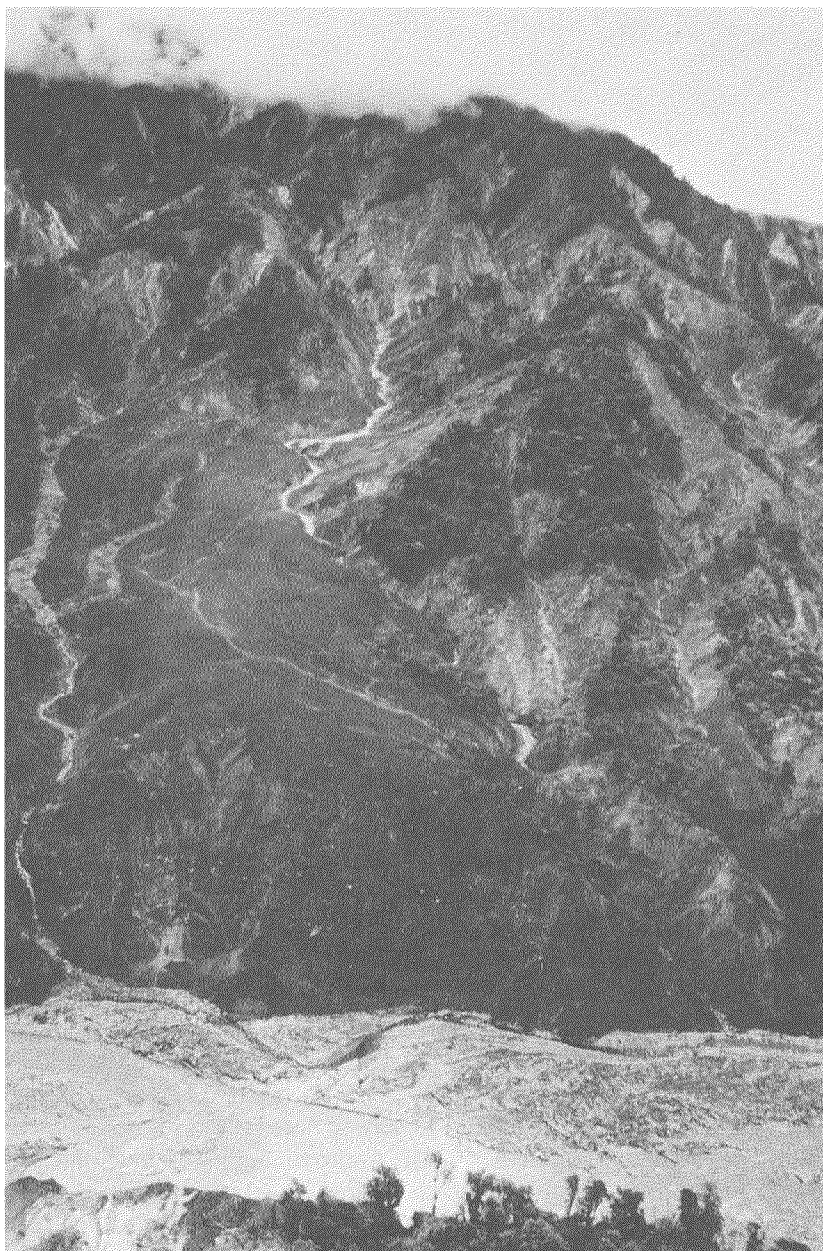
FIGURE 1.7 NE (left) valley wall of the Malo River, showing extreme denudation of slopes due to slips/avalanches/flows caused by the March 5, 1987, earthquakes.
