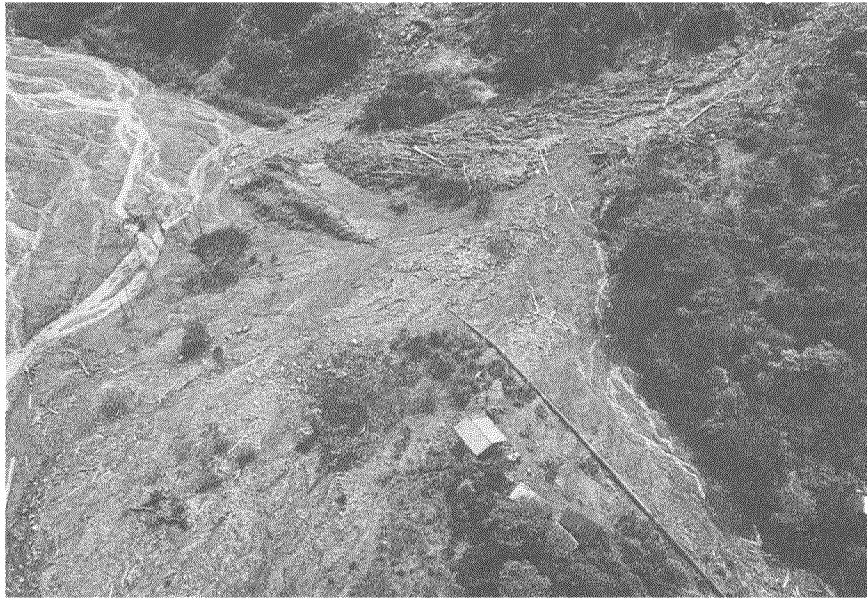
FIGURE 1.8 Aerial view of destruction of the Trans-Ecuadorian oil pipeline and adjacent highway by a debris flow issuing from a minor tributary of the Coca River. Location is near mouth of the Reventador River.

Given the size of the mass-wasting catastrophe in the Reventador area, damage caused by direct impact of deep-seated slides or slumps was secondary to that caused by thin slips, avalanches, flows, and floods. Although individual slides did some damage to the Trans-Ecuadorian pipeline (Figure 1.8), roads, and structures, the greatest destruction of property was caused by flood surges in the main rivers (Figure 1.9). Because of antecedent precipitation, the rivers were near flood stage before the earthquakes occurred, so that the large volumes of landslide debris that flowed into the

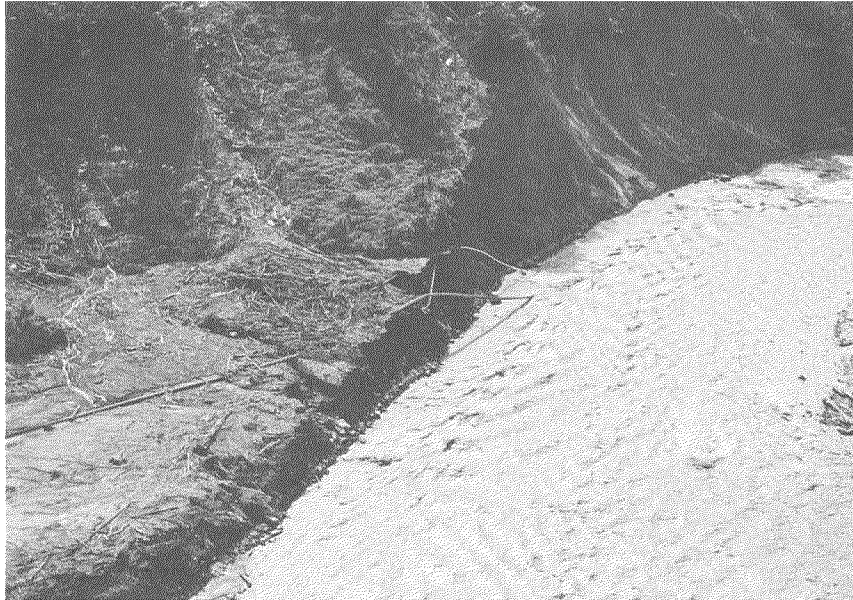
FIGURE 1.9 Destruction of Trans-Ecuadorian oil pipeline and highway by flood erosion on the left bank of the Coca River as a result of the March 5, 1987, earthquakes.
