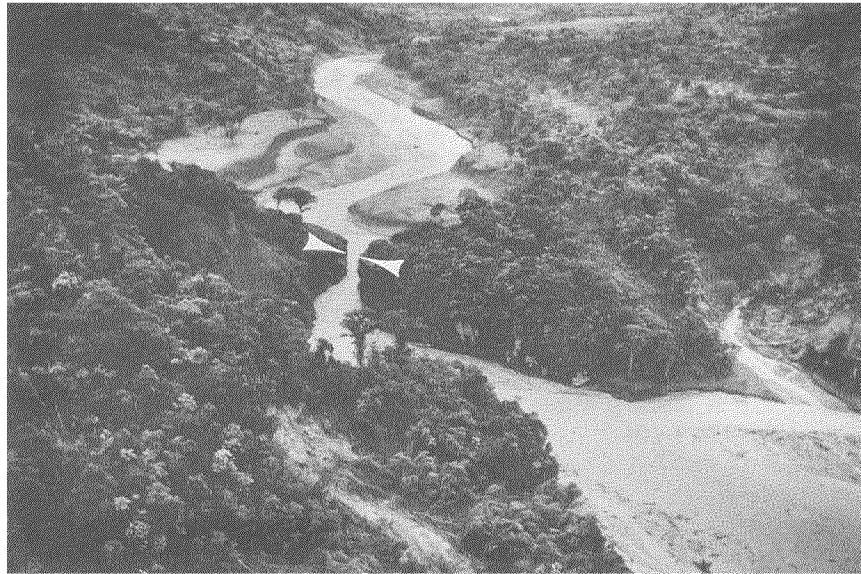
FIGURE 1.10 Upstream view of Salado River, showing location of bedrock constriction (white arrows) that caused short-lived damming of the river. Note trimline in jungle cover along lower valley wall upstream of the river constriction. This trimline indicates position of the shoreline that was formed by damming of the river to a level 10-15 m above current river level.
