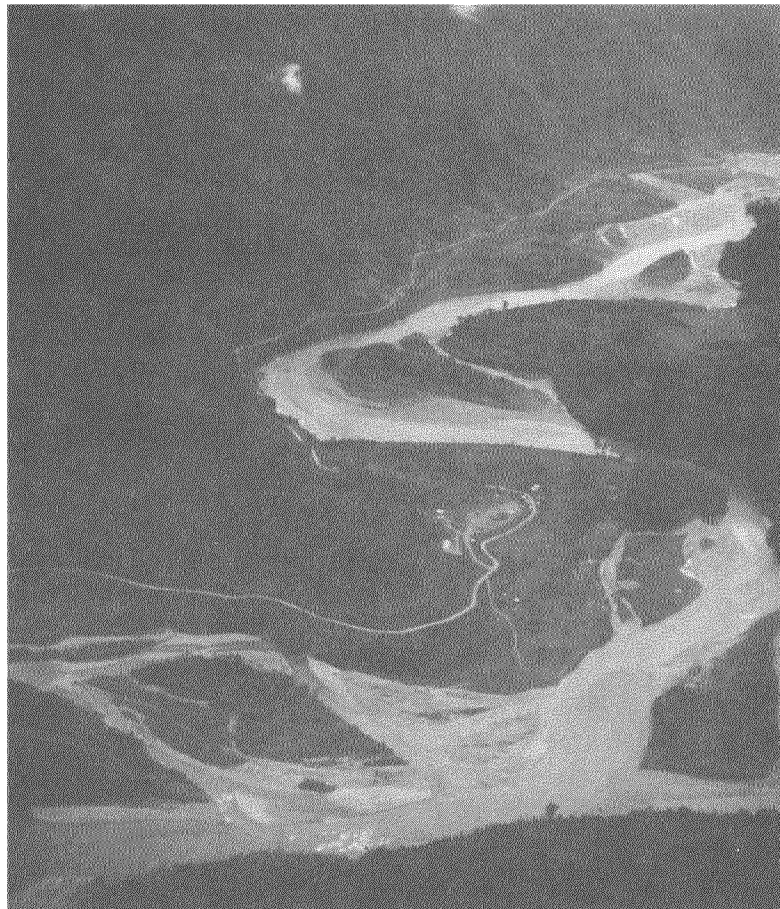
FIGURE 5.16A

FIGURES 5.16 Aerial oblique views looking downstream at the confluence of the Salado and Quijos rivers to form the Coca River. (A) 1978 view (photograph by William Savage, Pacific Gas and Electric). (B) April 1987 view illustrating that braided debris-flow and flood deposits (as much as 20 m thick) have covered much of the

“hyperconcentrated flows” or “mud floods.” However, based on (1) depths of sediment deposited in the rivers, (2) “trimlines” on the lower valley walls, which indicated the heights to which the rivers rose when charged with the debris flows, and (3) damage to the Trans-Ecuadorian pipeline and highway due to deposition and erosion, we know that considerable flooding occurred (Figures 5.16A,B, 5.17A,B, and 5.18). Figure 5.19 indicates
