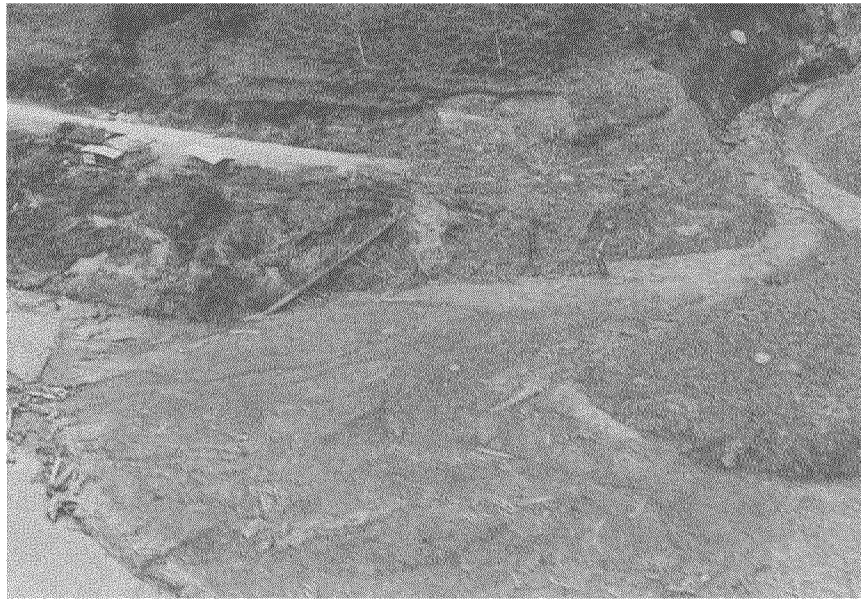
FIGURE 6.6 Pipeline broken by a debris flow that has eroded 6 m below the pipeline right of way.

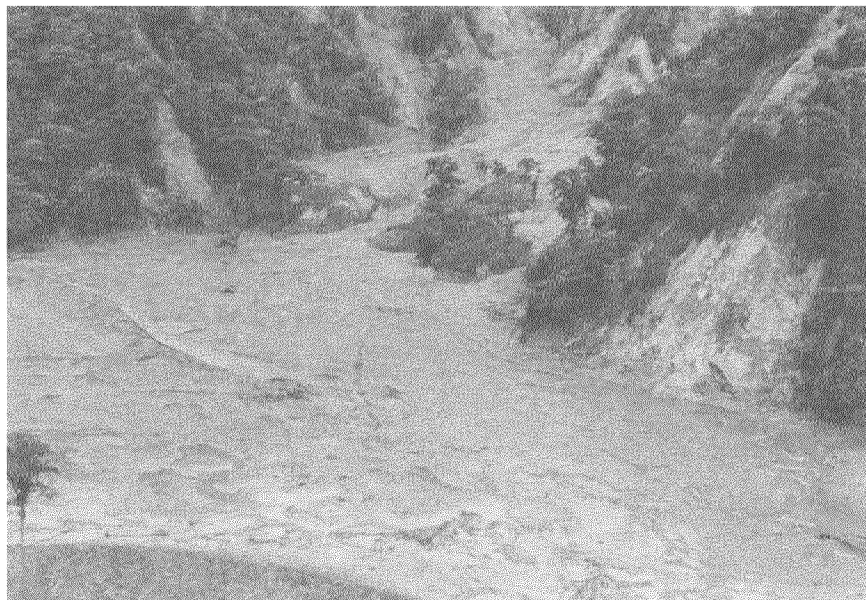
FIGURE 6.7 Flooding along the Coca River. Note the broken and deformed pipeline at the left side of the photograph.
