C. Hanshin (Kobe-Osaka) - People's Awareness

D. How People Felt the Seismic Event

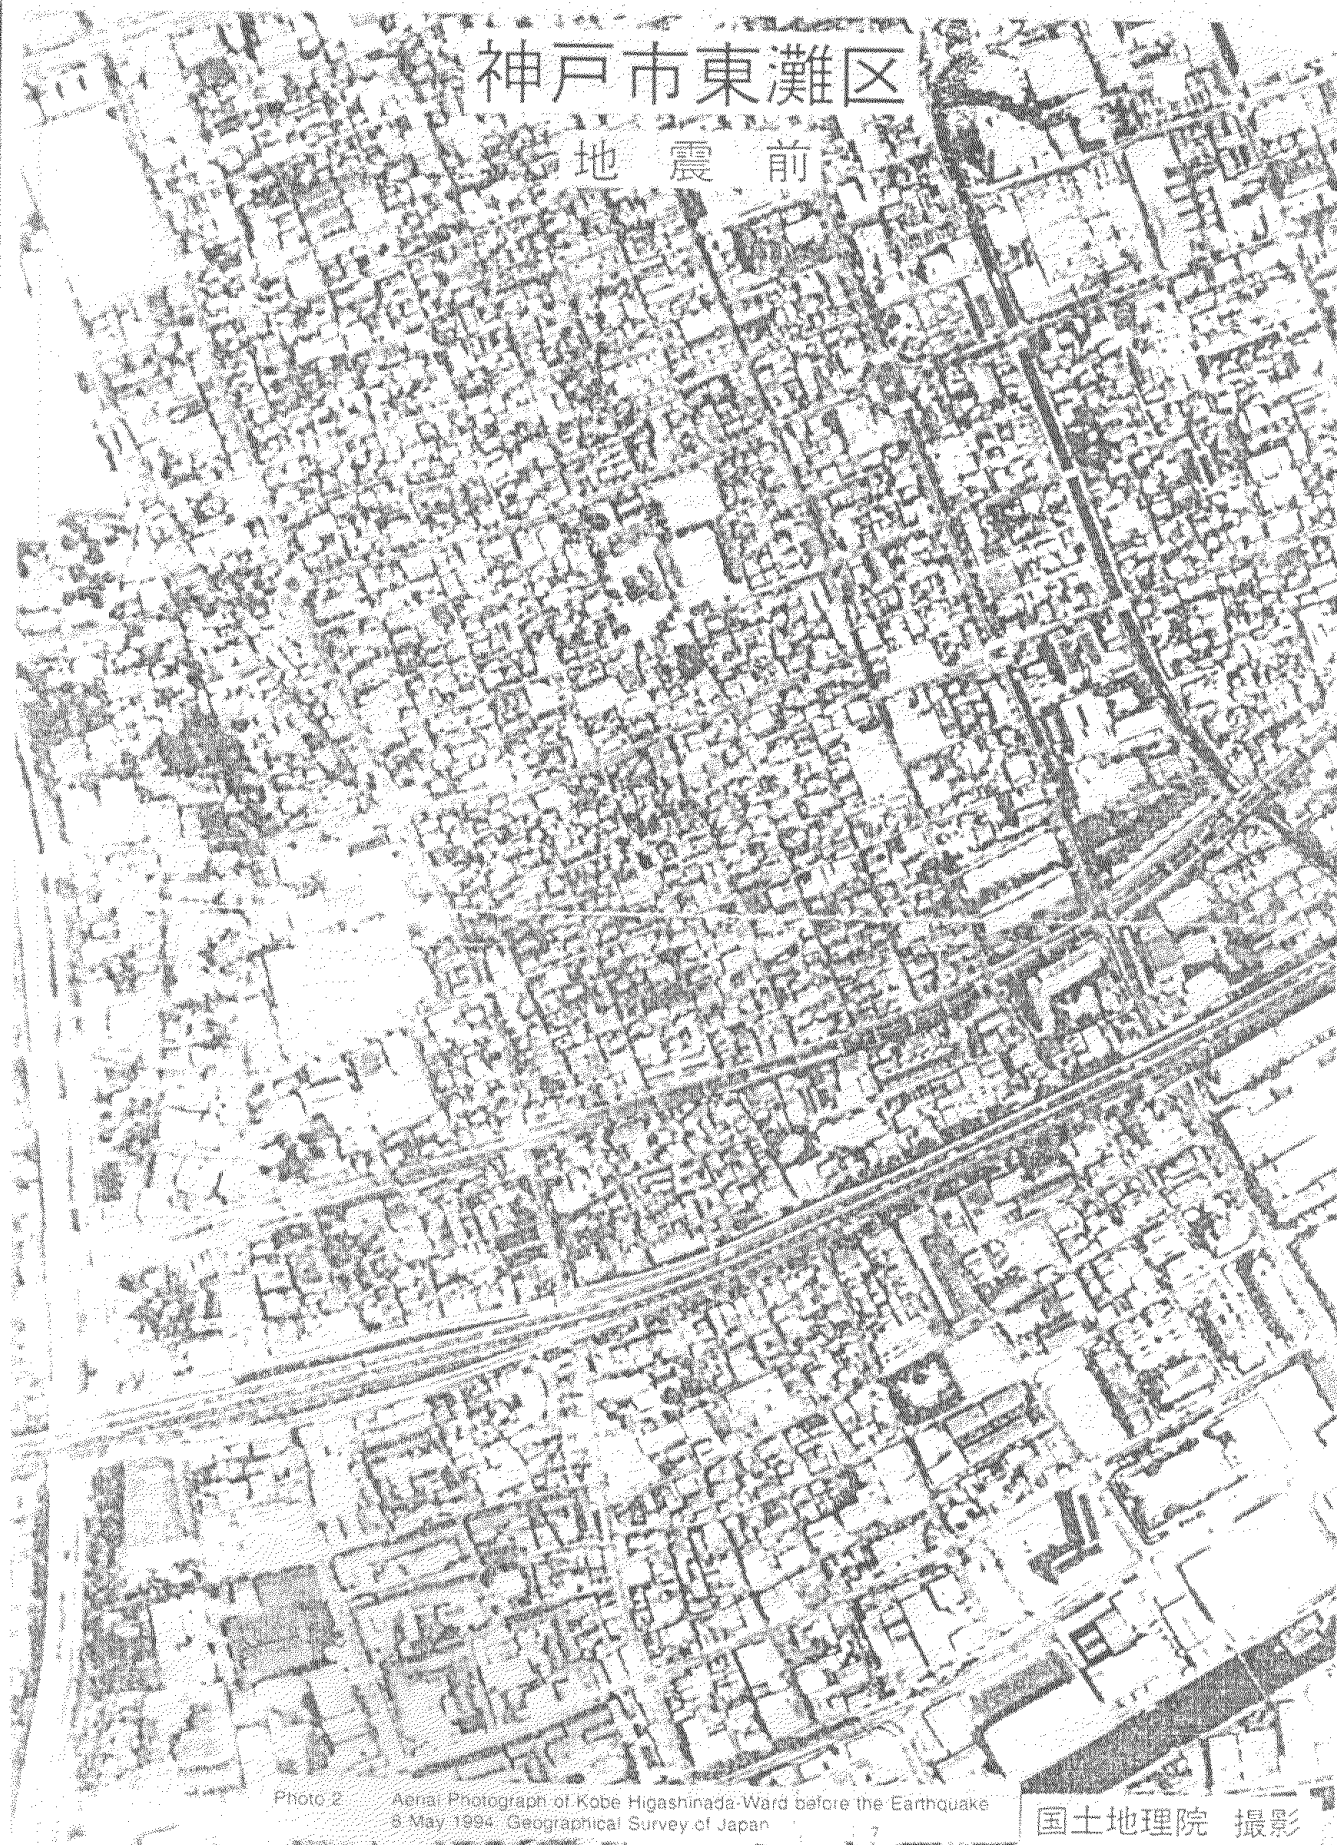
Photo 2 Aerial Photograph of Kobe Higashinada Ward before the Earthquake
8 May 1994 Geographical Survey of Japan

Population growth over the past few years has resulted in a densely populated belt area extending from east to west. Photo 2 shows an aerial photograph (taken before the earthquake) of the Higashinada Ward (population density 6,301/sq km; this was also where there was the most extensive collapse of buildings, i.e. the traditional wooden houses). It is easy to see that this is an extensively built-up area with very few open spaces. The only major empty spaces are the school grounds.
