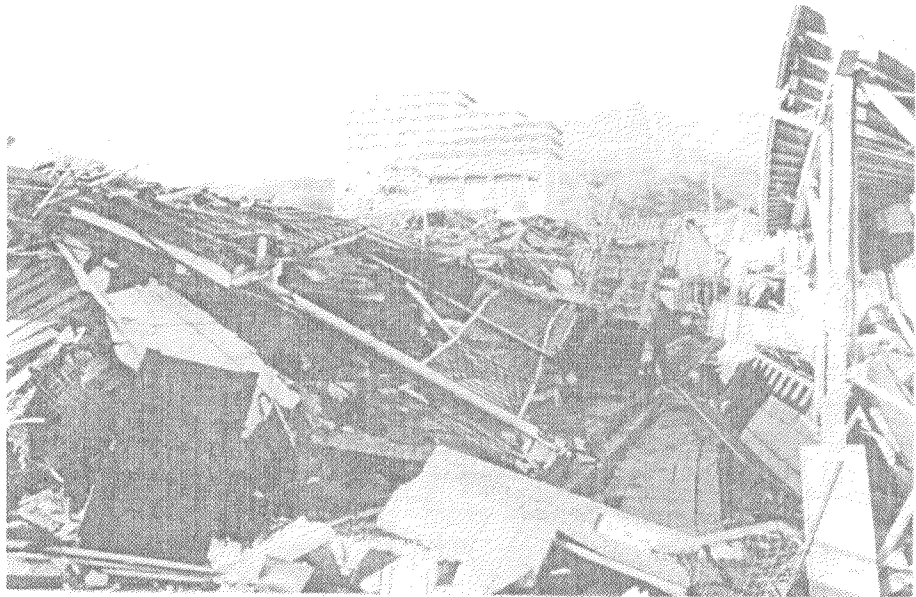
Photo 6 Collapsed Two Story "Bunka Apartment"
In the back there is a SRC building with no damage
Hyogo Prefectural Government

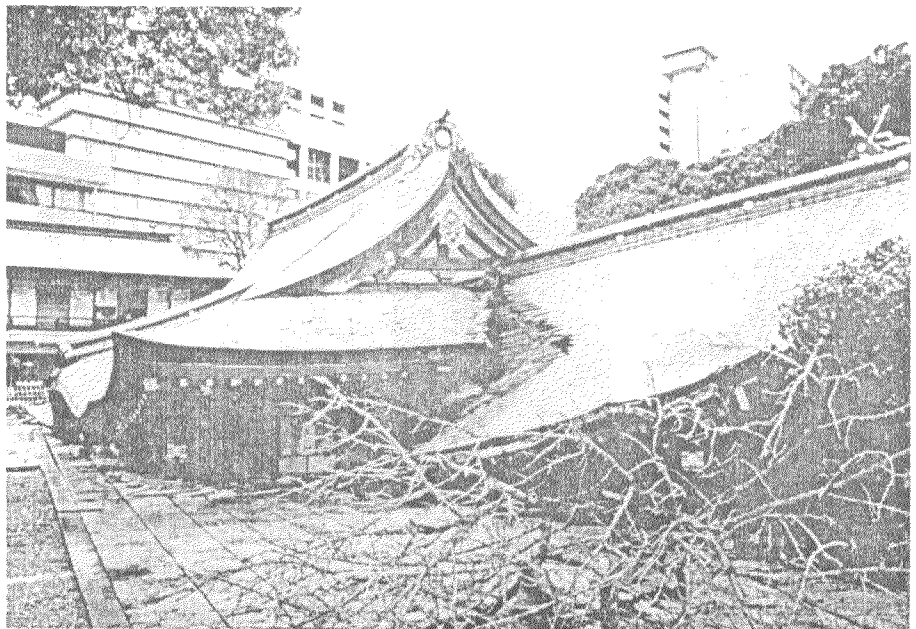
Photo 7 Traditional Wooden Column and Heavy Roof Shrine Collapsed
In the back another undamaged SRC building
Hyogo Prefectural Government

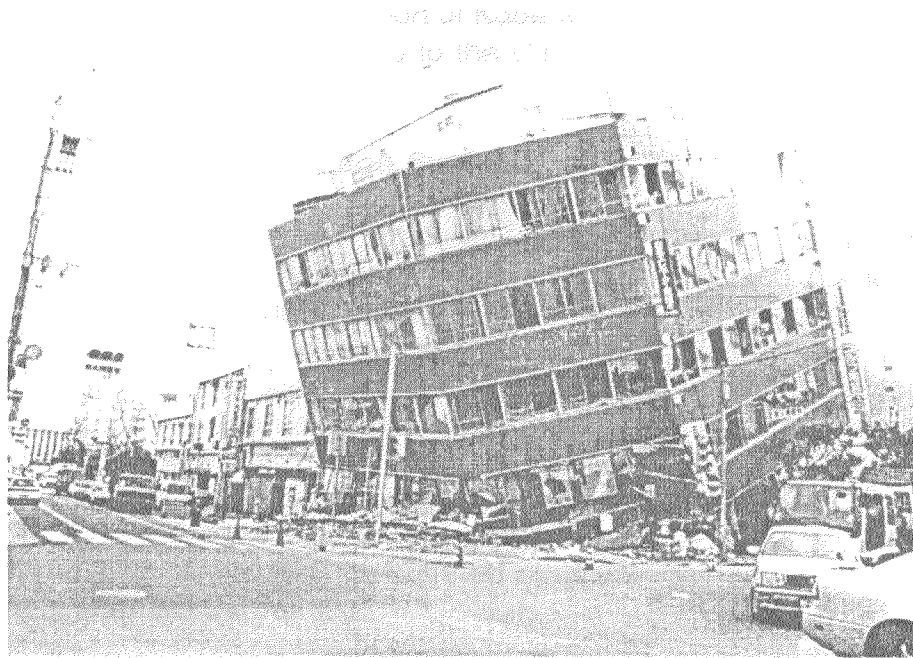
Photo 8 Ground Floor Collapse of Steel Structure Building
Ground floor with not enough structural walls gave in
Kobe Municipal Office

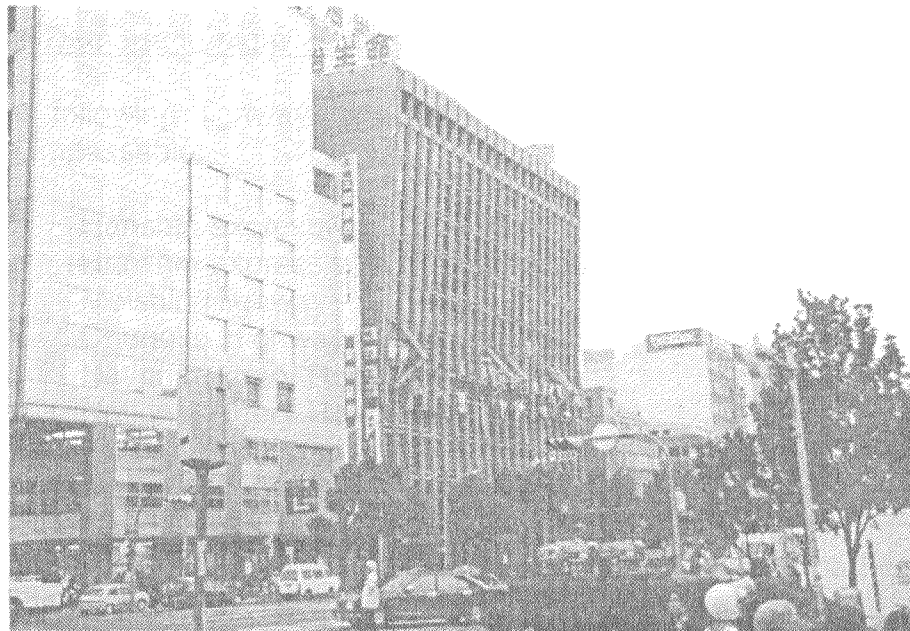
Photo 9 Damage to the Middle Floor of SRC Building
The new building next to it has no structural damage
Hyogo Prefectural Government
