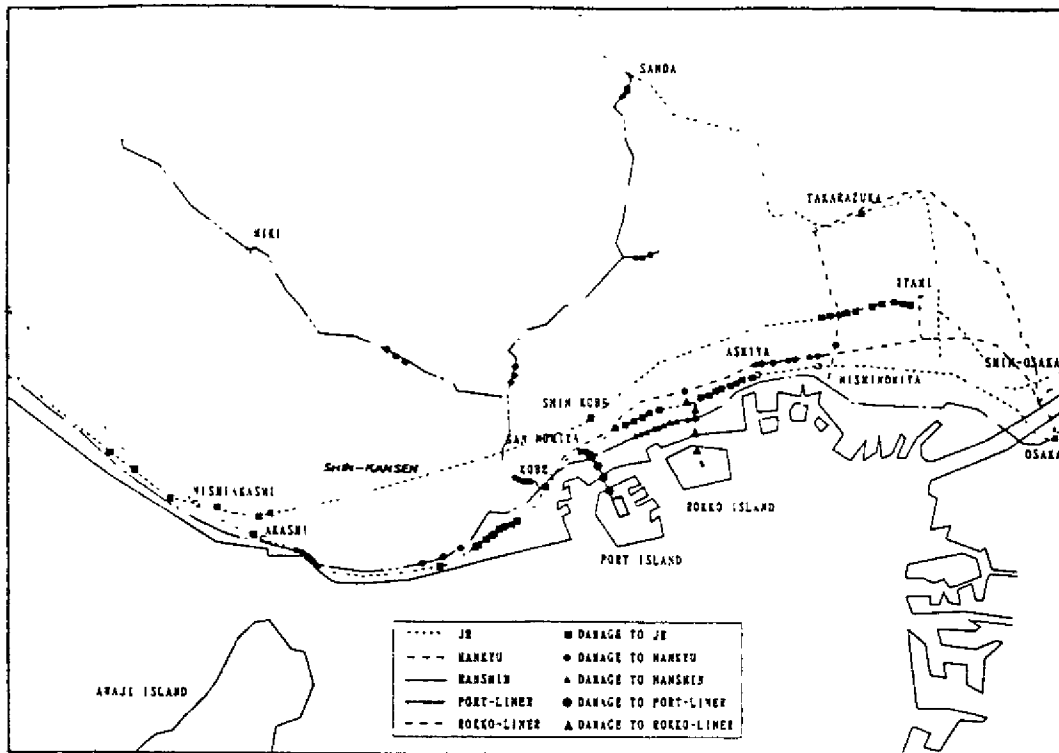
Figure 3 Damage to the Railway System,  
courtesy: Kobe University

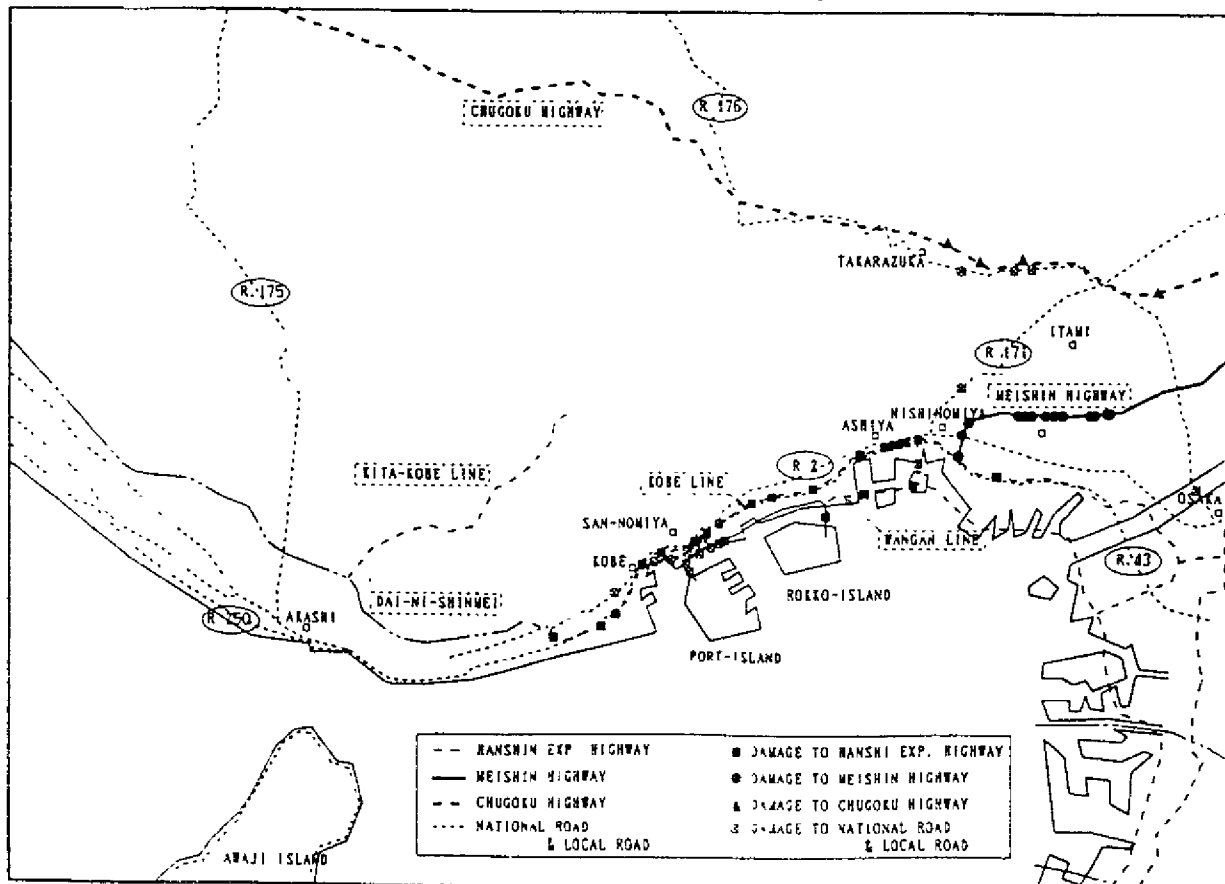
Figure 4 Damage to the Highway Networks,  
courtesy: Kobe University

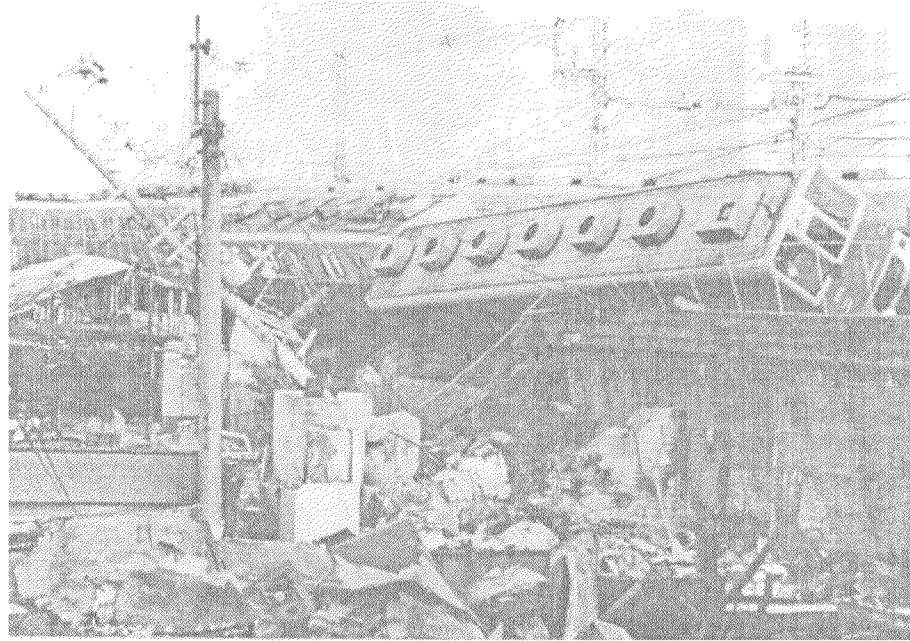
Photo 10     Railway Damage Hanshin Honsen Line  
Elevated railyards and stations suffered structural damage  
Hyogo Prefectural Government

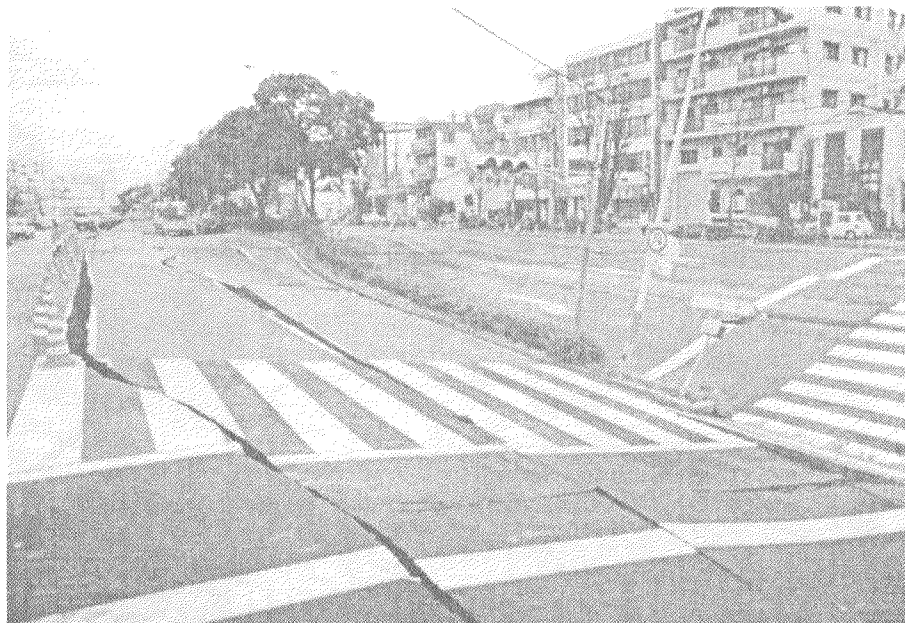
Photo 11     Artery Road Cut by Ground Failure  
Ground liquefaction made roads impassable  
Hyogo Prefectural Government
