### **III. The First Four Hours**

#### **A. Description of the City Immediately After the Quake**

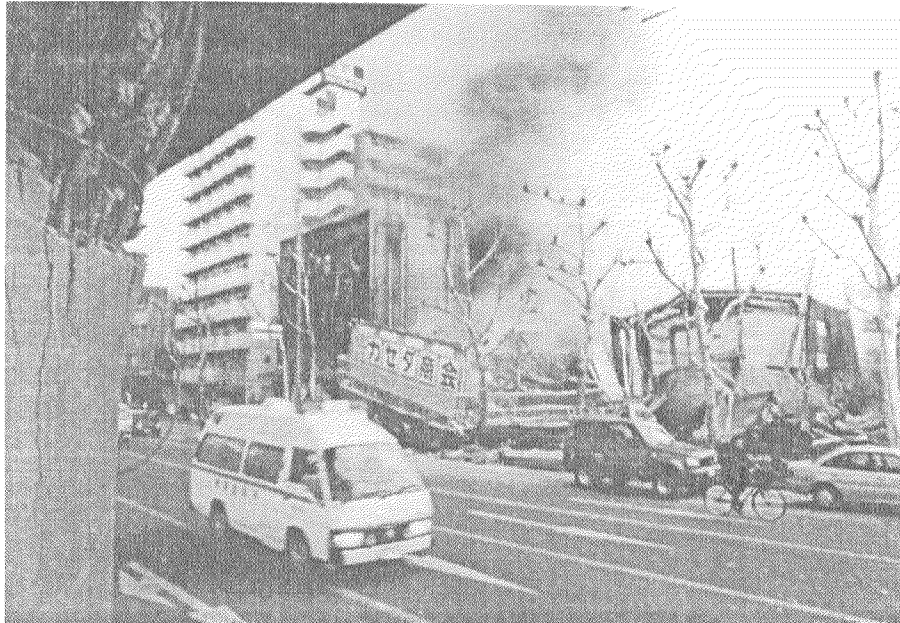
Photo 14      Ambulance Car in Rush, Fires Breaking out of Collapsed Building  
Traffic jams not yet  
Hyogo Prefectural Government

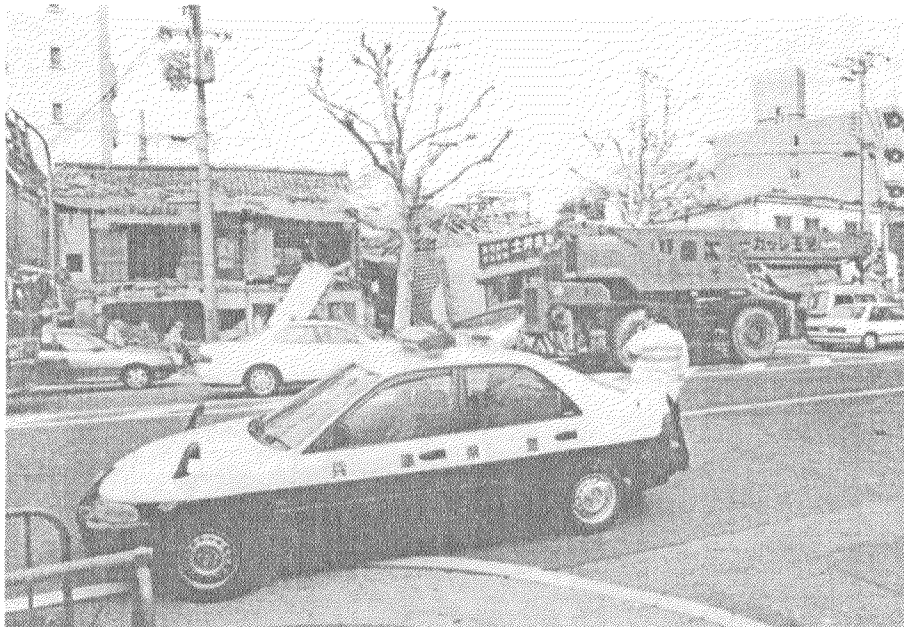
Photo 15      Police Patrol Car Arrives at One Collapse Site  
Policeman calling for additional manpower  
Hyogo Prefectural Government
