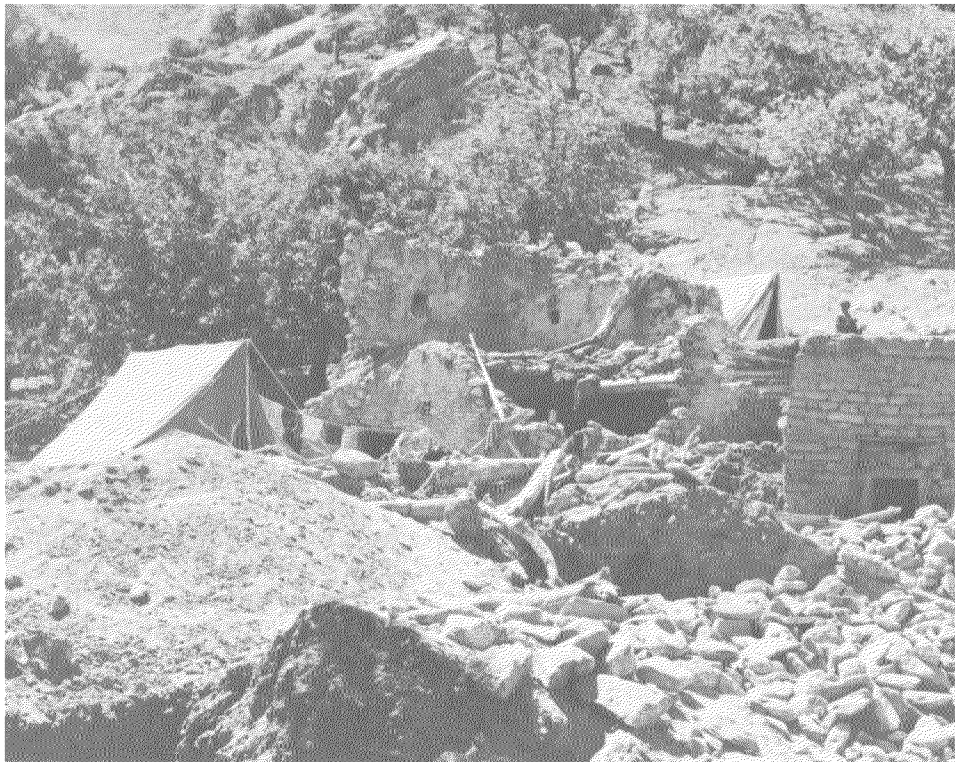
A 1976 flood in the Pansear Valley of Afghanistan washed most of this home away. Relief tents were placed within the building ruins, possibly to protect belongings (including animals) and preserve the ownership of the home.

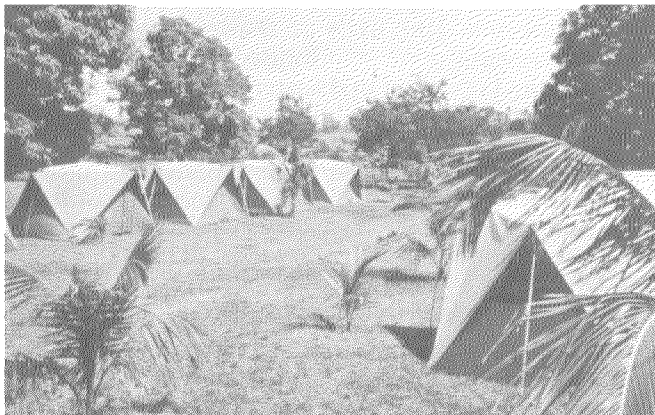
Managua earthquake, Nicaragua, 1972—Coyotepe Camp, Masaya. The tents came from the emergency stockpile of the US Government's Office of Foreign Disaster Assistance (OFDA). Three hundred and sixty tents were provided. Occupancy, at its peak, reached 60 per cent.
