LEARNING FROM EARTHQUAKES

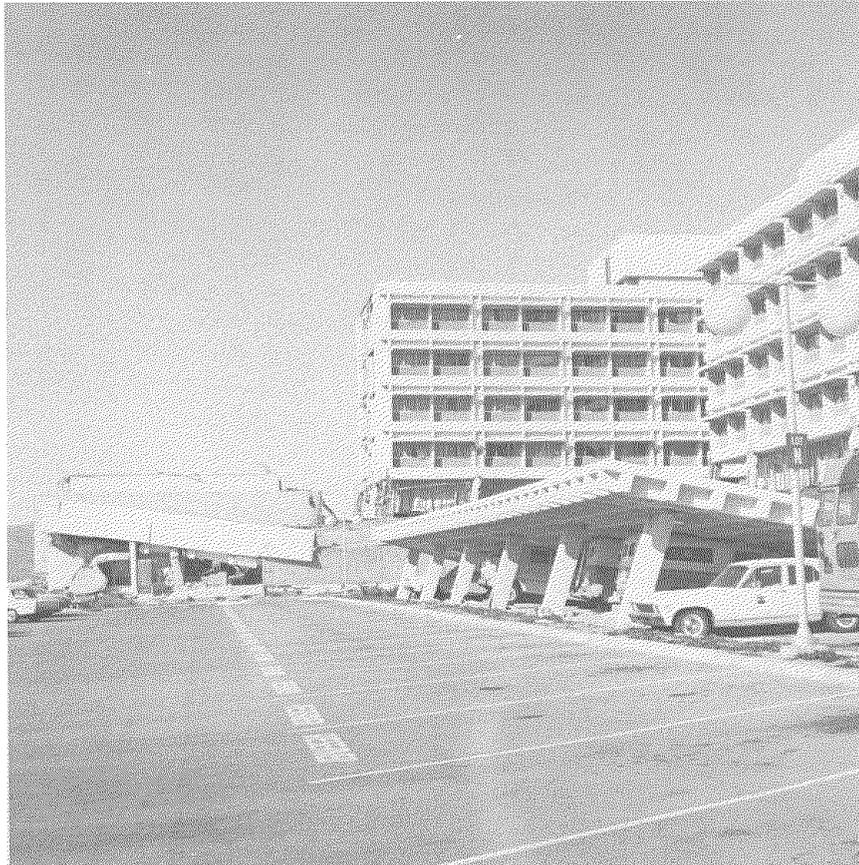
Figure I-7: Olive View Hospital. Note stair tower at left which fell away from main building. Roof in right foreground collapsed on parked ambulances. Eight hundred occupants were successfully evacuated from the main building. One person was killed due to a partial building collapse. (Los Angeles City Fire Department photo)

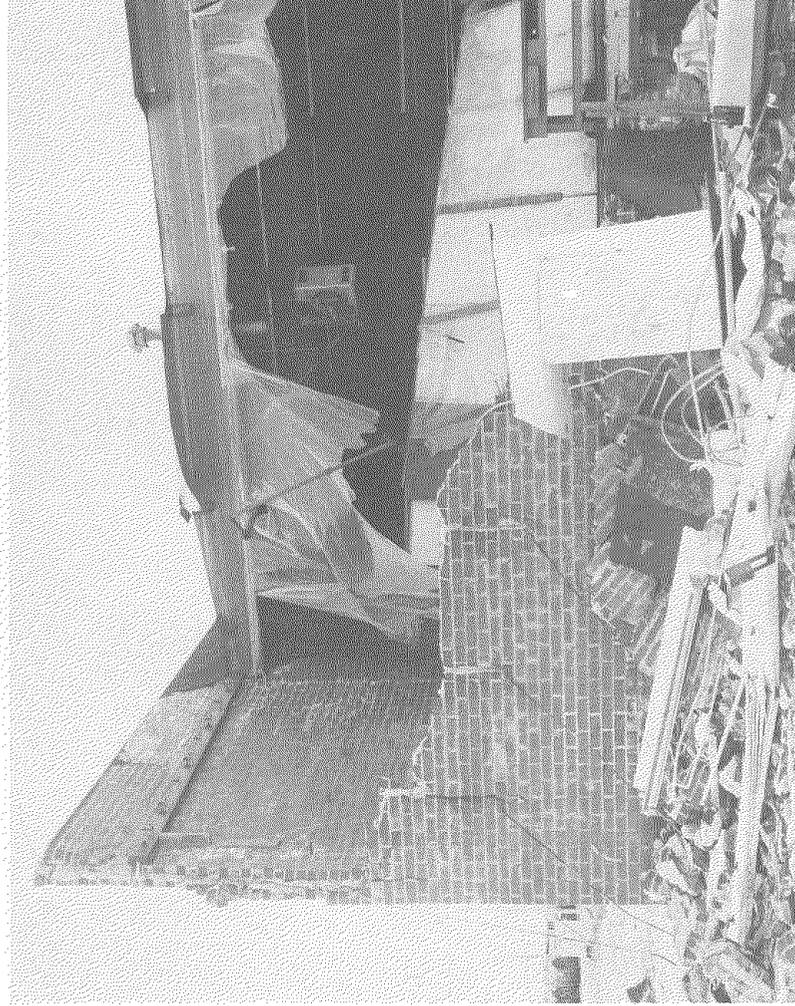
Figure I-8: Typical Industrial Building Damage in City of Sylmar. Average damage to this type of construction in the heavily shaken area was about 17 percent of value. (Los Angeles City Department of Building and Safety photo)

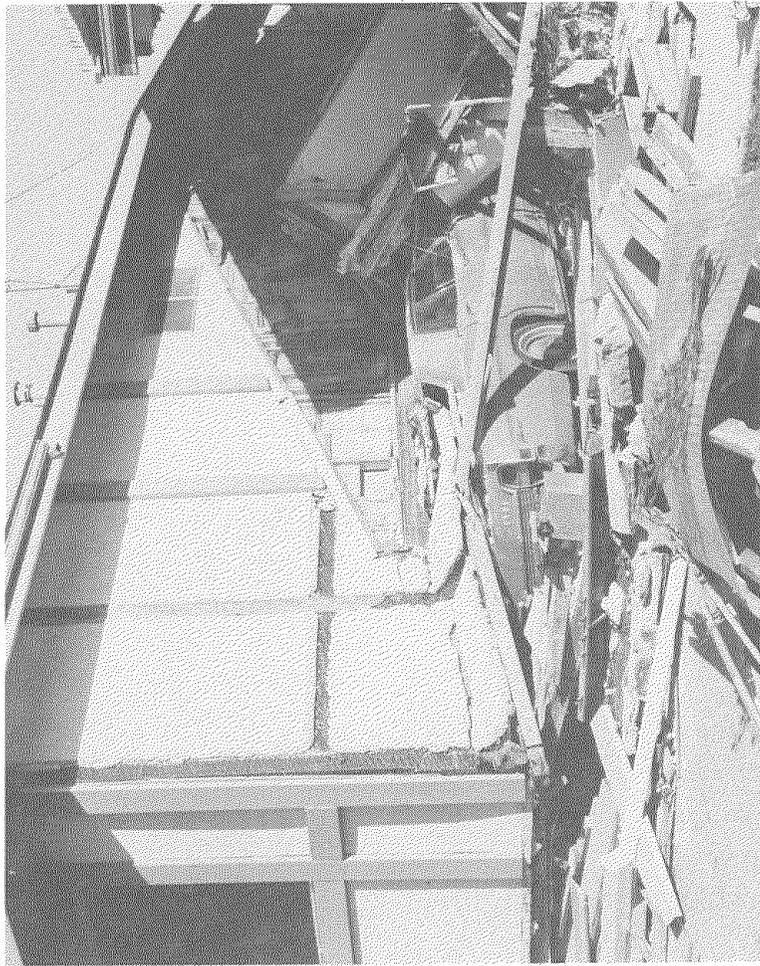
Figure I-9: Collapsed, Split-Level, Single-Level, Single-Family, Wood-Frame Dwelling near Olive View Hospital. Average losses to single-family, wood-frame dwellings in the heavily shaken area were about 7 percent. (Los Angeles City Department of Building and Safety photo)
