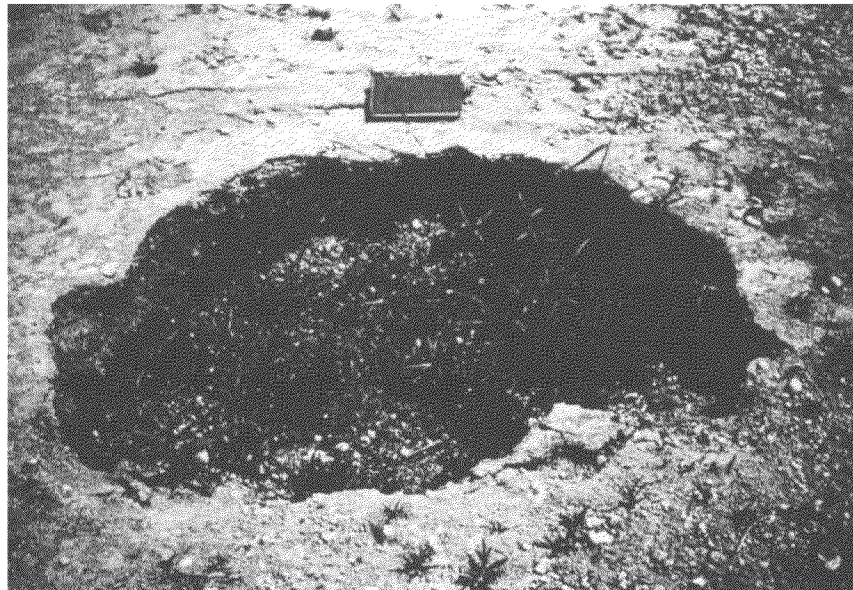
Figure 2. Flat bottomed, steep sided sand boil which does not have a cone of deposited sand associated with it, located near the mouth of the Villalobos River at La Playa, Guatemala.

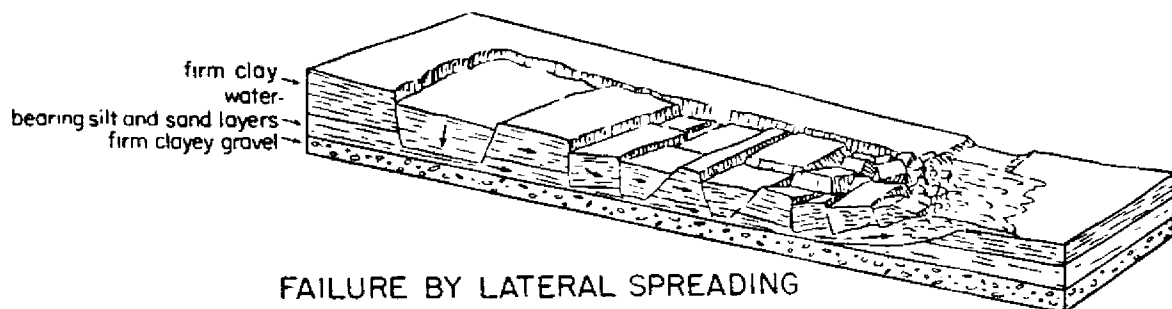
Figure 3. Diagram of a lateral spreading landslide (after Varnes, 1978).

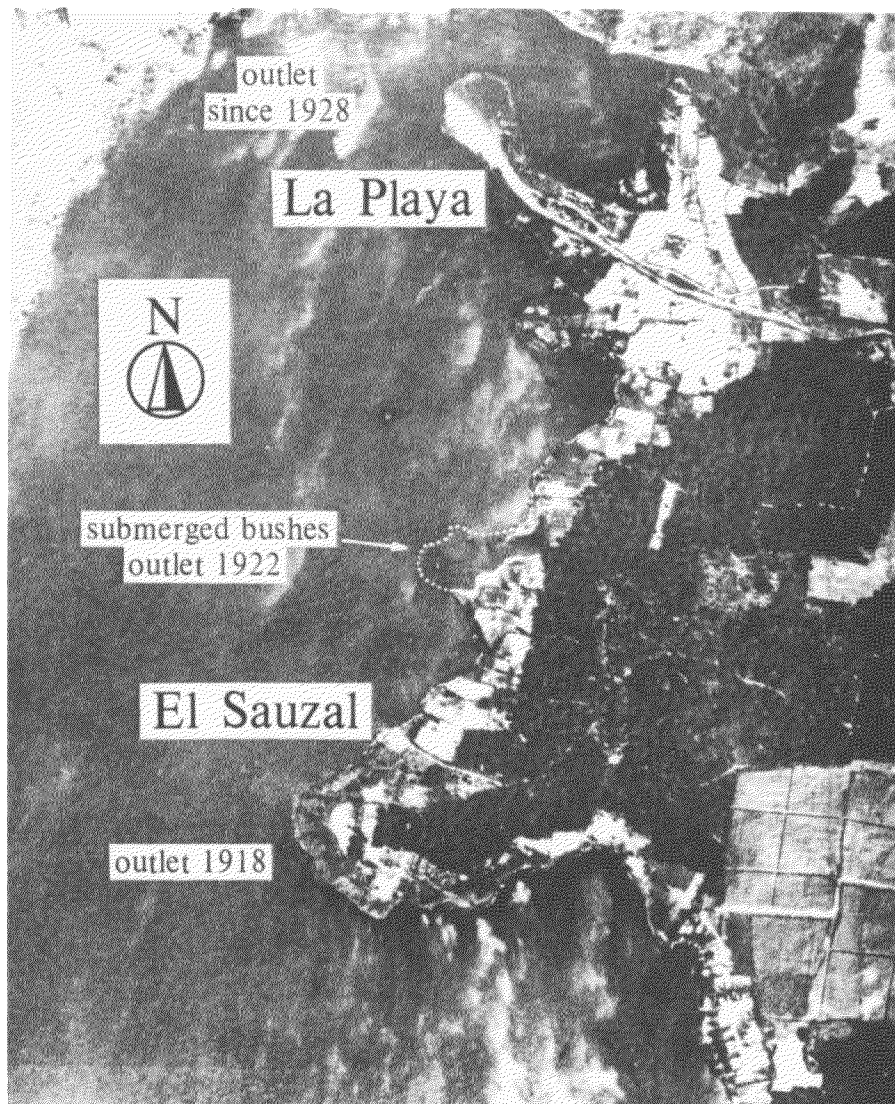
Figure 4. Airphoto of the El Sauzal and La Playa portions of the delta at Lake Amatitlan. The subsided 1922 lobe of the delta is marked by a few bushes poking up out of the lake waters. Many white patches are ejected sand caused by liquefaction. Dates of river outlets were given by local residents. (U-2 photography taken 13 February, 1976, by the U.S. Air Force under contract to the Office of Foreign Disaster Assistance of A.I.D., U.S. Department of State.)
