SETTLEMENT

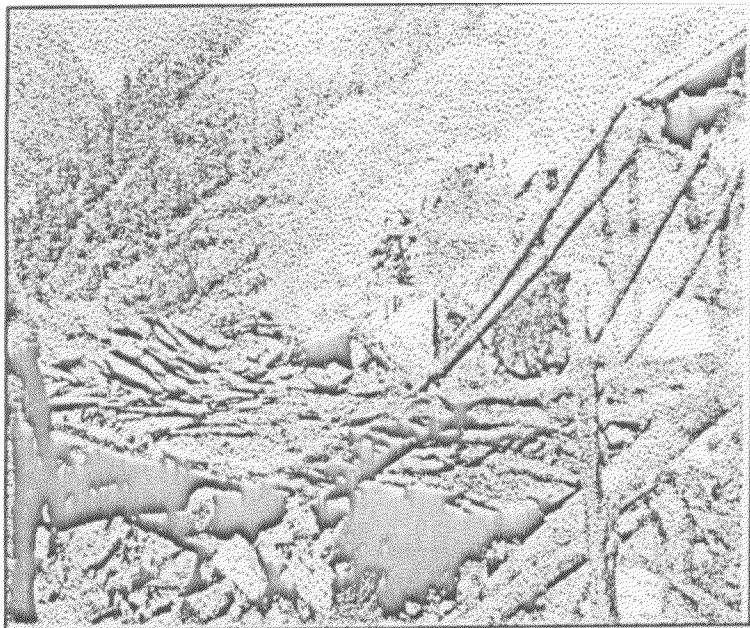
Collapsed house that killed three people in Huri village, Bhatwari Tahsil, Uttarkashi District

This house with a slate roof and random rubble stone walls collapsed killing three people. The main causes of this failure was the opening of a crack in the ground 10 cm wide behind the rear wall of the house and the subsequent collapse of the rear wall and the far gable. This was further aggravated by the collapse of the roof rafters that were not tied by a wall plate or timber tie beam at roof level. The collapse was limited to the first floor which was occupied. The intermediate floor was undamaged and cattle were penned in the rooms on the ground floor.

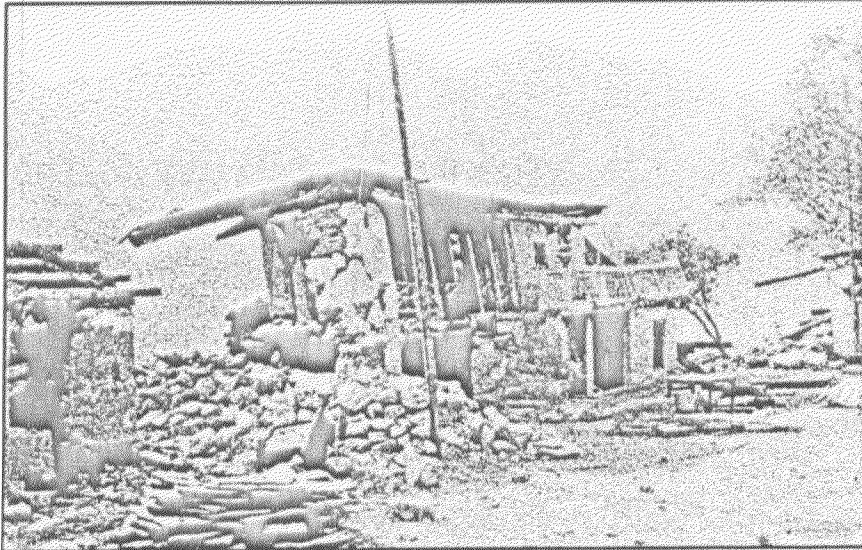
This building is one of a series that have been devastated around the central court in Maneri. This has collapsed due to settlement of the lower storey and resultant collapse of the upper masonry wall and then the intermediate RCC slab.

Collapse of building due to failure of masonry wall and settlement of ground storey: Village Maneri, Bhatwari Tahsil, Uttarkashi District
