RECONSTRUCTION

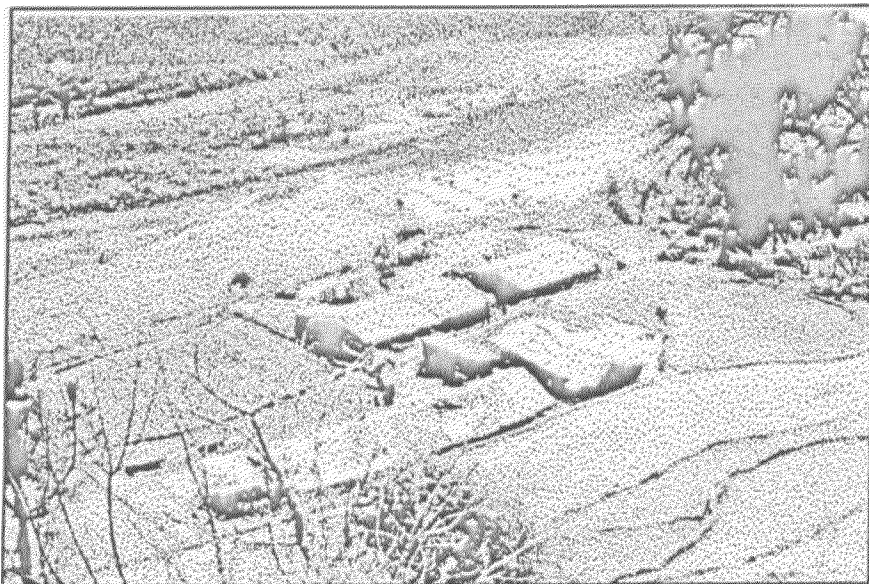
Completed emergency shelter: Village Maneri, Bhatwari Tahsil, Uttarkashi District

A completed cluster of emergency shelter as viewed from the village above. The villagers have located the shelters on the broad agricultural terrace below the ridge on which the village is situated. The "buildings" are being lived in and though small are fairly comfortable after a fire is lit inside. The onset of rains will create waterlogging problems and of the crop. Even some of these emergency shelters may have to be re-located.
