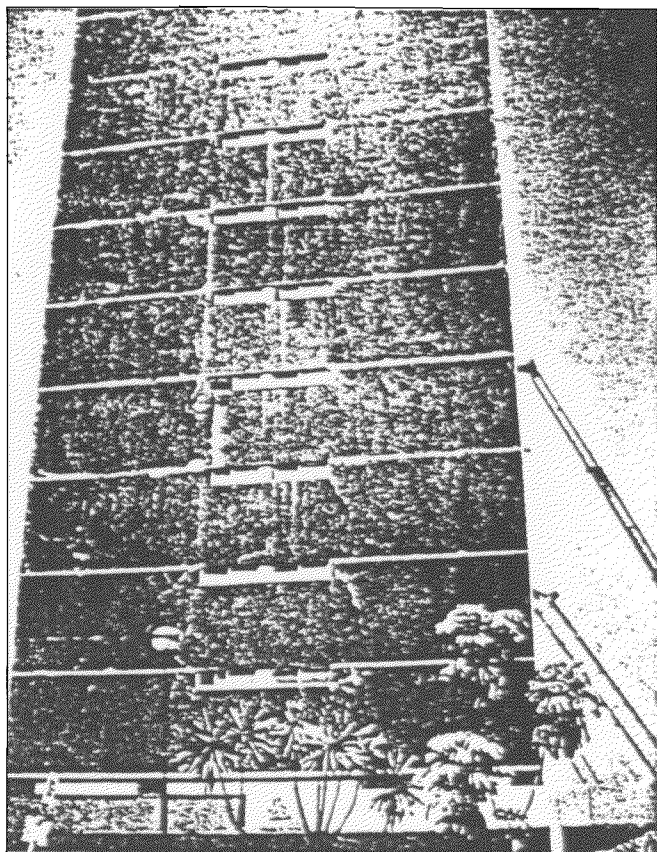
Nuevo Leon Housing Project -- remaining building end wall showing open first floor. The back of this building collapsed completely and caused many deaths.

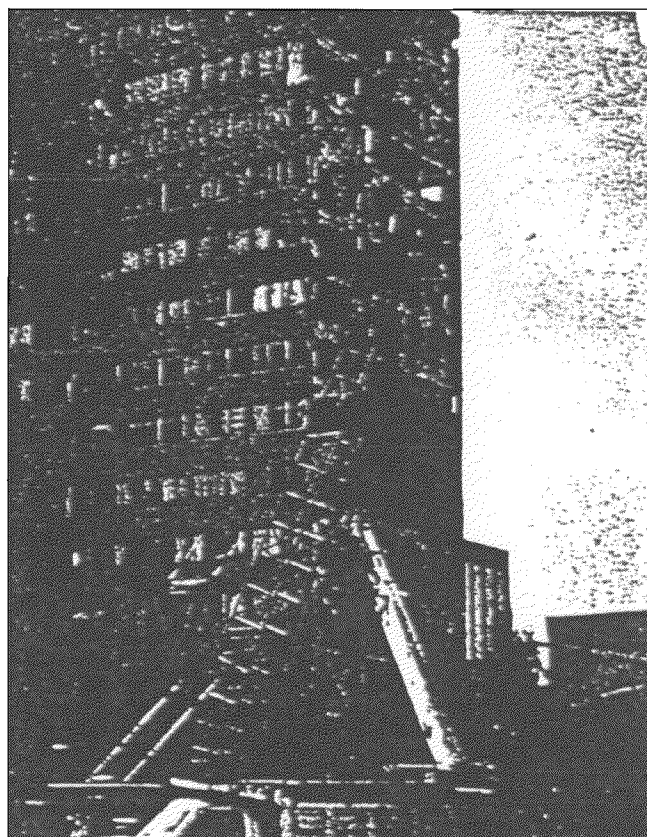
Nuevo Leon Housing Project showing the braced wall adjoining the building completely collapsed.
