EFFECTS OF REMEDIAL MEASURES AGAINST LIQUEFACTION AT 1993 KUSHIRO-OKI EARTHQUAKE

S. Iai[1], Y. Matsunaga[1], T. Morita[1], M. Miyata[1], H. Sakurai[1], H. Oishi[2], H. Ogura[3], Y. Ando[4], Y. Tanaka[5] and M. Kato[5]

ABSTRACT

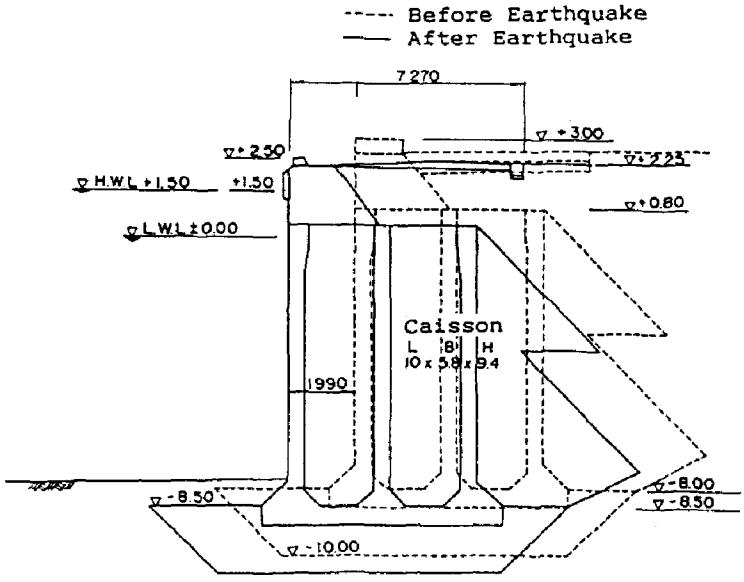
The most serious damage to the gravity quay walls in Kushiro Port was found at the North Pier in the East Port District. The location is designated in Fig. 2 as the site A. As shown in Fig. 6, displacement toward sea registered 2.0 meters at maximum, settlement 0.4 meters at maximum. The ground conditions shown in Fig. 7 indicates possibility of liquefaction down to an elevation of about -6.0 meters below the water level.

Fig.6 Damage to a quay wall at Site A

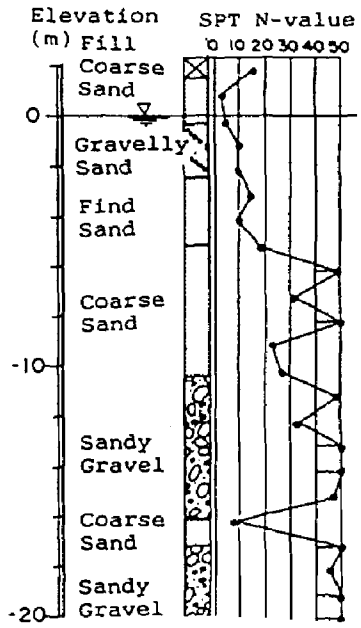
Fig.7 Ground Condition at Site A

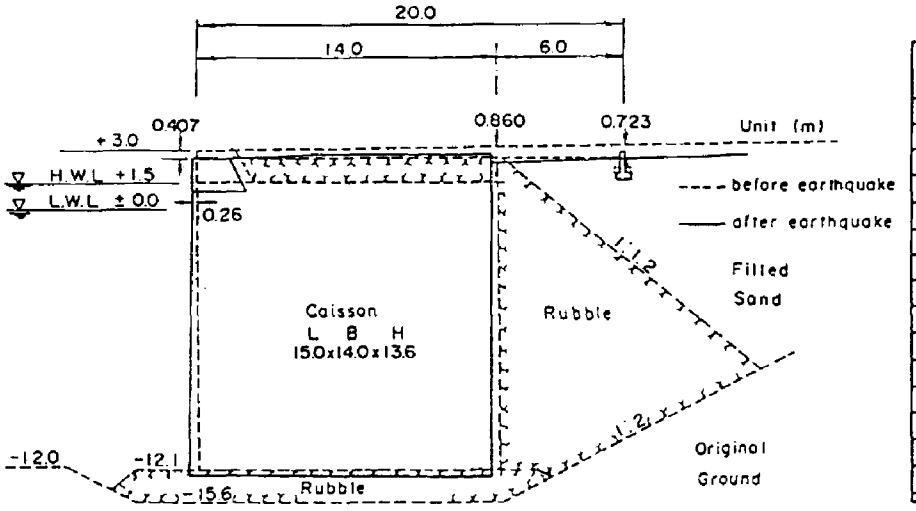
Among the gravity quay walls affected by liquefaction of backfill sand, quay walls designed with a seismic coefficient of 0.2 suffered relatively minor displacement. An example with a water depth of 12 meters is shown in Fig. 8. This quay wall is located at the south end of the Pier No.2 in the West Port District shown in Fig. 2 designated as the site B. As understood from the height to width ratio of the caisson being close to unity, the quay wall was designed to resist relatively strong earthquake motions.

earthquake hit the Kushiro area before the work was actually done. The backfill sand liquefied due to the earthquake. The caisson suffered deformation as shown in Fig. 8 but the displacement toward sea was only about 0.3 meters.

Fig.8 Damage to a quay wall at Site B

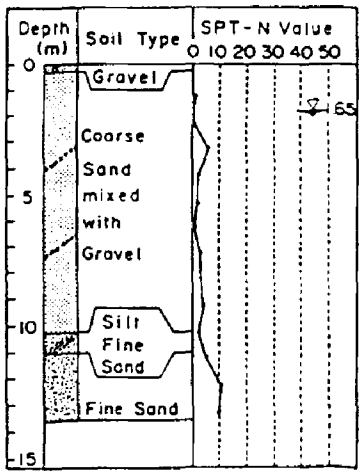
The backfill sand at this pier was loosely deposited and was of a coarse sand as shown in Fig. 9. It was planned to be compacted as remedial measures against liquefaction; unfortunately the

Fig.9 Ground Condition at Site B

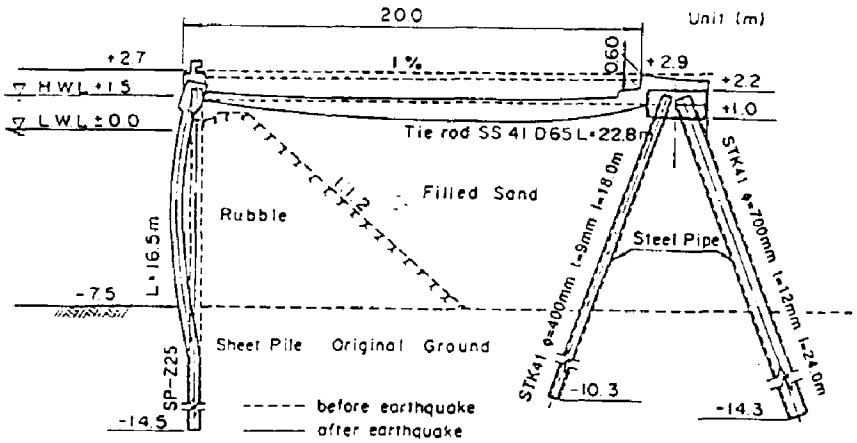
The most serious damage to the sheet pile quay walls in Kushiro Port was found at the Fishery Pier in the East Port District. The location is designated in Fig. 2 as the site C. The structure of this quay wall is of a steel sheet pile type anchored by battered steel piles. The cross section is shown in Fig. 10. As shown in Fig. 11, the ground at this pier consists of a loosely deposited backfill sand with a thickness of about ten meters, underlain by medium to dense sand deposit which forms the original ground.

The earthquake caused liquefaction in the backfill sand, resulting in the serious deformation of the sheet pile wall as shown by the solid line in Fig. 10. In accordance with the deformation of the sheet pile wall, the apron exhibited serious settlement between the sheet pile wall and the anchor piles. Detailed investigation of the sheet pile wall by diving in the sea revealed that cracks opened in the steel sheet pile wall at an elevation of four meters below the water level.

Fig.10 Damage to a quay wall at Site C

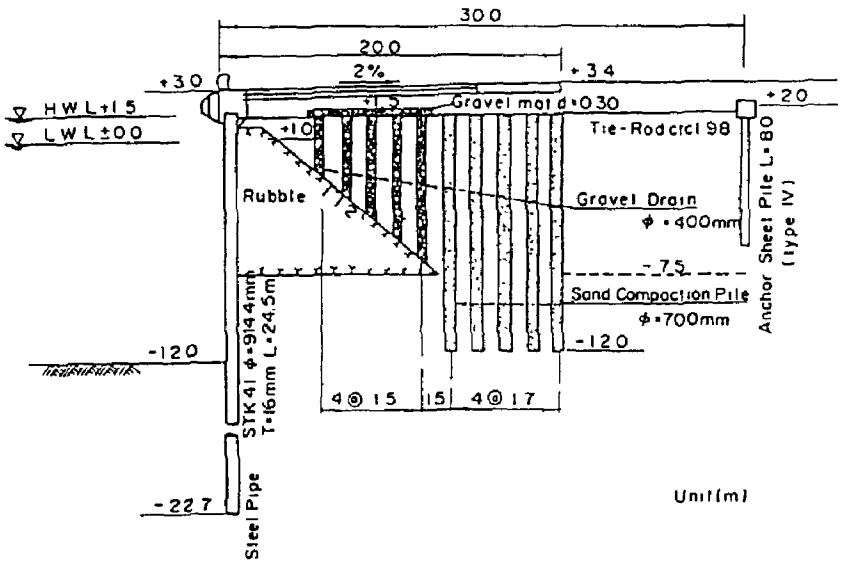
In contrast to the damaged sheet pile quay wall described earlier, quay walls with compacted backfill sand survived the earthquake without damage. An example, shown in Fig. 12, is the quay wall at the south end of the Pier No.1 at the West Port District. The location is designated as the site D in Fig. 2.

The structure of this quay wall is of a steel pipe pile wall anchored by a steel sheet pile wall with a water depth of 12 meters. The ground at this wall had originally consisted of fill sand with a thickness of about ten meters, underlain by the original ground of medium to dense sand. The backfill sand was later treated by a sand compaction pile method as shown in Fig. 12. The SPT N-values of the ground before and after the compaction are shown in Fig. 13. In order to avoid the adverse effect upon the existing steel pipe pile wall during the ground compaction work, gravel drains were installed near the wall as shown in Fig. 12.

Despite the strong shaking of the earthquake, the earthquake caused no effect on this quay wall. The measures against liquefaction as well as the overall design of the quay wall according to the current design practice (Ports and Harbours Bureau, 1991) was proven to be good enough to provide resistance the strong earthquake shaking.

Fig.12 Cross section of a quay wall at Site D

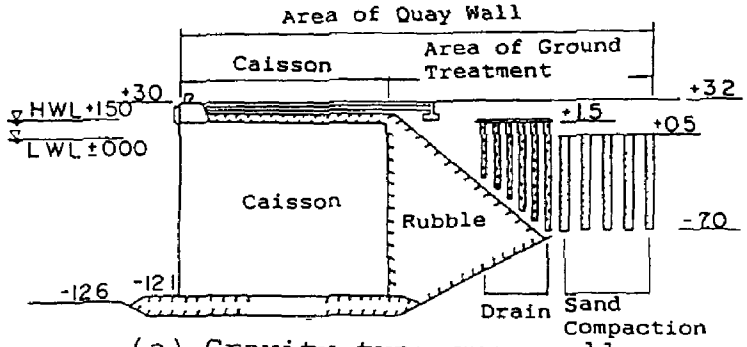
(a) Gravity type quay wall

From the point of view of measures against liquefaction, the backfilled part of ground consisting of rubble behind a wall shown in Fig. 14 might be regarded as treated area as measures against liquefaction. Though the area of this part is not wide enough to cover whole area of active earth failure zone, this

There was some concern about the performance of gravel drains during earthquakes. This was partly because the history of gravel drains as liquefaction remediation is rather new; the case history data on its performance during actual earthquakes has been scarce. After the earthquake, a site designated site-E, shown in Fig. 2, where gravel drain was installed as remedial measures against liquefaction, was excavated in order to examine the clogging of gravel drains due to migration of sand from natural ground. The cross section of the quay wall and the remediation measures are similar to that shown in Fig. 14 (a).

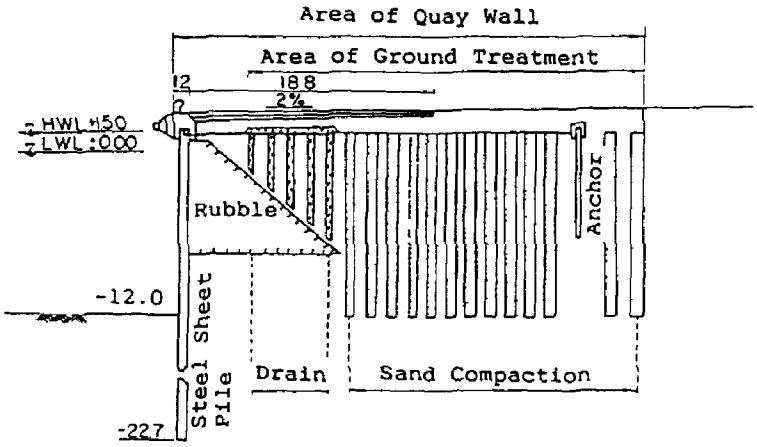
(b) Sheet pile quay wall

In order to grasp an overall picture of the effects of liquefaction on damage to quay walls at Kushiro Port, Table 1 summarizes the relevant data of the quay walls with water depths deeper than 7.5 meters. In this table, "liquefaction" is identified with respect to the soils within "the area of a quay wall cross section," shown in Fig. 14, which includes the backfill area treated as measures against liquefaction. This similarly applies to the quay walls without measures against liquefaction, including the backfill area which is supposed to be treated as remediation against liquefaction.

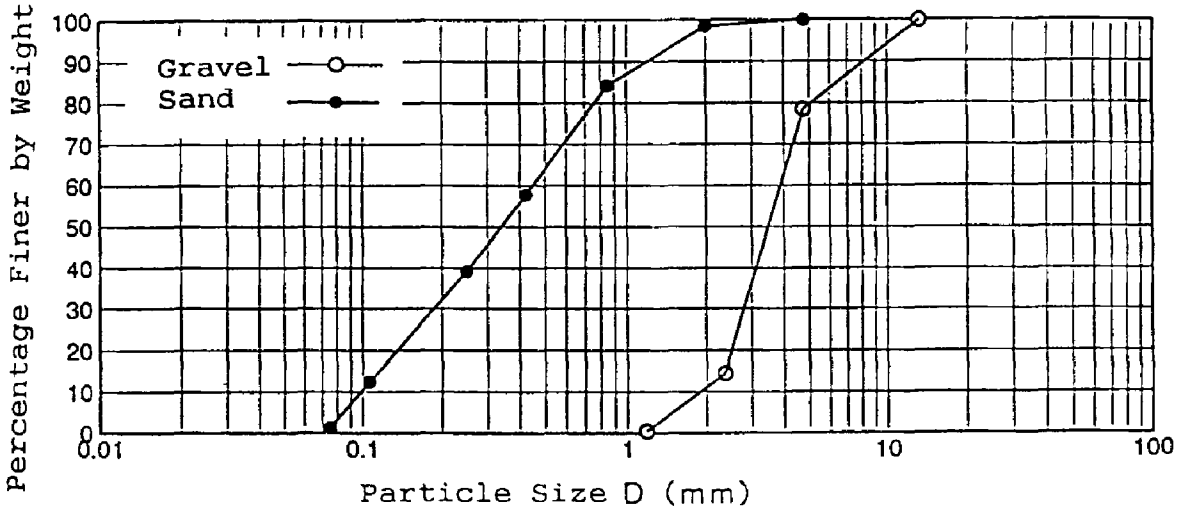
The gravel drain piles are 40 cm in diameter, installed at a space of 5.0 meters. The sand consisting of the ground and the gravels used for the drain have those gradations shown in Fig. 15. The 15% diameter of the filtering material (i.e. the gravel) d_{F15} and the 85% diameter of the sand D_{S85} read off from this figure are

$$d_{F15}/D_{S85} = 2.8 \quad (3)$$

This ratio should be more than adequate for passing such a filtering criterion as

Fig.15 Gradation of sand and gravel

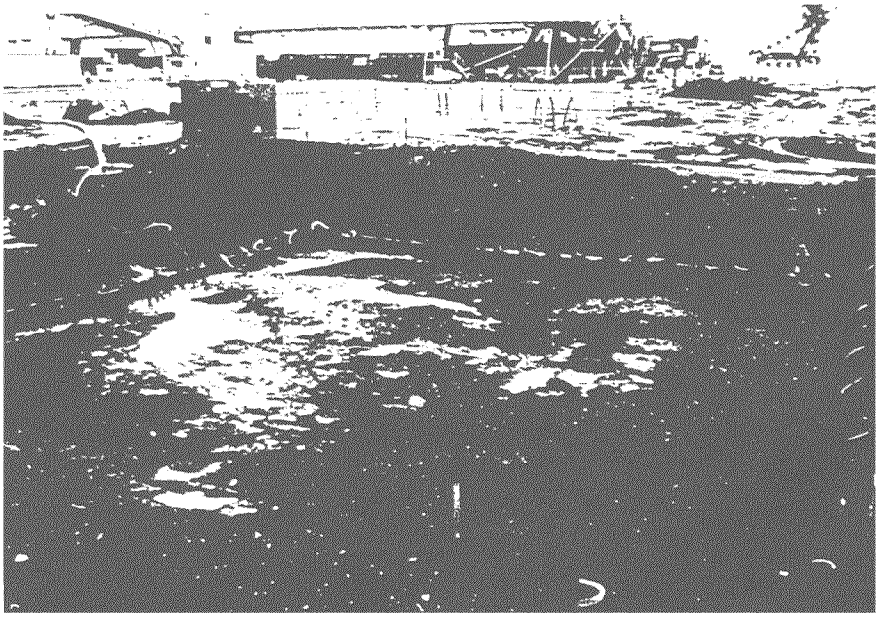
Excavation was done by at first lowering the existing water level at +1.20m to a level of +0.00 m, then by digging out to a level of +0.00 as shown in Figs. 16 and 17. Close eye inspection of a gravel drain, shown in Fig. 18, found no migration of sand.

Fig.16 General view of excavation of gravel drain site

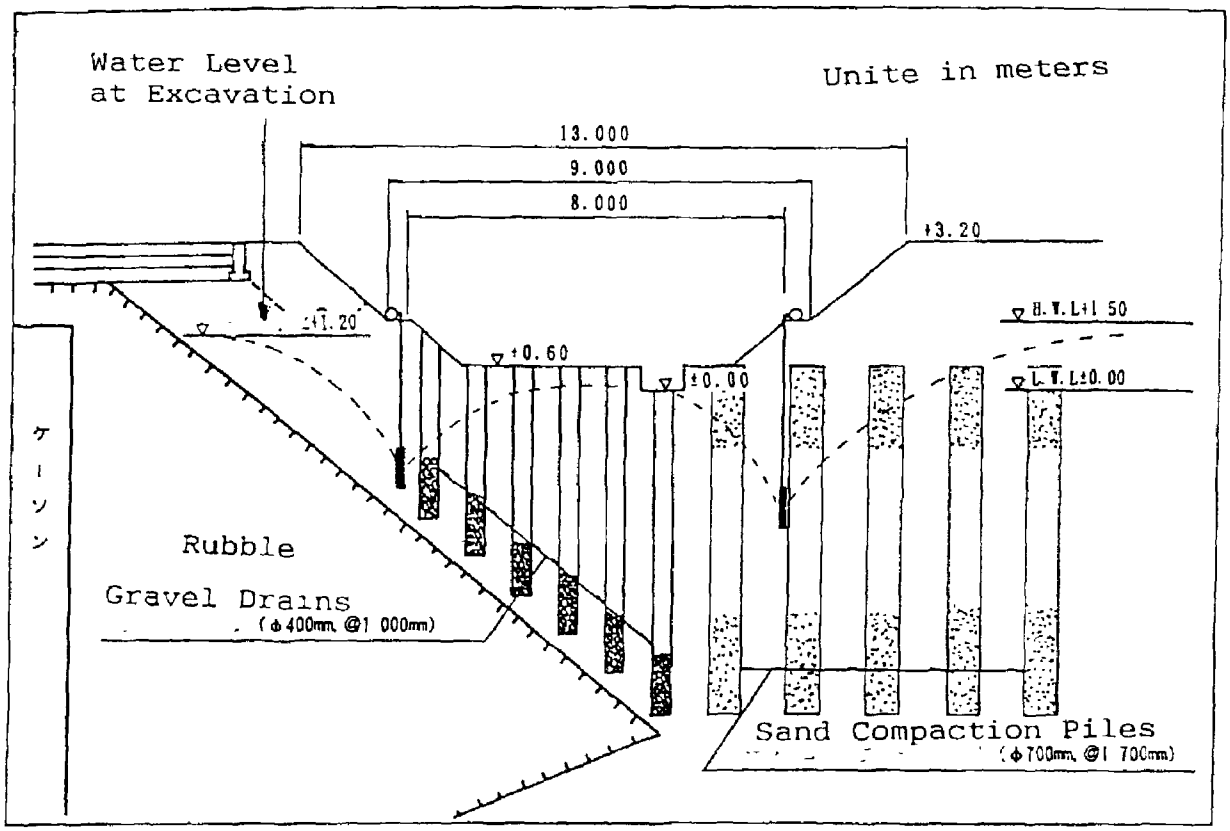
Fig.17 Cross section of excavation details
