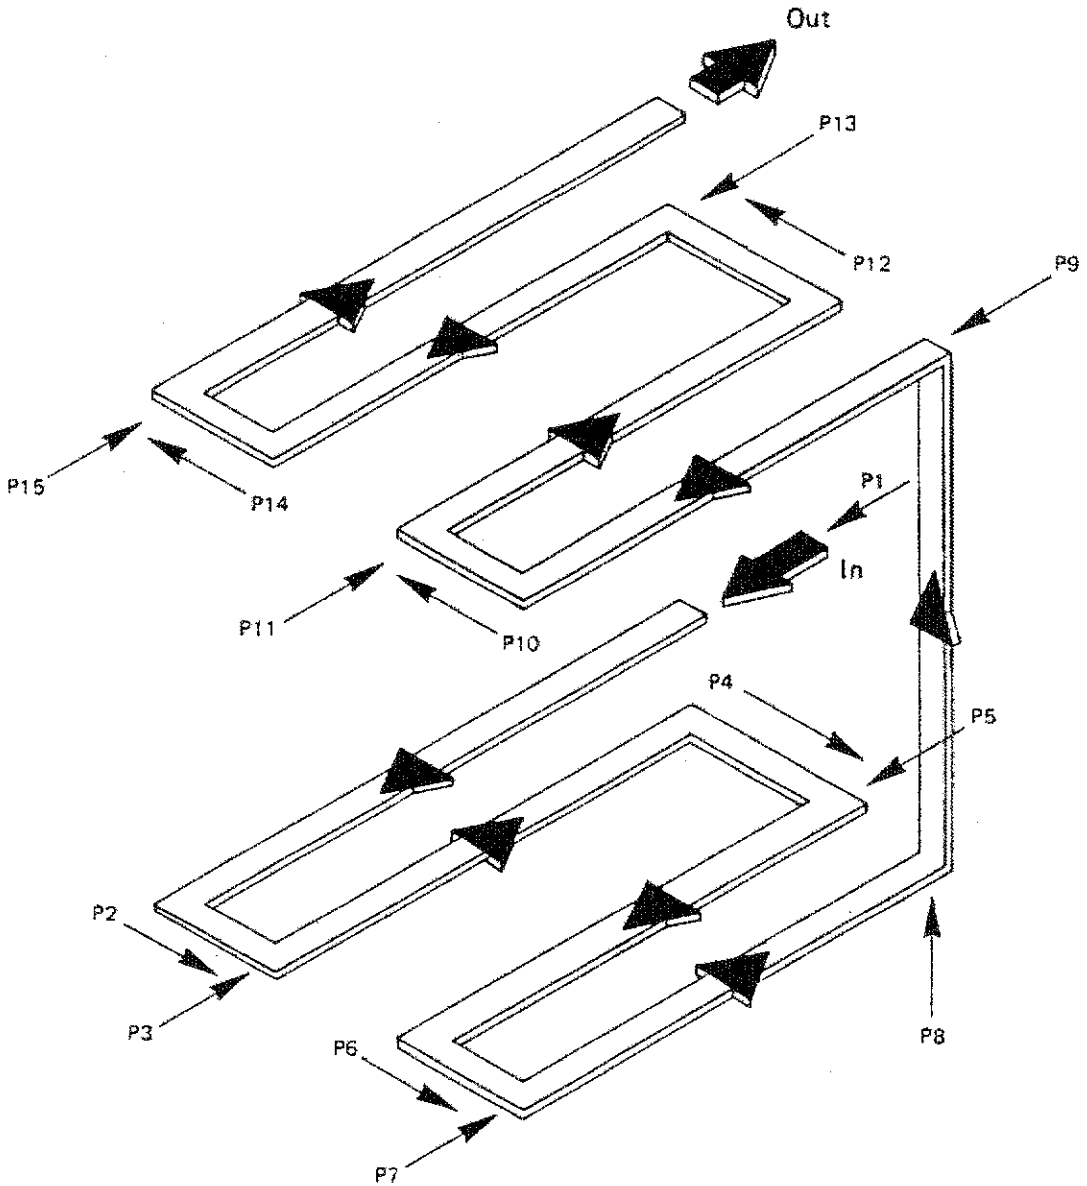
FIG. 8. Schematic diagram of the transport of product boxes in the irradiator. (By courtesy of Nordion International Inc.)

Between 1975 and 1981, a number of incidents occurred at irradiators from the same supplier, in the USA and elsewhere (including the incident in San Salvador in 1975) in which damaged product boxes obstructed the source rack and caused it to jam. Consequently, in 1981, the supplier distributed *Warning Notice IND-81-1*,

The owner of the plant received this warning notice but never had its recommendations implemented owing to their cost and the increase in the exposure time that would be necessary to compensate for the shielding effect of the shroud. By the time of the accident in February 1989, the product boxes had been in use for a number of years. Many were in extremely poor condition and had been repaired with adhesive tape.

in which it recommended that a steel source shroud be fitted around the irradiation position. It was also recommended that the condition of the boxes be routinely checked and that boxes in marginal condition be replaced.

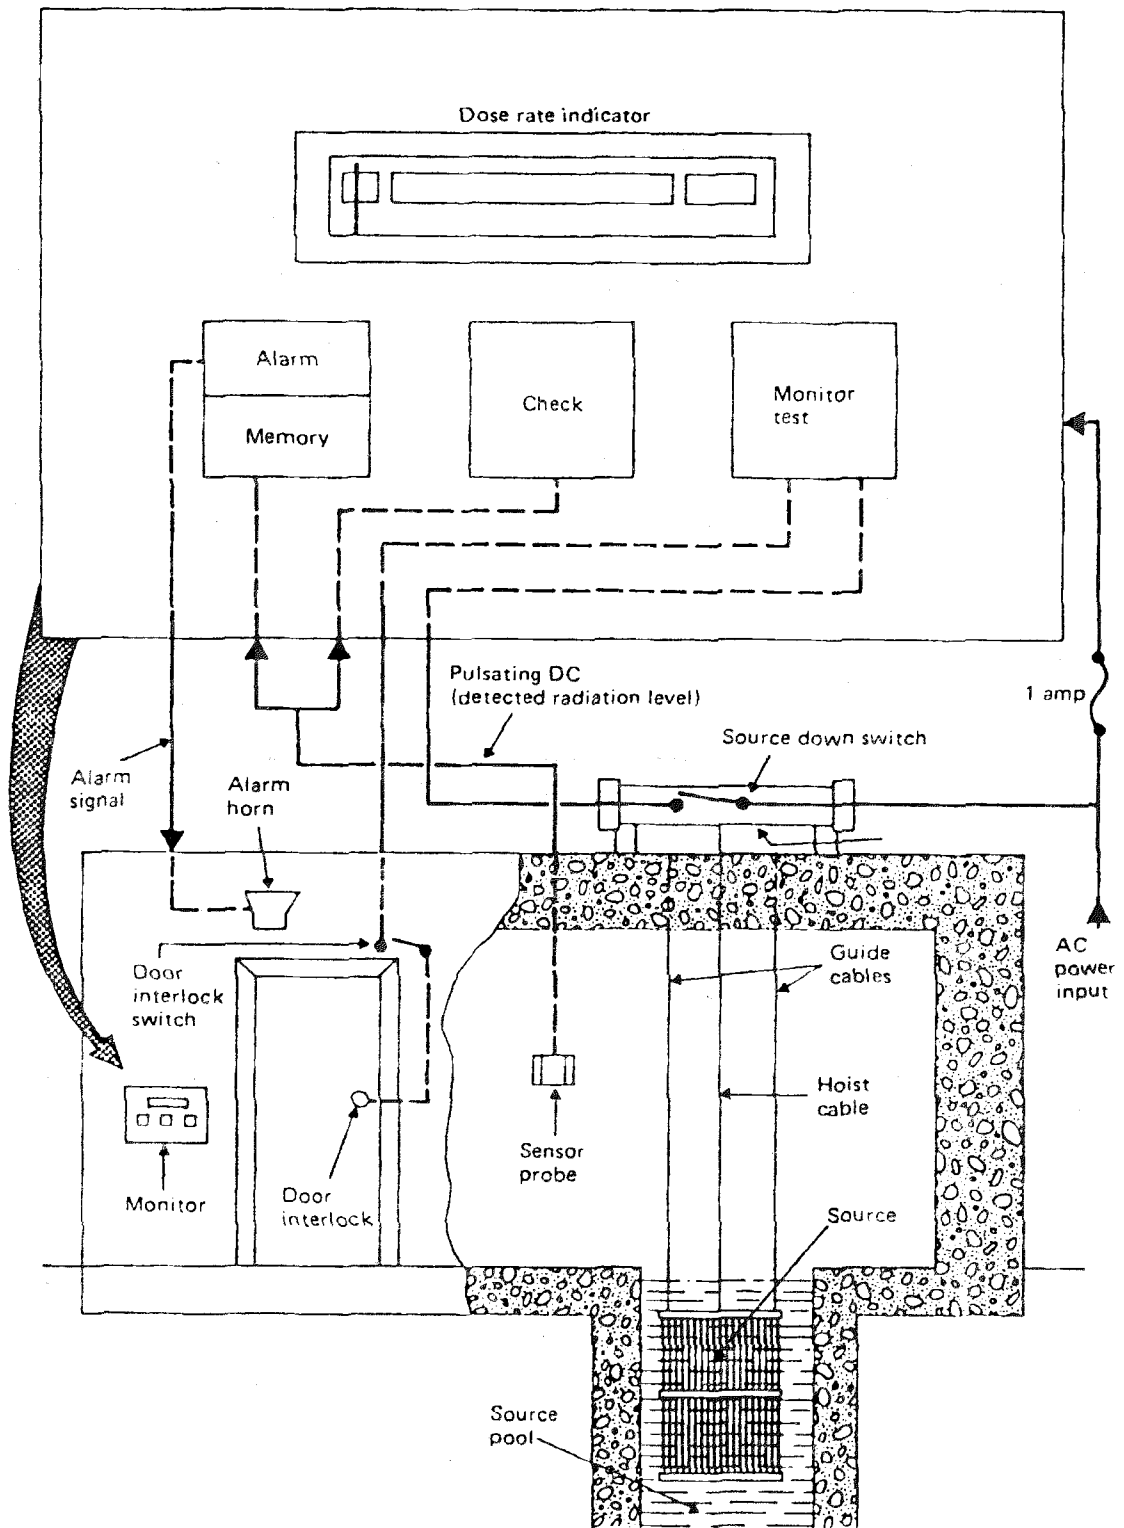
FIG. 11. Schematic diagram of the circuits for the monitor in the radiation room. (By courtesy of Nordion International Inc.)

More than five years before the accident, the monitor probe had failed and the probe assembly had been removed. Its cabling remained. Removal of the monitor probe should have disabled the irradiator. However, it was discovered that access could be gained to the radiation room by depressing the monitor test switch and repeatedly cycling the buttons on the panel of the radiation monitor. This method of gaining access became the 'usual' procedure. The access door had not been maintained and had become badly fitting, with the result that it could also be opened by force or by using the blade of a knife to slip the catch (see Photographs 5 and 6). Thus one major safety feature of the design was bypassed.

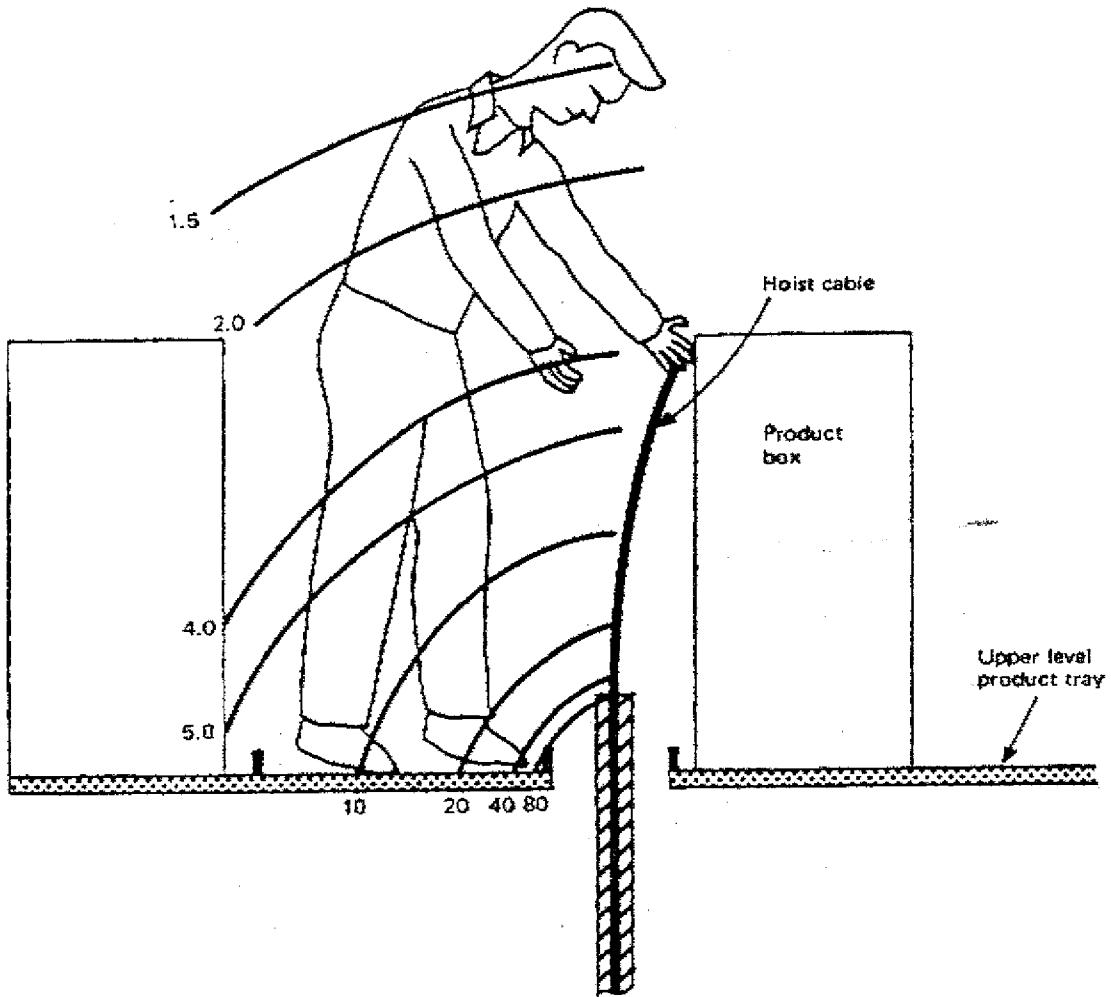
The next phase of the accident was probably when the three workers sustained the largest share of their doses. They would have been moving, but the positions and dose rate contours shown in Figs 13-15 can be taken as indicative of the patterns of exposure. In order to free the source rack they first had to raise it (a mass of about 60 kg) by all three pulling on the hoist cable. Eventually the three men were standing broadly in line on the upper level (Fig. 16). Worker A was in a crouching position with his legs slightly apart and his right leg forward directly in front of the rack. To his right, Worker B had his left leg nearer the source. (The leading leg of each man

FIG. 14. Dose rate contours for a standing figure: rates in $Gy \cdot min^{-1}$. (Source: REAC/TS.)

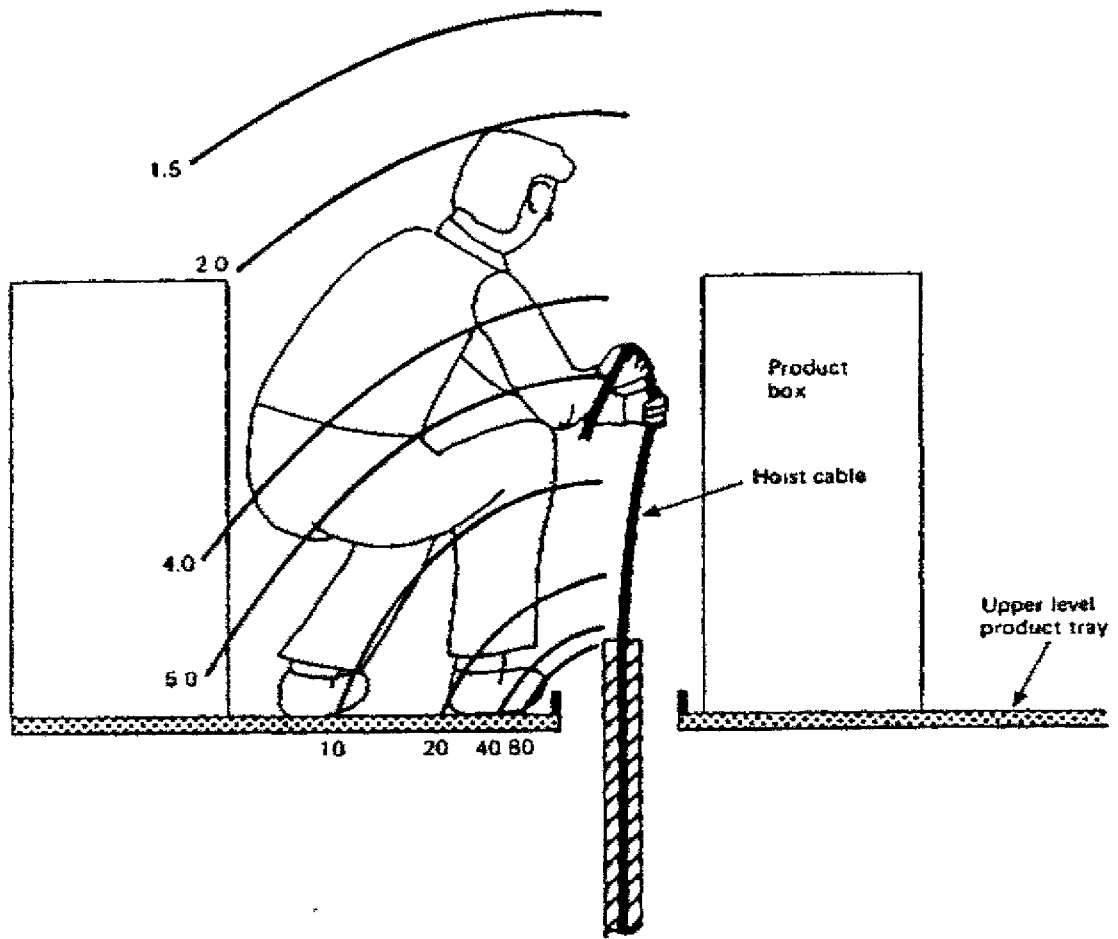
FIG. 15. Dose rate contours for a squatting figure: rates in $Gy \cdot min^{-1}$. (Source: REAC/TS.)

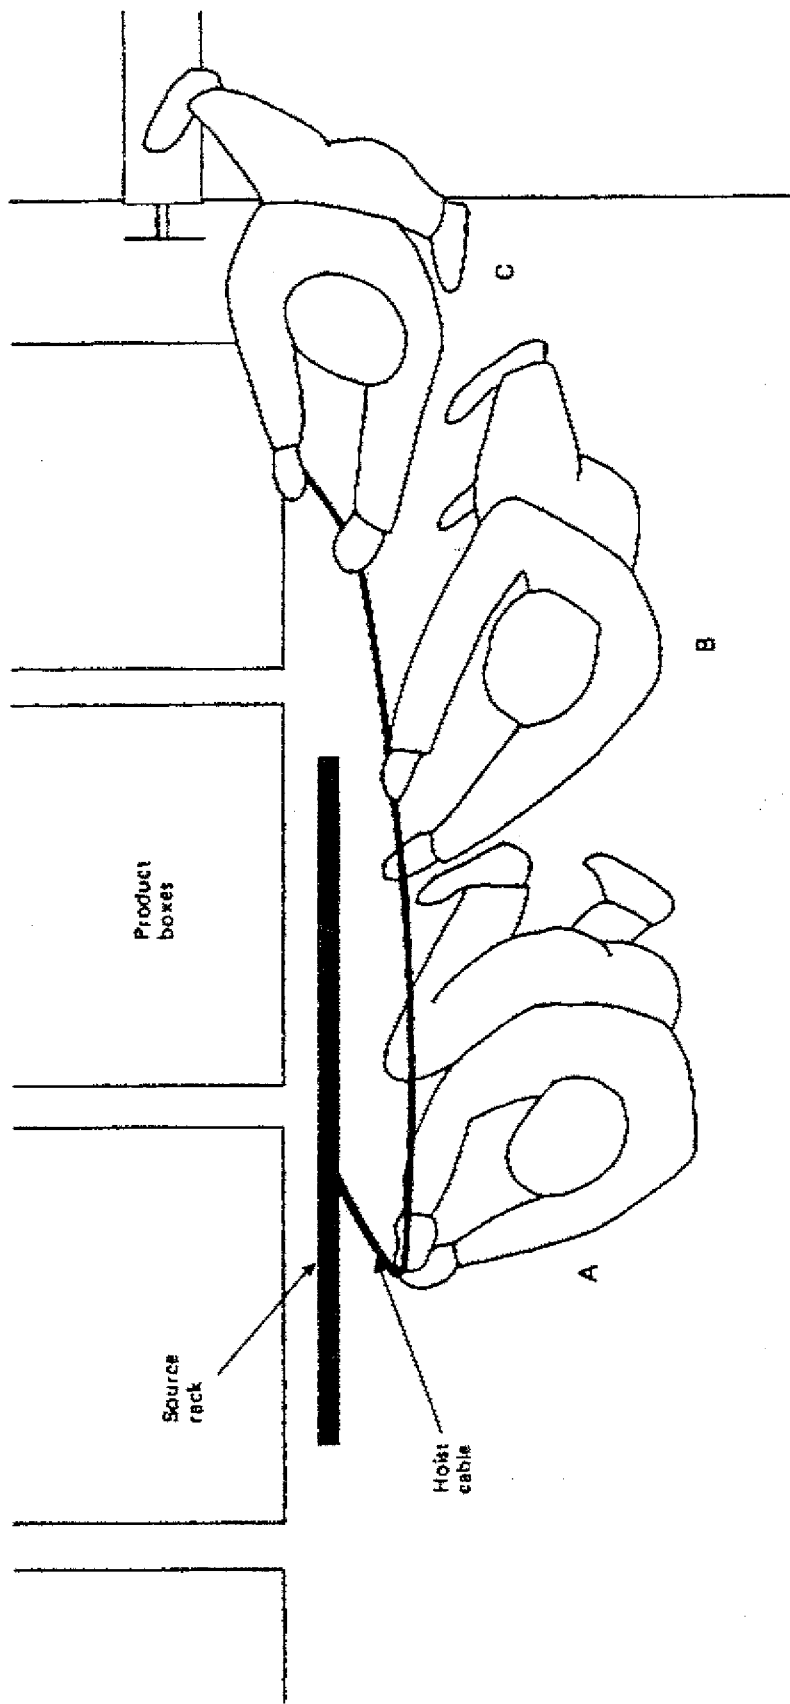
FIG. 16. Plan view of the positions in relation to the source rack of Workers A, B and C while attempting to free the source rack. (Source: REACTS.)
