# **THE 1974 LANDSLIDE IN CENTRAL PART OF PERU**

**By: Miguel Luis Estrada Mendoza**

Japan-Peru Center for Earthquake Engineering Research

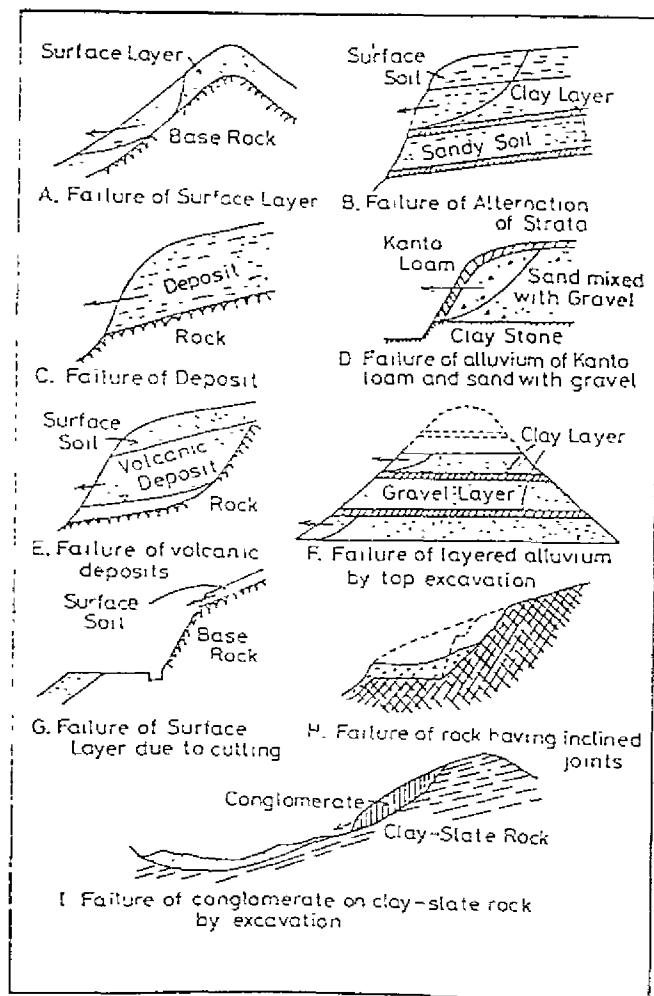
Fig 2 Types of Slope Failure

Primary causes, Fig. 2 shows several types slope failures related to topography, geology and soil qualities. When investigating the slope failure, it is necessary to watch ground conditions and also surface conditions such as vegetation as seen in aerial photograph. Exciting causes, Fig. 3 shows the relation between continuous rainfalls and slope failures and also Fig. 4 shows the relation between intensity of rainfall and slope failures. In addition, care must be observed when strong earthquakes and earthquakes associated with rainfalls occur.

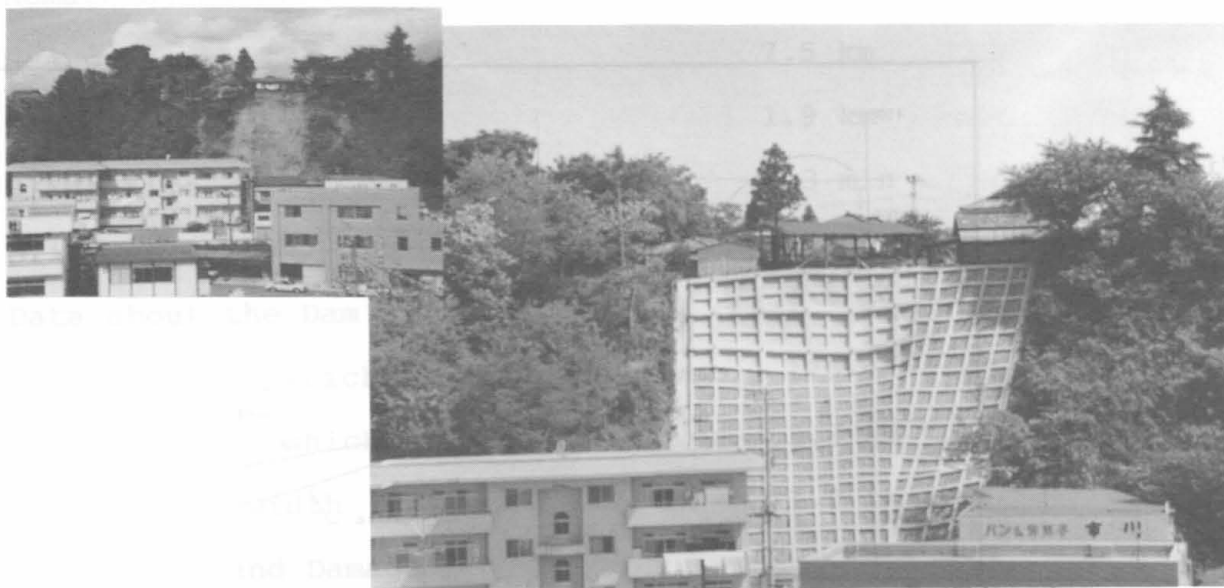
Photo 1. Slope Control Works in Japan

Now we can see the development of new technology as satellite data, remote sensing and robotics engineering to help us to forecast the phenomenon. For example here in Japan we saw a good work on slope control as shown in the next photo.
