6.1.3. Analysis of Transmission Systems Damage

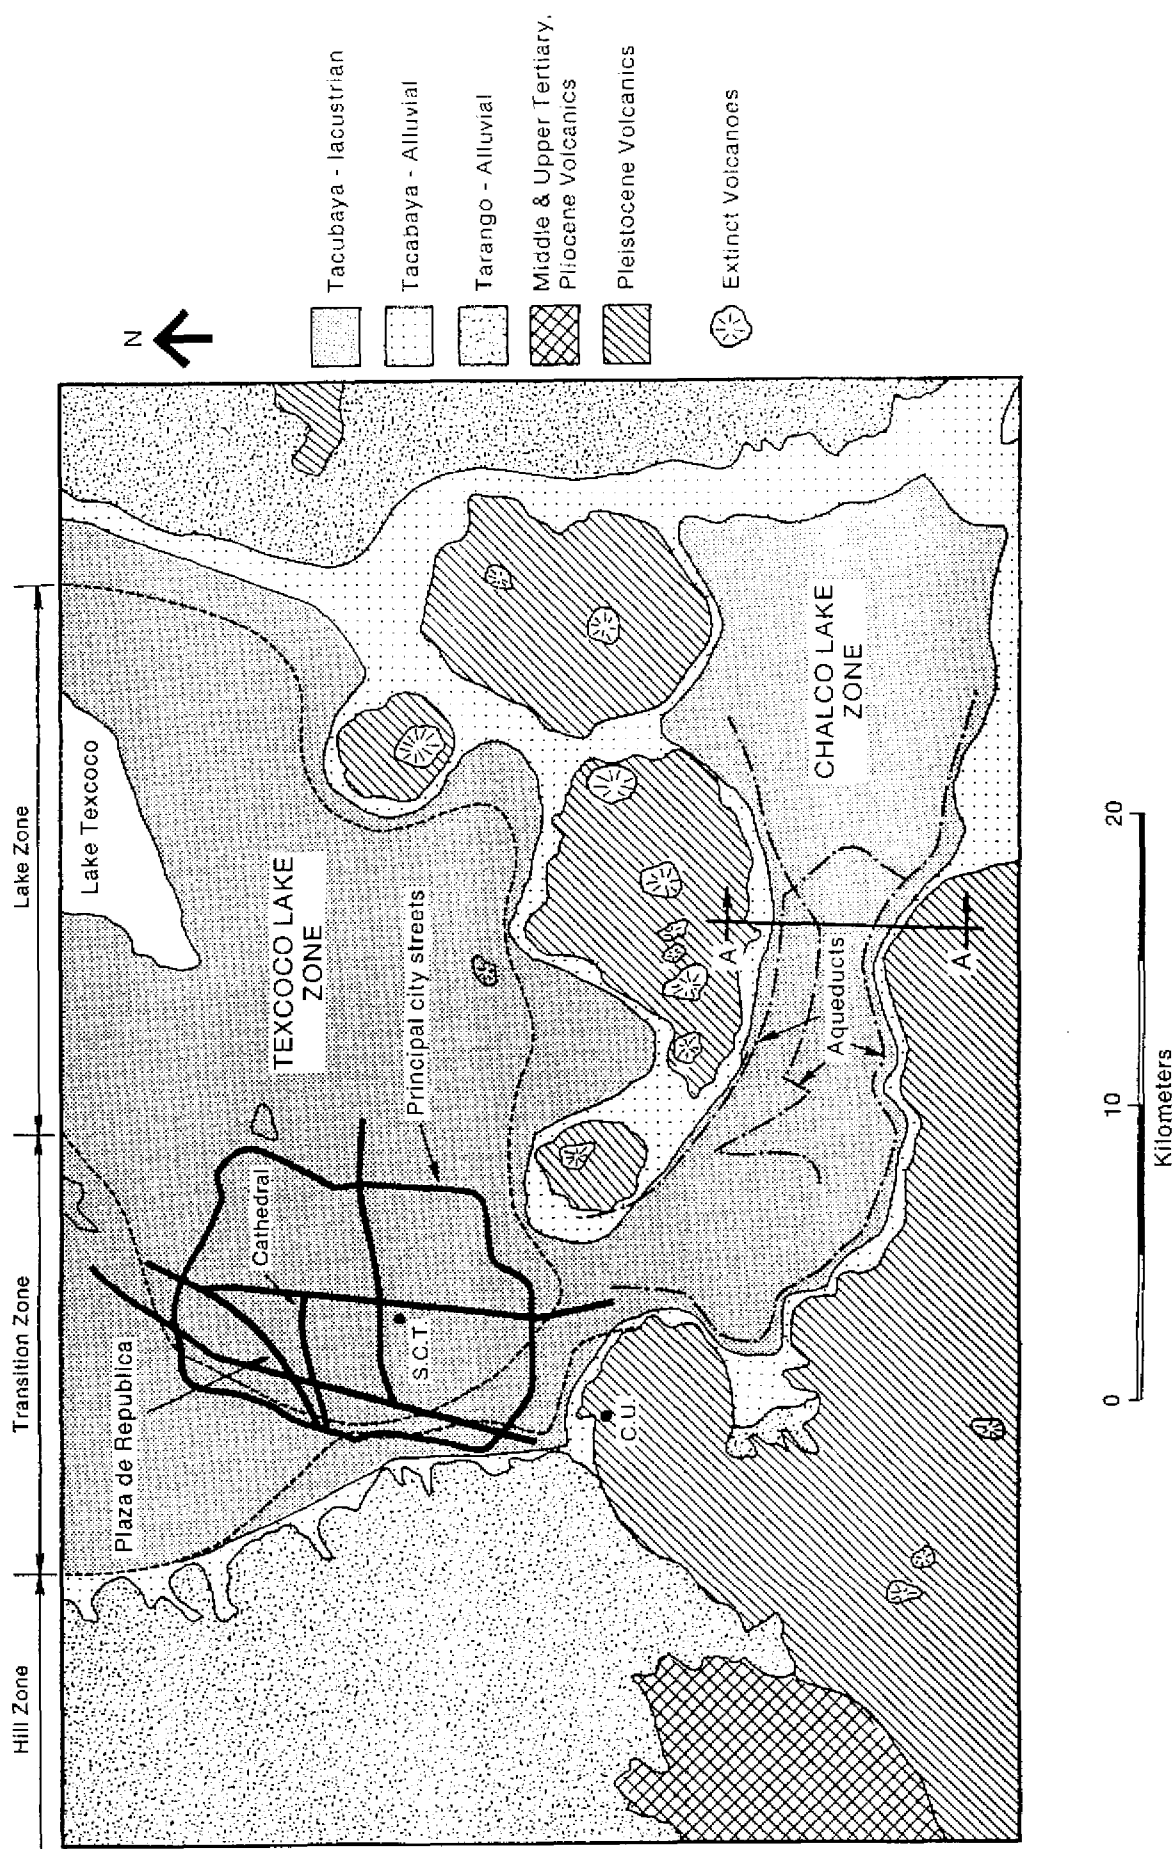
FIGURE 6-8 Location Of Damaged Aqueducts With Respect To Surrounding Mountains

Figure 6-8 shows the two damaged aqueducts located between the Cerro de la Estrella and the Cerro de Santa Caterina to the north and the Sierra del Ajusco to the south. An approximate elevation view is shown in figure 6-9. Tlahuac, which is considered to be in the Lake Zone, is located in the valley between these two groups of mountains. There were two seismographs located in Tlahuac; one at a pump station (Tlahuac Bombas, TLHB) and another at a sports club (Tlahuac Deportivo, TLHD). Two other Lake Zone seismographs were recorded north of the Cerro de la Estrella and the Cerro de Santa Catarina, at

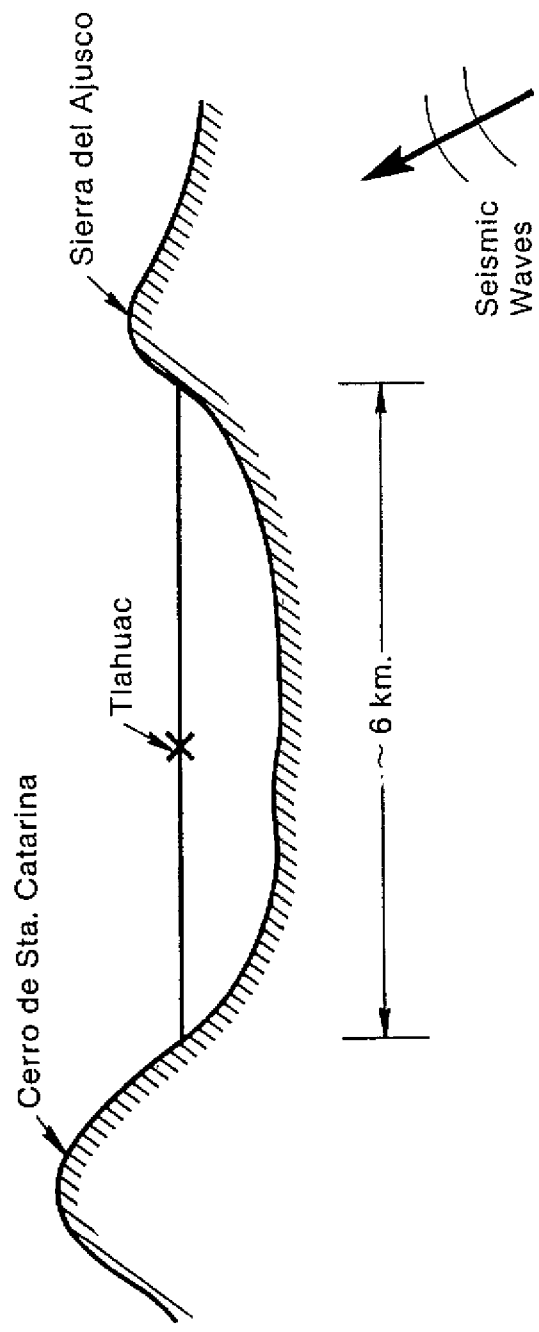
FIGURE 6-9 Idealized Elevation View Showing Tlahuac

It is the authors belief that the local topology of this valley containing Tlahuac resulted in large ground displacement amplitudes as well as fairly severe local variations in ground displacement amplitudes. These factors in turn lead to the transmission system damage.

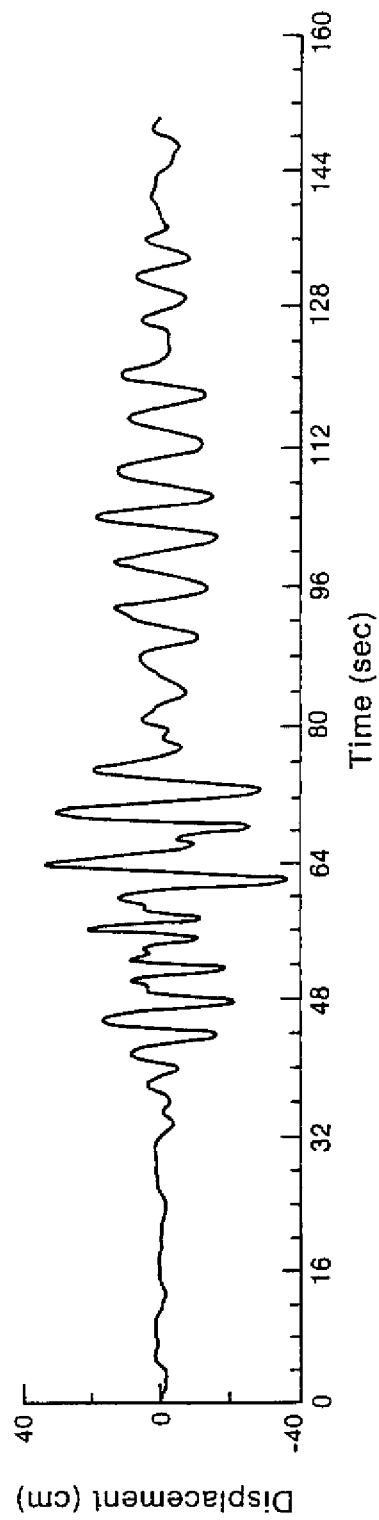
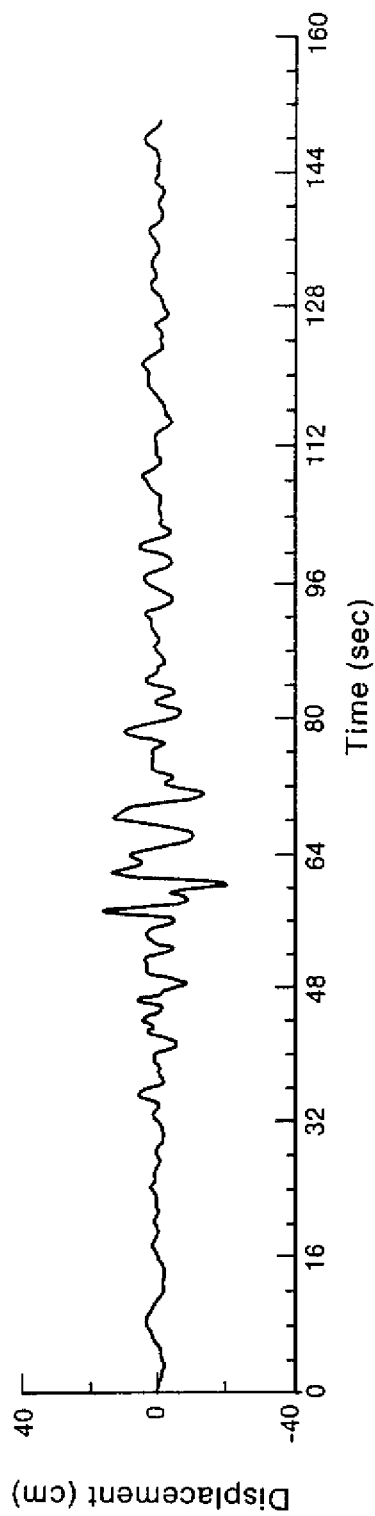
FIGURE 6-10 North-South Ground Displacement Time Histories At Tlahuac - 1985 Michoacan Earthquake

The TLHB peak ground displacements were roughly 1.5 times larger than the next largest which were recorded at Central de Abastos. That is, during the 1985 event, the area of aqueduct damage experienced the largest recorded ground displacements.

Another important factor is the large local variation in ground displacement near Tlahuac. Tlahuac Bombas and Tlahuac Deportivo are separated by about 3 km. Yet the horizontal ground displacements at THLB were roughly double those of THLD. This difference is shown graphically in figures 6-10 and 6-11. The North-South ground displacement time histories at THLB and THLD are shown in figure 6-10 while the East-West components at the two stations is shown in Figure 6-11.
