Geotechnical Observations at the Van Norman Complex after the 1994 Northridge Earthquake

C.A. Davis, Associate Engineer,
Department of Water and Power, Los Angeles, CA.

J.P. Bardet, Associate Professor,
University of Southern California, Los Angeles, CA.

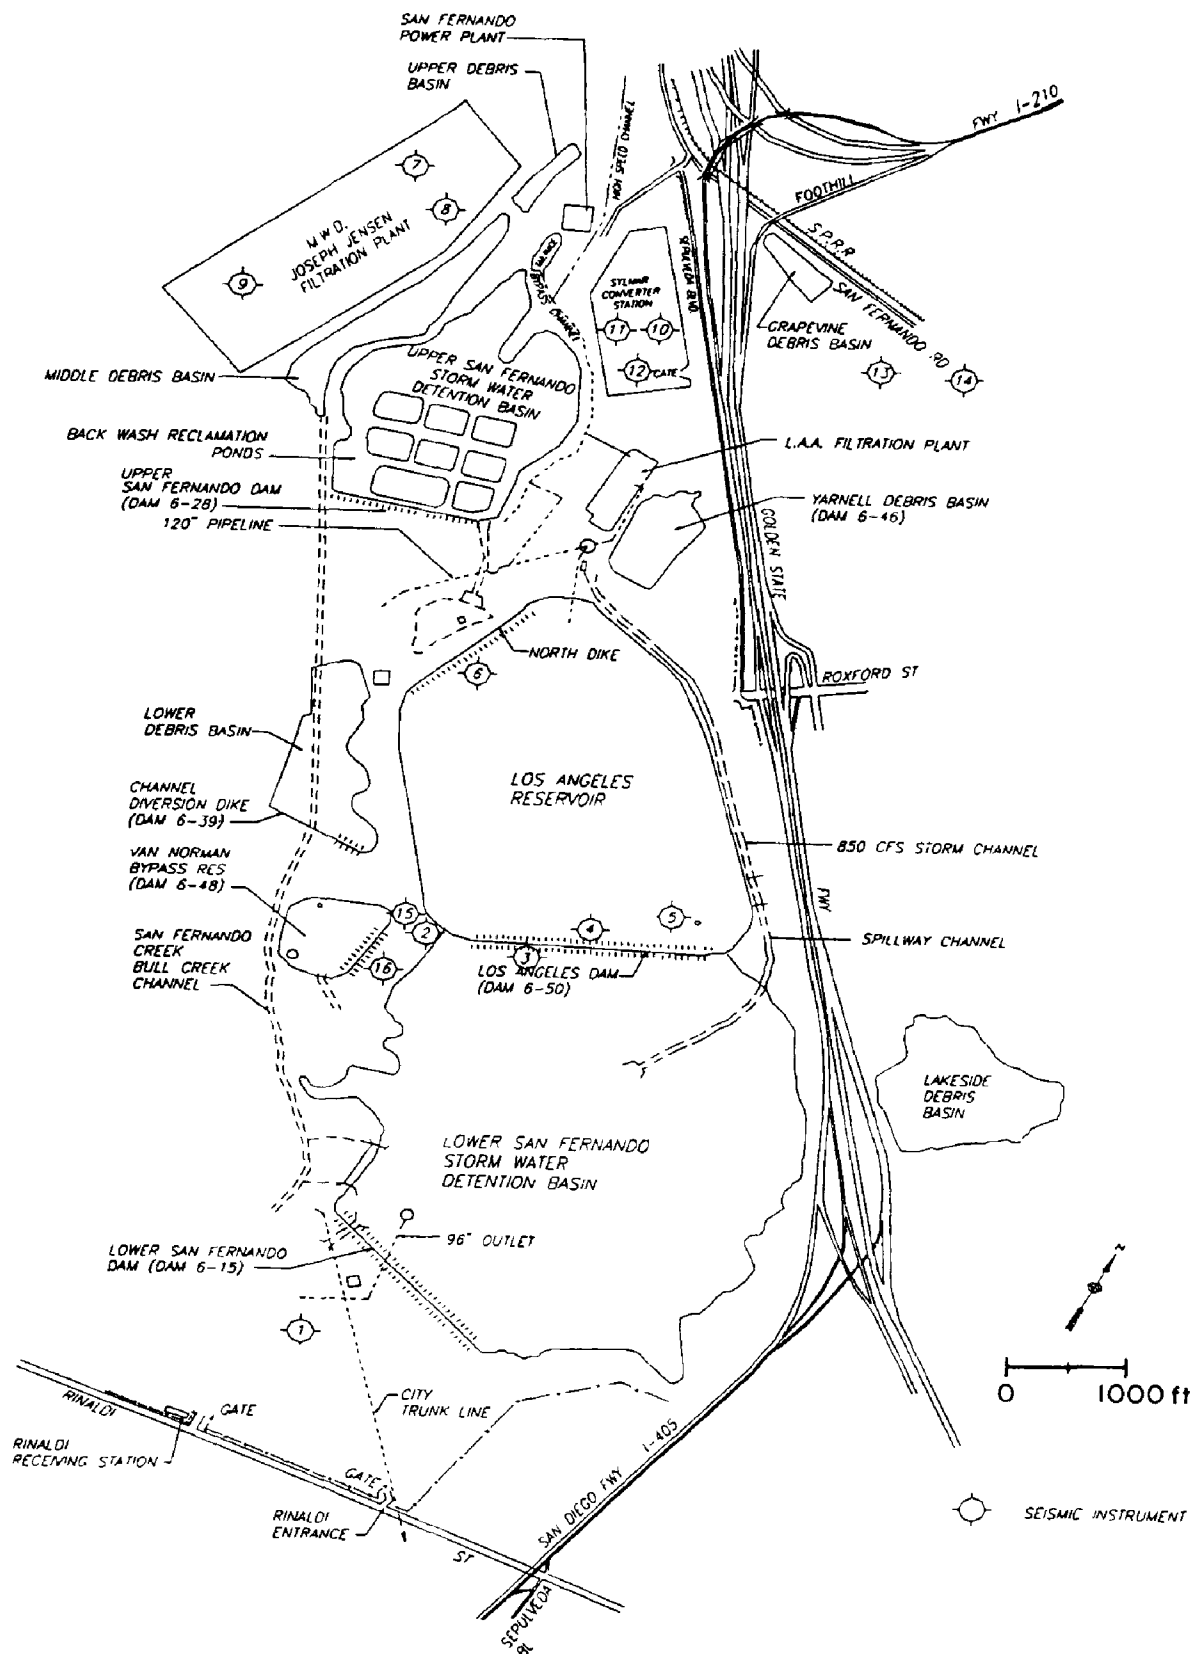
Figure 2. General view, main structures, and location of strong motion recordings of Van Norman complex.

The Northridge Earthquake produced an unprecedented number of near source seismic recordings. Fig.2 and Table 1 present the site locations and recorded peak ground accelerations of the seismic instruments on and around the Van Norman Complex, which include fourteen accelerographs (1-14) and two seismoscopes (15-16). Fig.5 shows an example of the time history of horizontal and vertical accelerations recorded at the Rinaldi receiving station, located to the southern end of the complex and referred to as No.1 in Fig.2. The horizontal peak acceleration (0.84 g) is observed at about 2.5 second and corresponds to a low-frequency and high-energy pulse, which is noticeable in all the recordings in the complex. The vertical acceleration has a shorter dominant period, but an even larger peak value (0.85 g) than the horizontal components.

As shown in Fig.2 and Table 1, there were five seismographs located at the reservoir. Surprisingly, all their recordings were lower than those throughout the complex, which reached record-breaking levels of accelerations. Thus, the reservoir site was subjected to a much lower level of shaking than the surrounding areas.

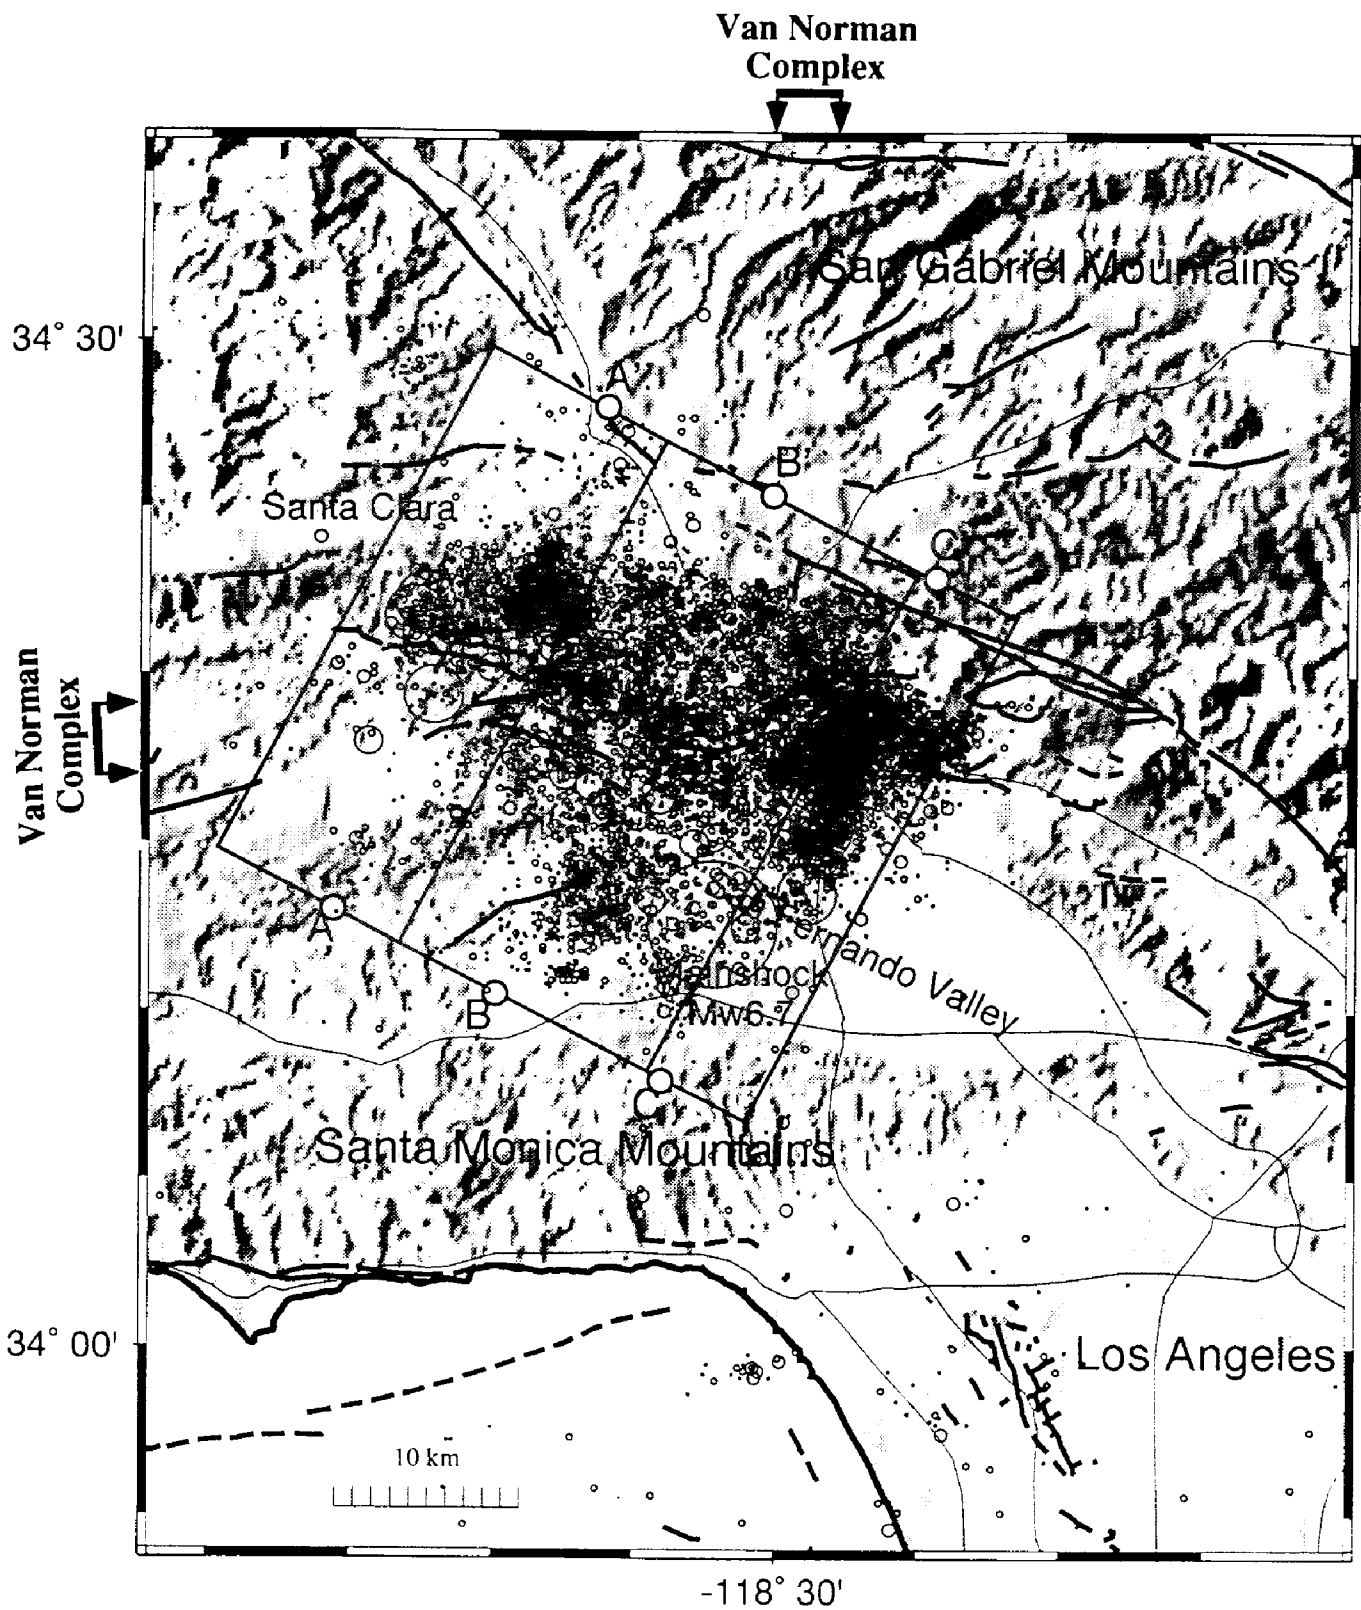
Figure 3. Map of aftershocks after the Northridge earthquake from January to July 1994 (after Hauksson, 1994).

A great number of aftershocks took place below the complex. This is easily seen in the aftershock map in Fig.3, and the cross-sections BB' and CC' in Fig.4 (after Hauksson, 1994). The aftershocks in Fig.3 are so dense that they completely cover the complex which had to be situated by its coordinates. As shown in Fig.4, the aftershocks
