EARTHQUAKE DAMAGE INSPECTION AND EVALUATION

The Namioka Town Hospital, a reinforced concrete five stories building, suffered earthquake damage by the 1983 Nihonkai chubu Earthquake. The application results of the GUIDELINES FOR POST-EARTHQUAKE DAMAGE INSPECTION AND EVALUATION and the GUIDELINES FOR RESTORATION TECHNIQUES FOR DAMAGED BUILDINGS are presented as an example.

3. OUTLINES OF BUILDING AND DAMAGE

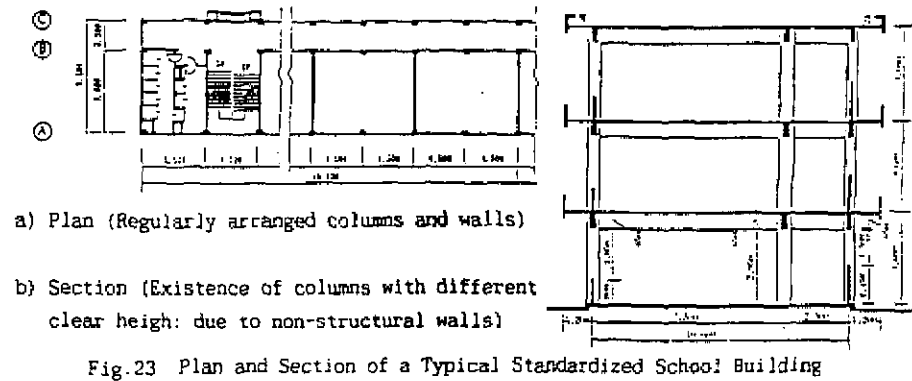
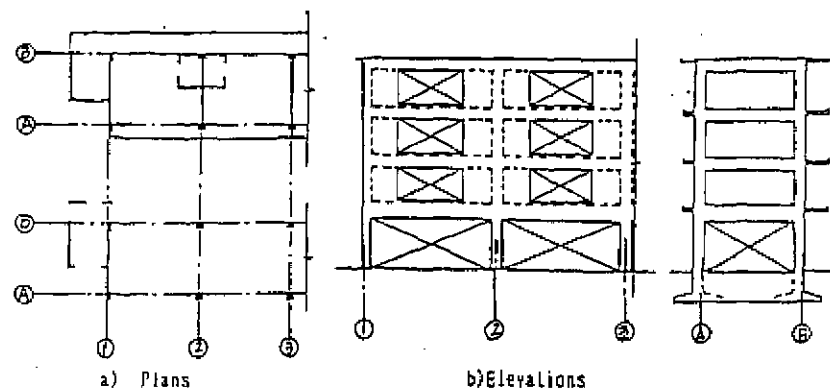
Fig.24 Plan and Elevation of a Typical Apartment House with Soft First Story

Tokyo Metropolis had constructed dozens of public apartment houses with open space at the ground floor for the purpose of solving the apartment shortage of parking area. As understood from Fig.24, these buildings are generally three or four stories for dwelling use but almost no walls in the both directions of the longitudinal and transverse. The famous Kaiser Hospital in U.S.A. is well known as it was severely damaged by the 1971 San Fernando earthquake but also in Japan, several buildings with the soft first story were severely damaged by the 1983 Miyagiken-oki Earthquake. Soon after this experience, Tokyo Metropolis decided to investigate seismic safety of this kind of apartment houses with soft first story and asked Building Research Institute, Ministry of Construction, Japan to investigate them with practical support of a private investigation company. However in this time, dwellers' agreement for evacuation from the objective buildings could not be obtained, so actual strengthening, even if it is necessary for the upper portion, had to be limited only to the open ground story.

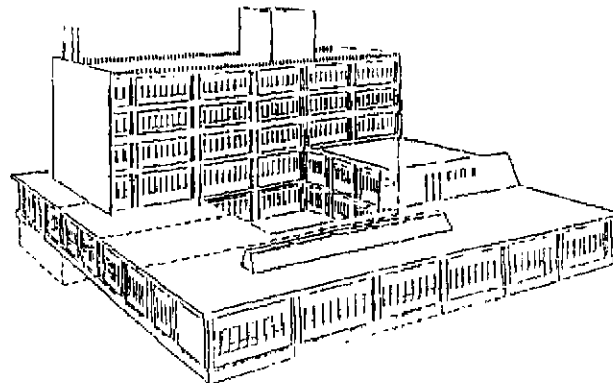
Fig 3.1 : PERSPECTIVE VIEW OF THE NAMIOKA TOWN HOSPITAL.

The Namioka Town Hospital is located at about 190 km east of the epicenter. The construction of buildings began in 1968, and the buildings completed in 1970. The hospital building has a little complicated floor planning with a court as shown in Fig 3.1 through Fig 3.3. The north building (ward for inpatients) consists of the six storied reinforced concrete frame structures with including one story's basement floor. A part of east block (for outpatients) is two stories, and the others (for examinations) are single story building.

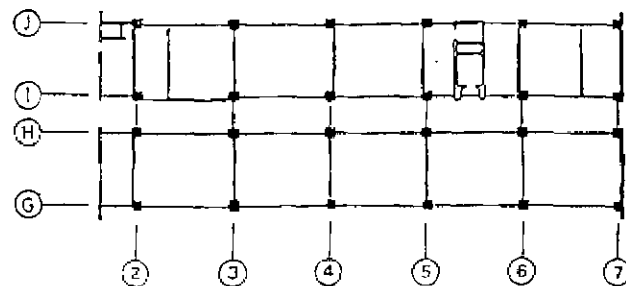
Fig.7.1 : LAYOUT PLAN OF COLUMNS OR WALLS AT THE 3RD FLOOR

The seismic performance before earthquake damage in X-direction at the third floor was estimated as followings by using the second level procedure of seismic screenings. Fig 7.1 shows the layout plan of columns or walls at the third floor.
