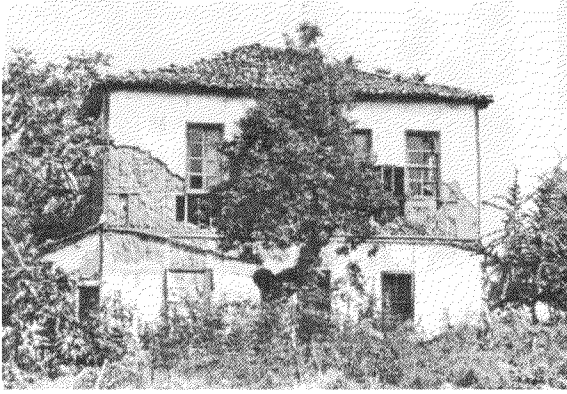
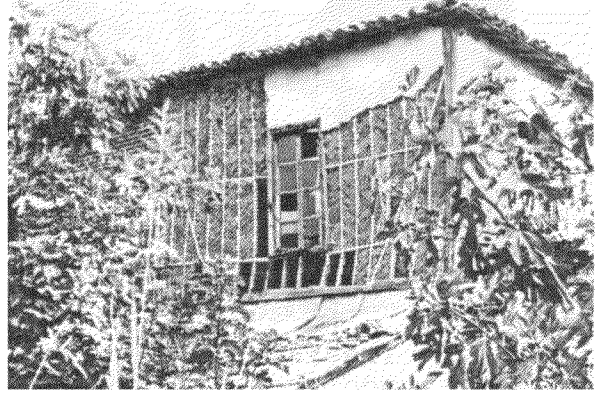
FIG.13 Adobe infilled timber framed dwelling in epicentral area of the Volvi 06.20.78 EQ. Many of them experienced only moderate damage
