**Retrofit Design Detail**

**Location:** Sucre Street, Barrio La Loma

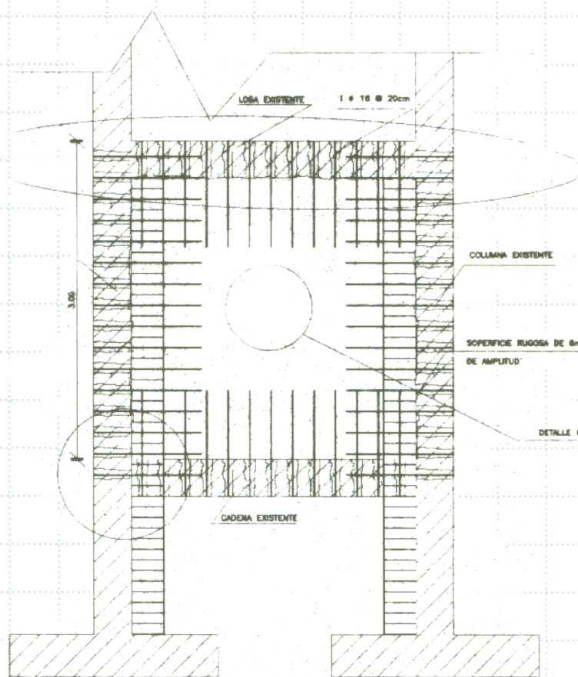
Experimental Sucre's beams and columns are not sufficiently strong to provide earthquake resistance to their structures. Door and window openings have created short columns. The first story of each transverse block lacks infill walls, creating a soft-story condition. The transverse buildings will likely pound against the main building during an earthquake.

Shear walls will be added to the buildings in both the longitudinal and transverse directions. Two options have been proposed for constructing the shear walls. The first consists of adding reinforced masonry walls to the first floor (transverse buildings only) and replacing the walls of upper floors with properly connected reinforced masonry ones. The second design consists of adding unreinforced masonry walls to the first floor (transverse buildings only), and surface strengthening them and upper-floor walls with steel mesh and concrete. Shear walls will increase the stiffness of the portal frames and thereby mitigate soft-story and pounding hazards. Separation joints will be added between walls and columns to mitigate short-column hazards.

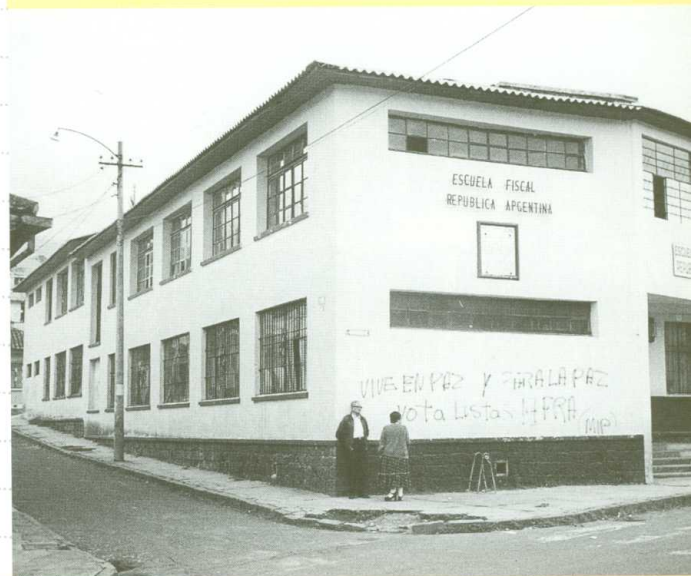
**Building Plan**

The interior and exterior unreinforced masonry bearing walls have openings that create, in effect, a hazardous short-column condition. The beam-wall connections are deficient. Since the wood beams and roof structure are supported by the walls, failure of the beam-wall connections during an earthquake would result in building collapse.
