Location: Rocafuerte and Cumandá streets

The República de Chile elementary and high school consists of four reinforced concrete-frame buildings (Blocks 1 through 4) with unreinforced masonry infill walls. Blocks 1, 2, and 3, built in 1945, are two stories. Block 1 has a total floor area of 1,090 m² (11,730 ft²). Block 2, square-shaped in plan with a total floor area of 240 m² (2,580 ft²), is used for circulation between the other three blocks. Block 3 has an area of 600 m² (6,460 ft²) and is of construction similar to Block 1. Blocks 1, 2, and 3 have rectangular and cylindrical columns, some of which are dangerously slender. Piers of ciclópeo (large-aggregate) concrete support the columns, and stone footings support the walls. There are no tie beams between piers. Block 4, a one-story structure built in 1994, consists of concrete frames only in the transverse direction. It has a floor area of 200 m² (2,150 ft²).

The Río Amazonas high school consists of 12 two- and three-story reinforced concrete buildings and one steel-frame building, all constructed between 1978 and 1985. This project considered three reinforced concrete buildings constructed in 1978: the two-story, C-shaped mai

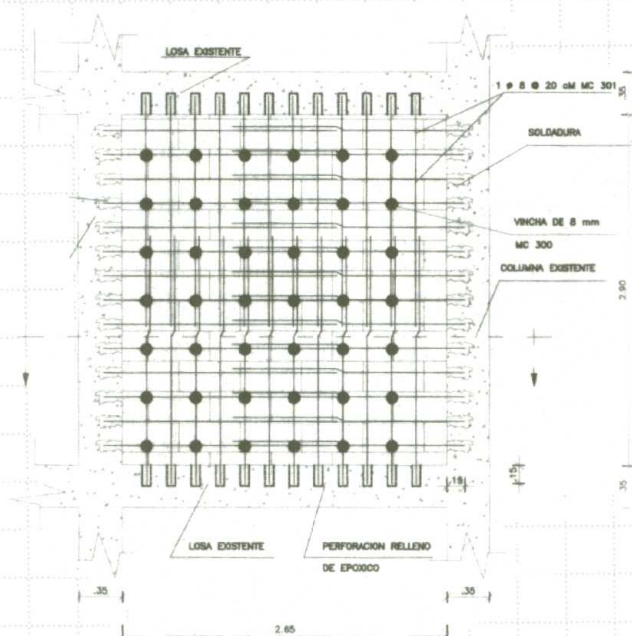
Retrofit Design Detail

The original building designs did not consider lateral forces. Inadequately connected portal frames in the longitudinal direction do not provide sufficient stiffness or strength to transfer properly lateral loads during an earthquake. Construction joint separations are too small and could permit pounding during an earthquake. Window and door openings and mid-height partition walls create short-column conditions. The staircase modules show excessive deflection.

Additional structural elements will be added to the buildings in order to increase their longitudinal stiffness. Two options are recommended: strengthening the unreinforced masonry infill walls by replacing them with reinforced masonry walls with proper connections to the concrete frames, or surface strengthening the existing walls with steel mesh and reinforced concrete. Separation joints will be added between walls and columns to mitigate short-column hazards. Supporting elements will be added to control deflection of the staircase modules.
