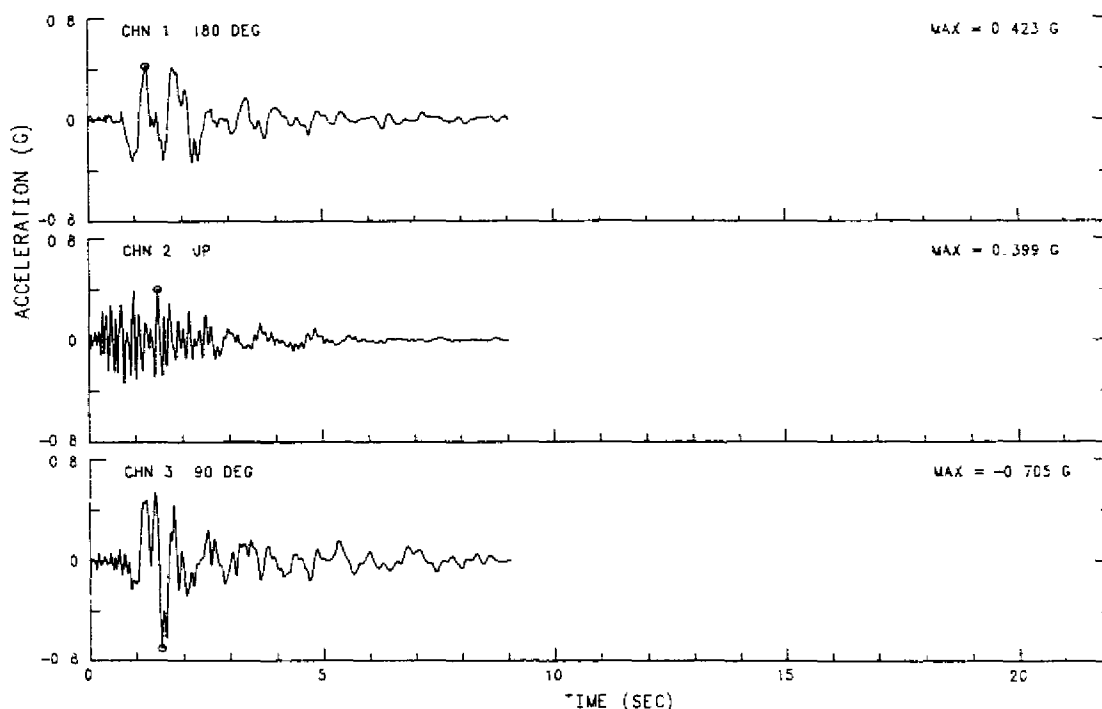
**Fig. 25 THE 1986 SAN SALVADOR EQ: ACCELEROGRAMS RECORDED AT THE GEOTECHNICAL INVESTIGATION CENTER (CIG) (Shakal et al. [26])**
