THE ARMENIAN EARTHQUAKE OF DECEMBER 7, 1988 [28, 29]. The main shock of this EQ, with a body wave magnitude M_b =6.3, corresponding to a surface wave magnitude M_s =6.8 and an estimated moment magnitude M_w =6.8, occurred at 11:41 am local time near the relatively new town of Spitak (population about 20,000), which is located midway between the cities of Leninakan (population about 290,000) and Kirovakan, 60 km east of Leninakan (population about 170,000). This main shock, with a focus (hypocenter) estimated at 15 km and with strong motion lasting nearly 30 seconds, caused catastrophic damage and was followed four minutes later by an aftershock with M_b =5.9, causing significant additional damage. Although the exact number of people killed is not known, official reports placed it at about 28,000 (ranging from 25,000 to 35,000) and unofficial reports gave a death toll ranging from 45,000 to 60,000. It has been estimated that about 130,000 people were injured, of which 18,000 required hospital care. The mortality among the injured was also high, particularly among those who remained buried alive for long periods of time. The number of people left homeless was estimated at between 500

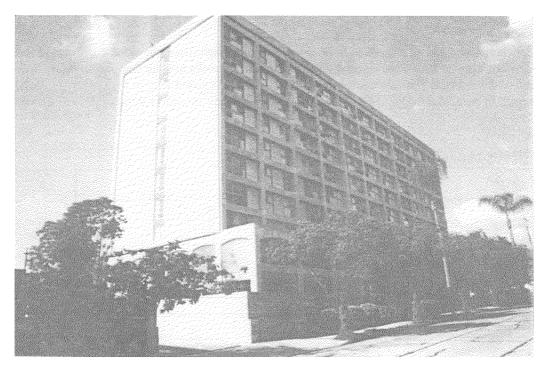
Fig. 28 GENERAL VIEW OF THE 10-STORY RC BUILDING WHERE THE ACCELEROGRAMS SHOWN IN FIG. 29 WERE RECORDED

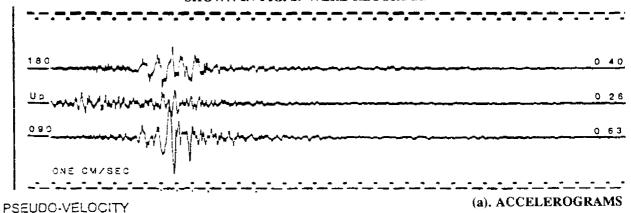
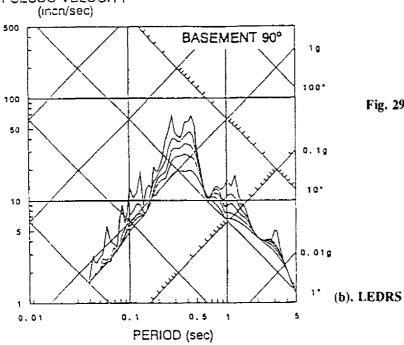
Fig. 29 ACCELEROGRAMS RECORDED
IN THE BASEMENT OF THE
BUILDING IN FIG. 28 [27] (a),
AND THE LERS FOR THE 90%
HORIZONTAL COMPONENT
(5=0, 2, 5, 10 AND 20%) (b)

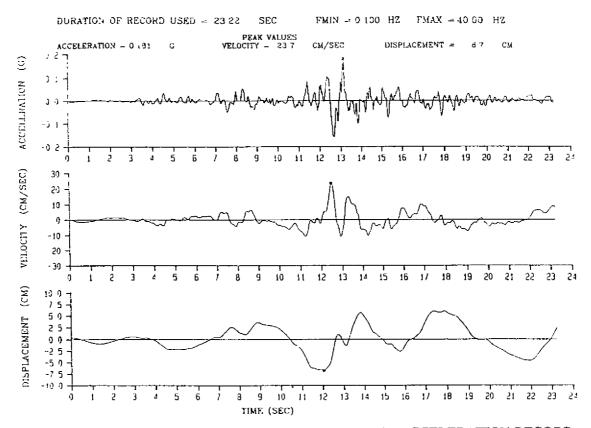
Fig. 31 1989 ARMENIAN EQ, GHOUKASIAN: FILTERED ACCELERATION RECORD FOR TRANSVERSE HORIZONTAL COMPONENT WITH COMPUTED VELOCITY AND DISPLACEMENT.
