# BULLETIN OF EARTHQUAKE RESISTANT STRUCTURE RESEARCH CENTER

# Report of the Damage caused by the Mid-North Iwate Earthquake of September 3, 1998

Kazuo KONAGAI, Atsushi MIKAMI, Toshihiko KATAGIRI, Raquib AHSAN  
and Daisuke MARUYAMA

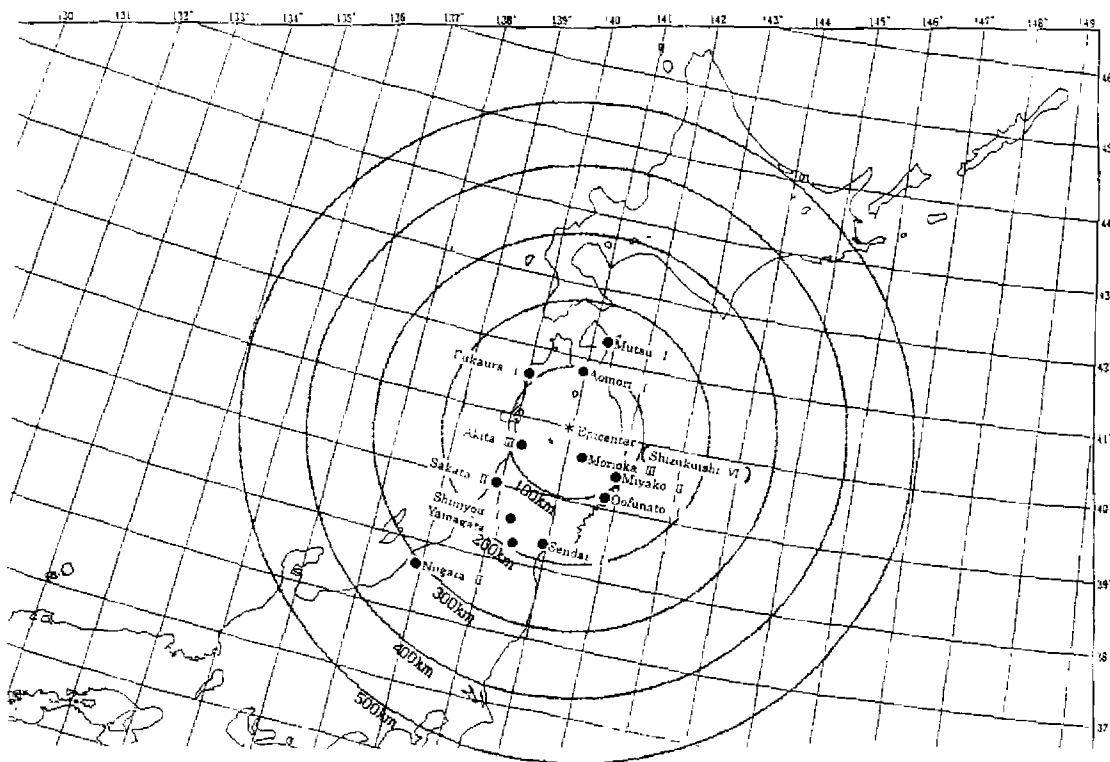
An intense earthquake shook northwestern area of Iwate prefecture at 16:58, September 3, 1998, injuring 10 people. An intensity 6-weak on the Japan-Meteorological Agency (JMA) scale of 7 was registered in Shizukuishi (Fig. 1), the one of two biggest shakes exceeding 6 we have had in Japan since the latest revision of the JMA scale in 1996. The hypocenter of the earthquake (39.8N, 140.9E, focal depth = 10 km, origin time 16:58, JMA) was located about 20 km north-west of Morioka city. The magnitude of the main shock was 6.1 on JMA scale.

Fig 1 Epicenter and JMA intensity distribution

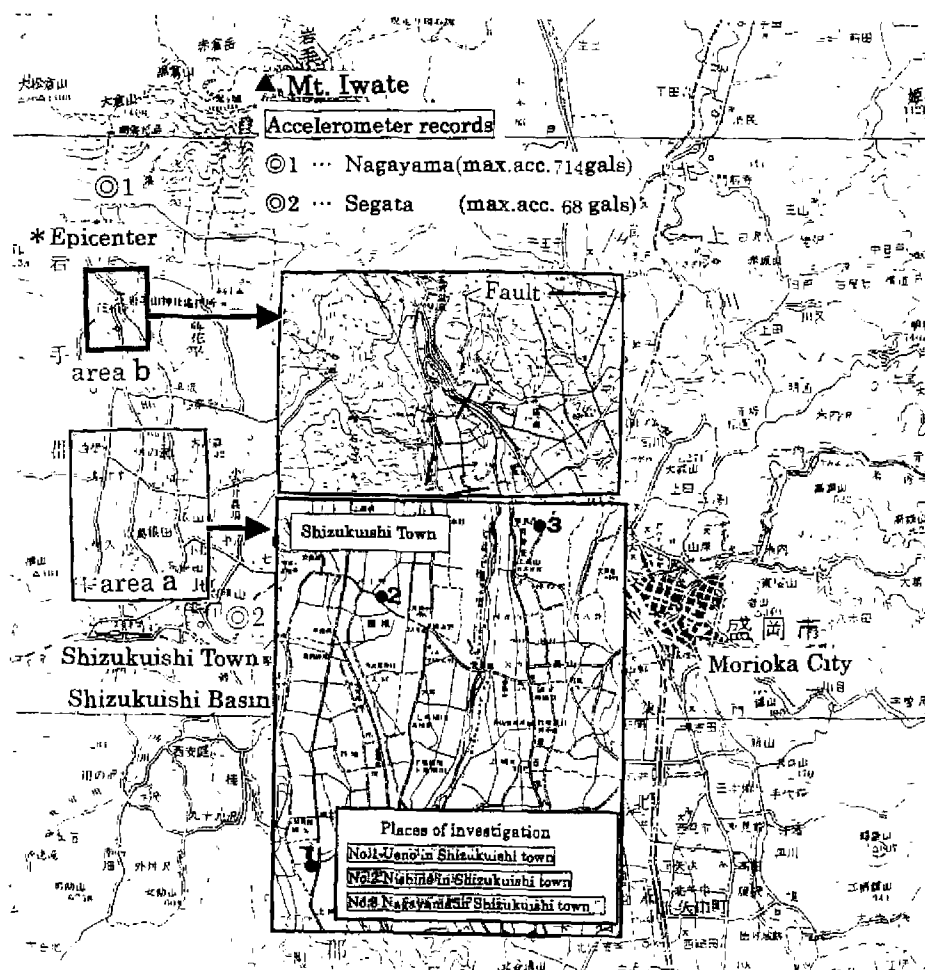
The authors investigated the damaged area (Sept. 5-7 and Sept. 9-11) in Shizukuishi (Fig. 2). Within the limited time, they made every effort to find the damages caused by largely deformed soils. Their findings are hereby discussed being based on the observed records.

Fig 2 Investigated area

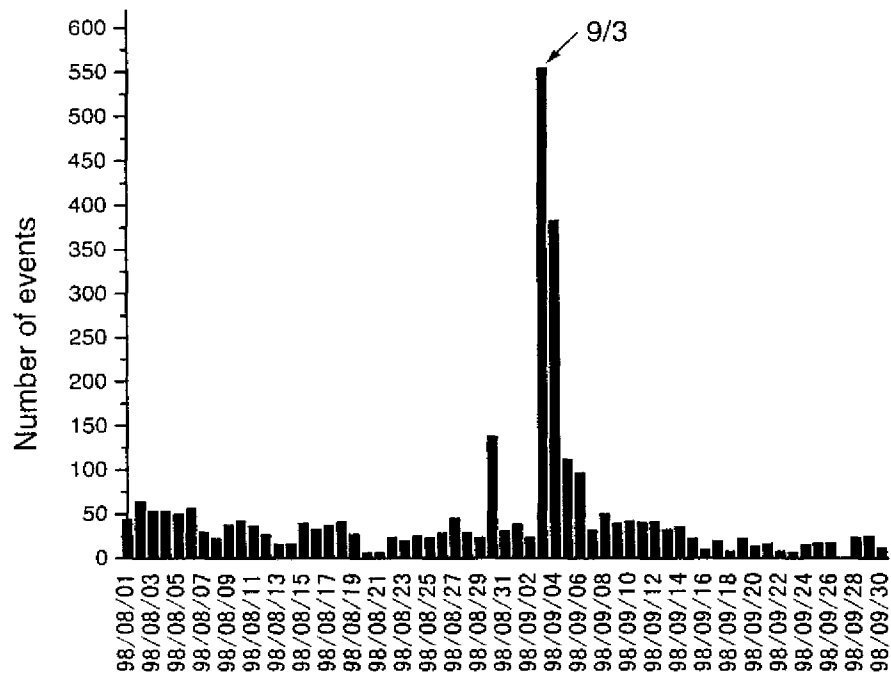
Fig.6 Number of tremors observed (Matsukawa observation station, Tohoku University)  
(provided by Japan Meteorological Agency)
